MAIN CONTROLLER AAAA0079 INSPECTION

Date: 25th June 2020
Revision: 1.0
Author: Tony Little
Product: Electric Skateboard
Company: Globe Brand

Customer return. Charger failure.

2020-06-05 - Battery current sensor fault (water ingress?). Battery charger failed.

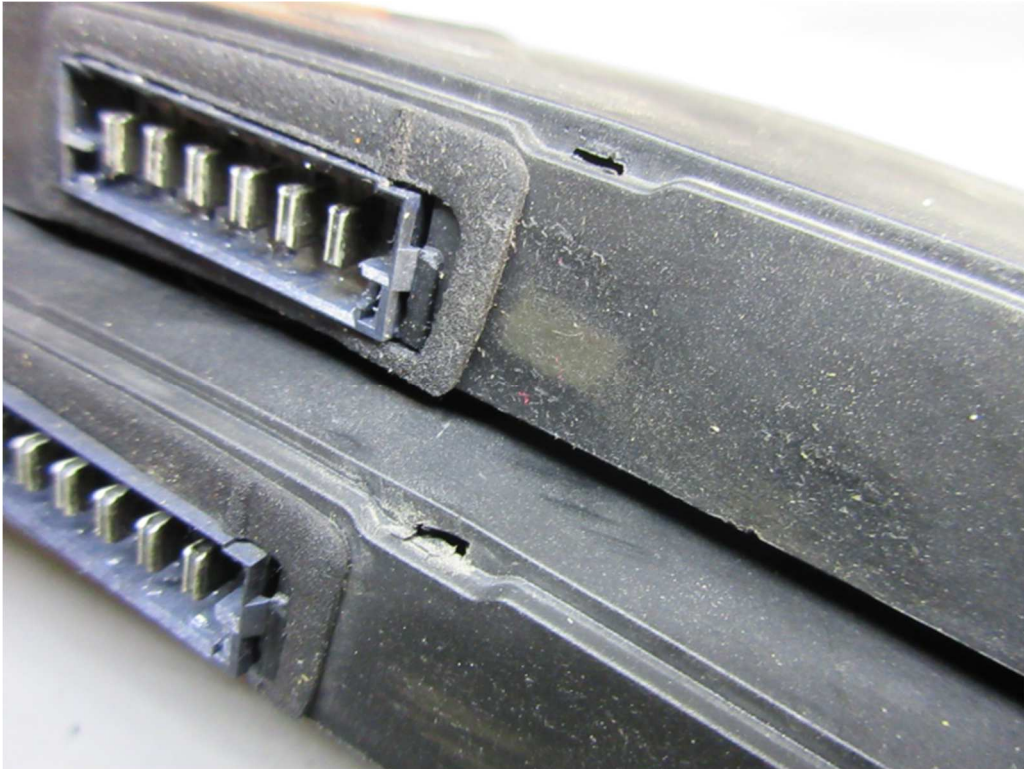
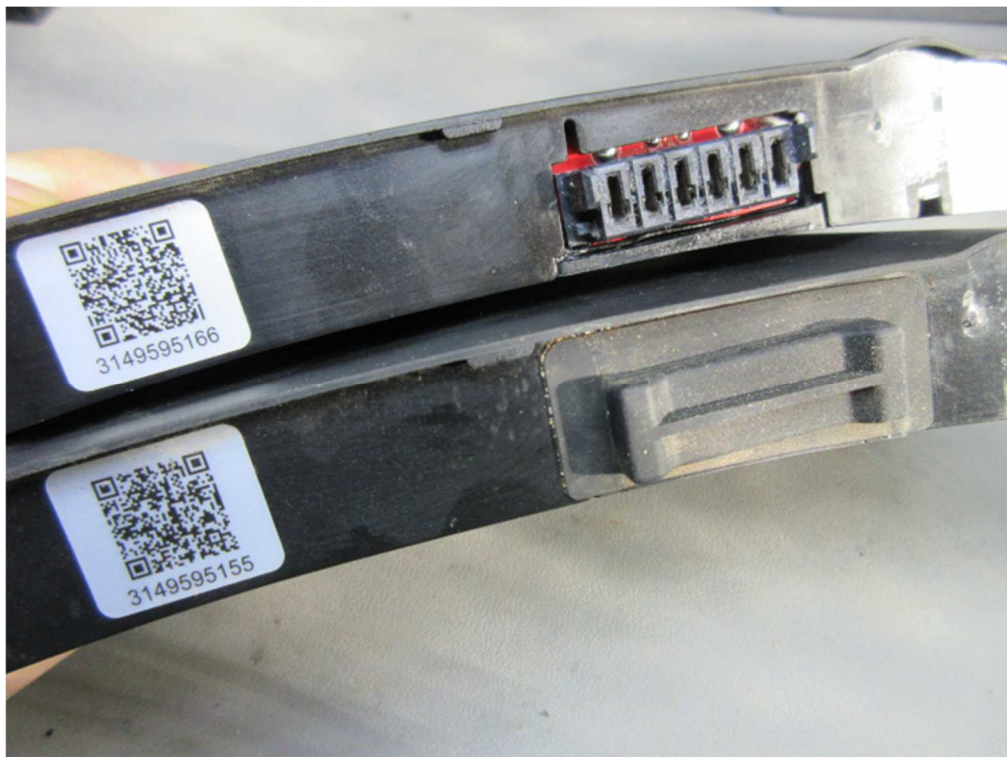
Not surprising to find the modules dirty given 366km traveled.

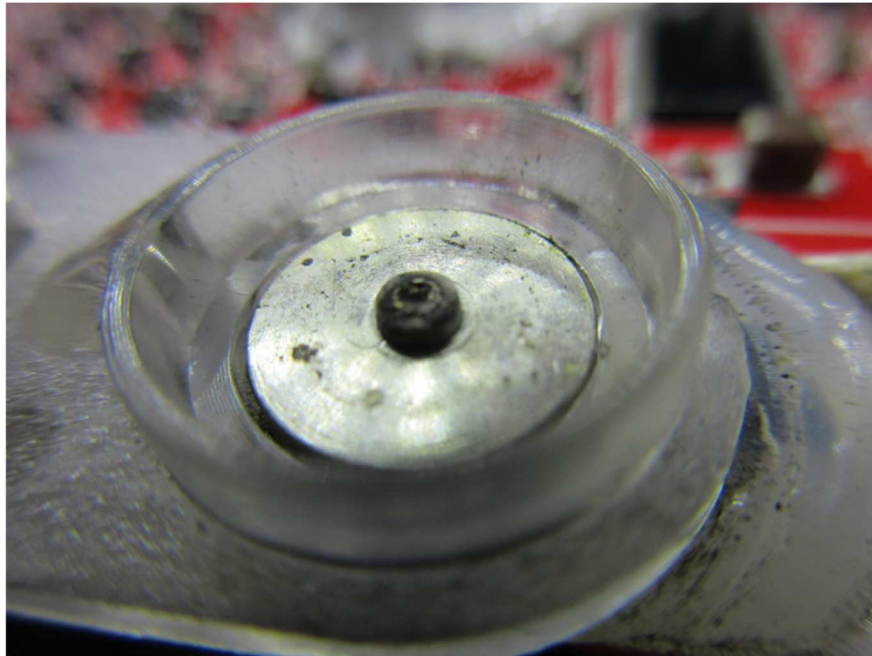
The image below is of the charging connector AFTER being cleaned. The center pin has quite significant arcing damage. The negative contact has some arcing damage. This is likely a result of dirt preventing sufficient electrical contact.

The battery charge port cover was missing. The charging connector was contaminated with an excess level of dirt. Arcing damage is evident. Significant electrical corrosion damage is evident on the PCB soldering of the magnetic connector. This occurred from charging while water was present on the circuit board. Water may have contributed to the connector damage.

Both magnetic receptacle and charging cable would need to be replaced. Replace charge port cover required.

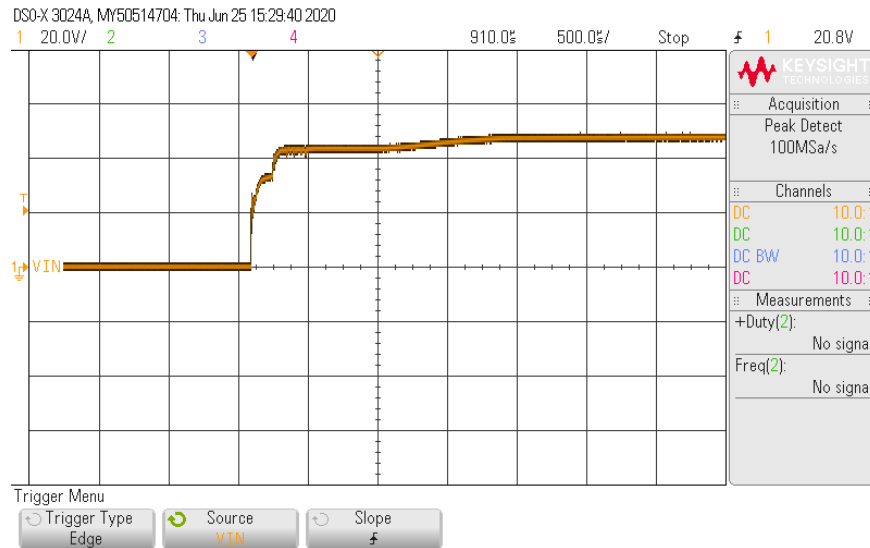
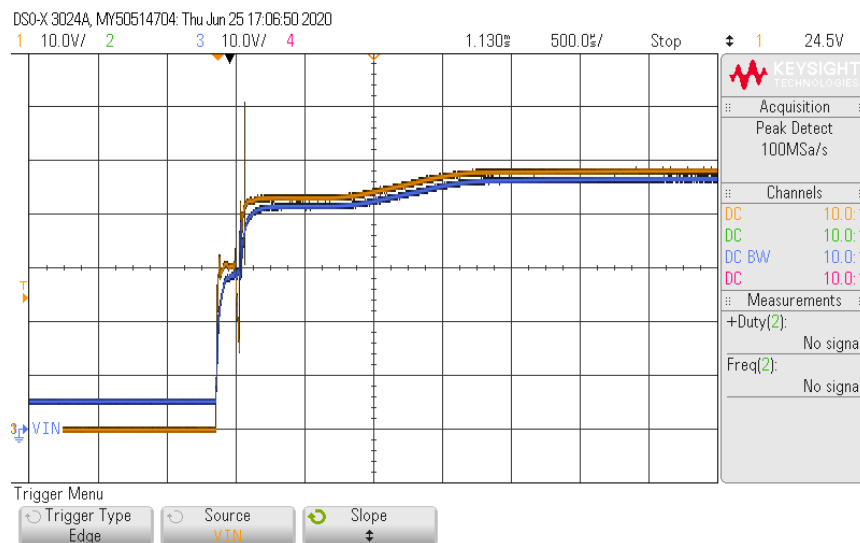
60V transient captured with one connection. Blue trace taken after FET switch, but prior to PI filter. Snubber performance was excellent in filtering harmful spike.

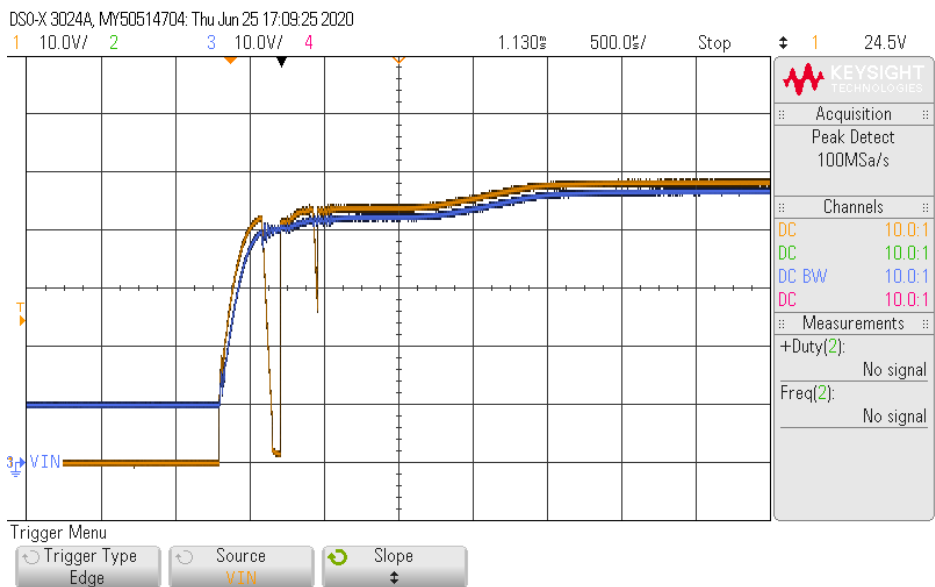
Input circuitry (blue) successfully filters connection disturbance (yellow).

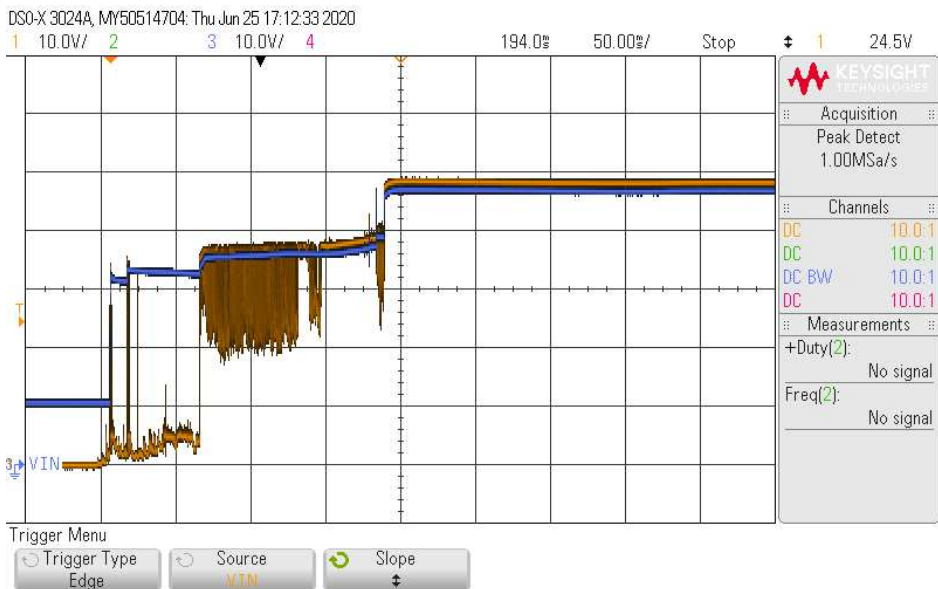
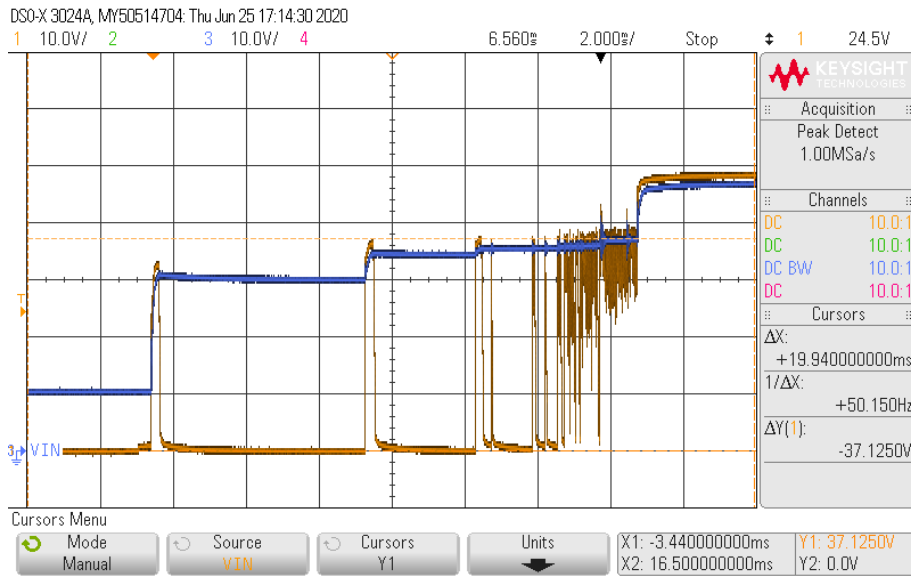
Worst case examples. Connector fitted on an angle with some restraint.

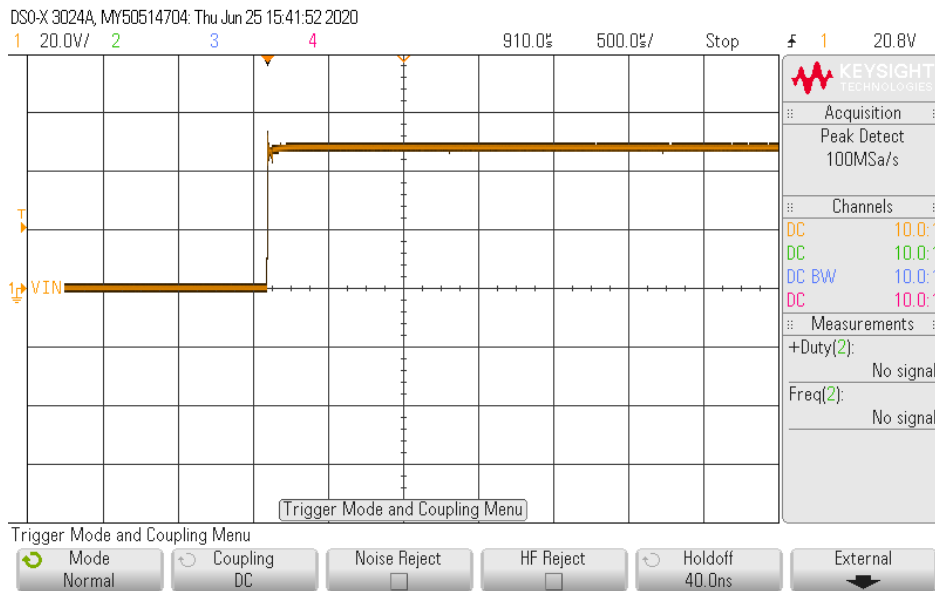
Example below shows the connection to a well-used development board, which has a socket in good condition. The same charger and charging cable was used.

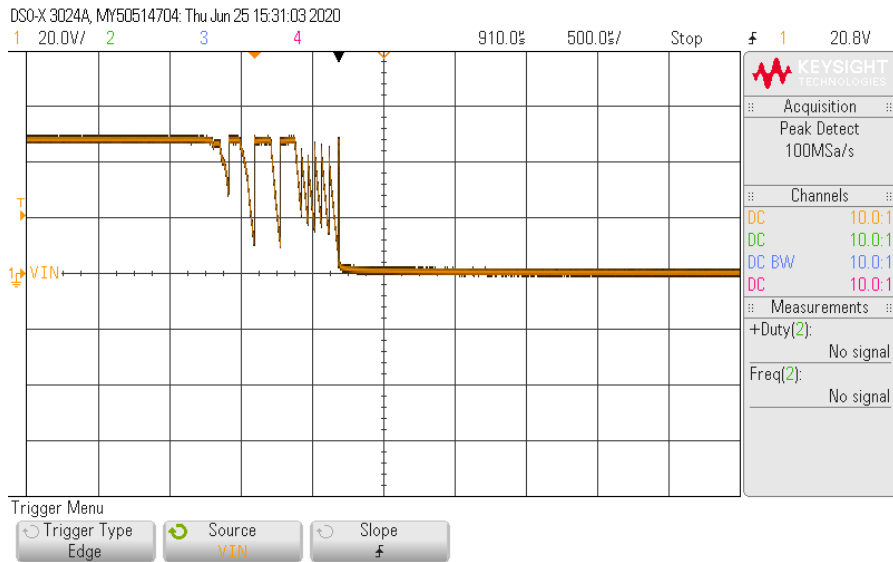
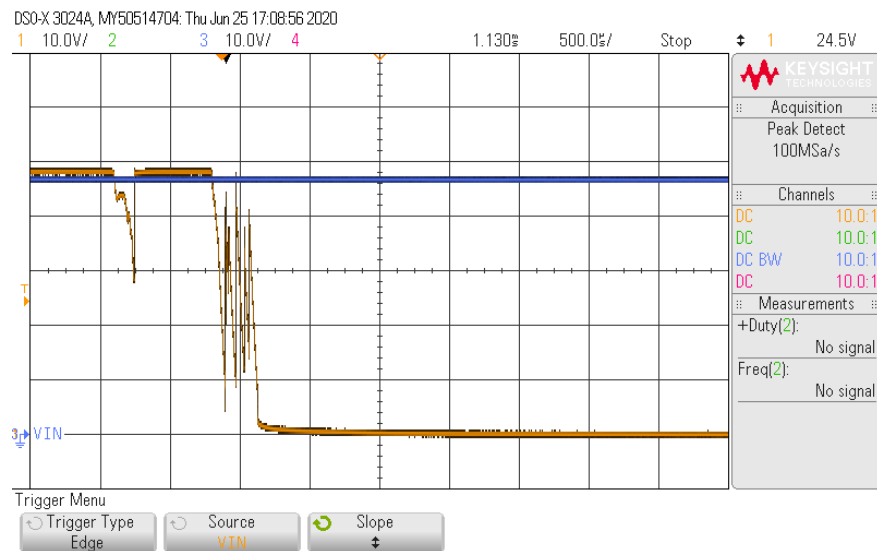
Terrible disconnection transitions....

The damage to the charging connector causes excessive connection and disconnection noise. This was inspected closely to determine if this could cause the battery charger to fail. The magnetic input switch circuitry, filtering and noise snubber were all performing as intended. These collectively prevent this connection/dis-connection noise from propagating through to the battery charger regulator.

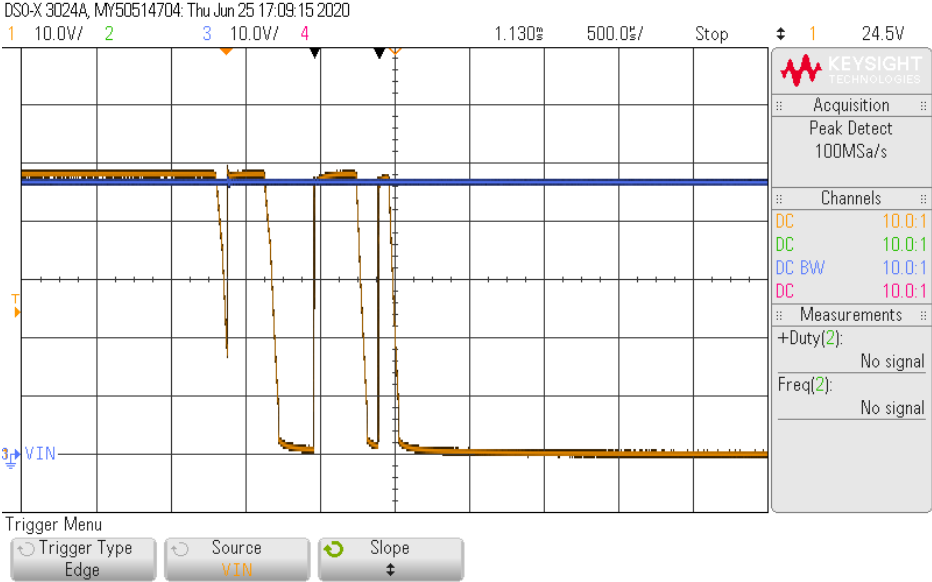
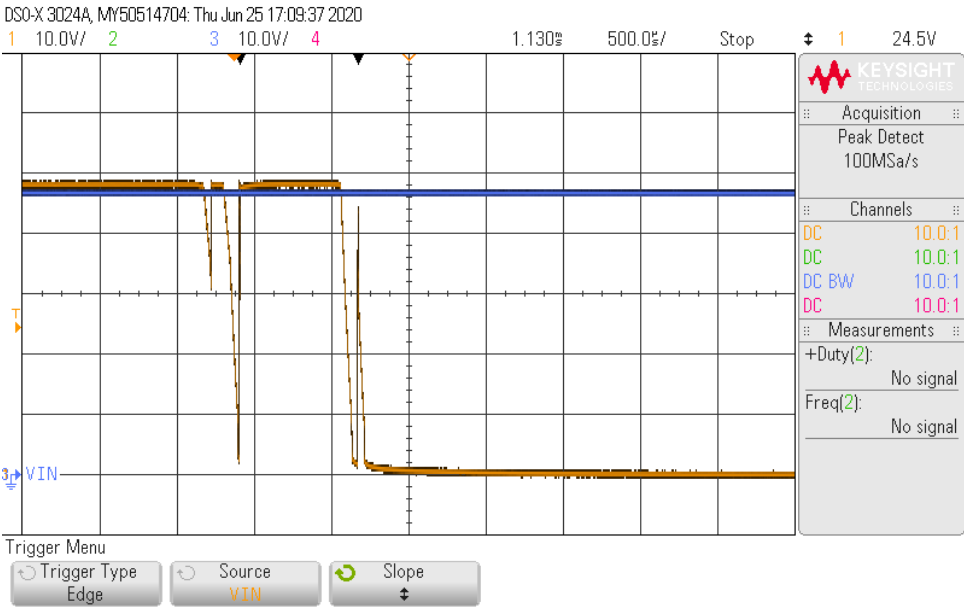
The input connection system (blue) electronically disconnects from the input (yellow) with a seamless transition. The system holds the voltage stable with input capacitance, preventing the disturbance from causing a negative offset across the battery charger.

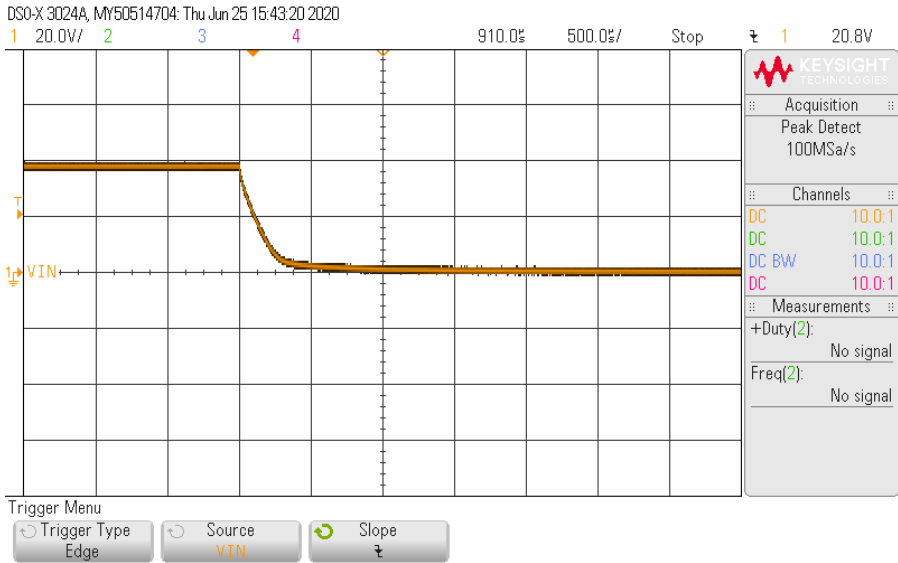
Very clean disconnection. Quite the contrast to the damaged receptacle.

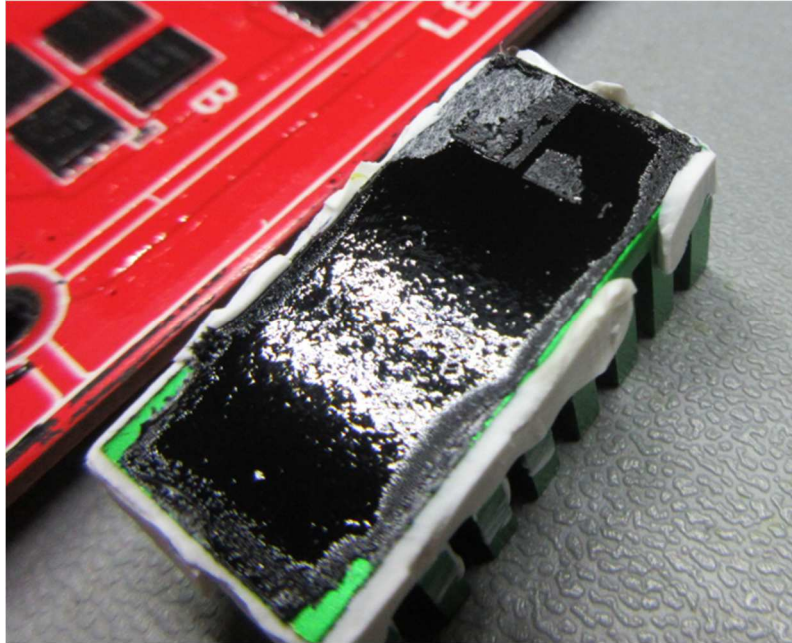
Heatsink had insufficient contact with MOSFETs. No contact with battery charger IC.

MOSFETs pass diode test; not shorted.

Battery charging failure likely the regulator chipset. Not replaced to check.

The battery regulator chipset has failed. Cause cannot directly be determined. The charging chipset needs to be replaced.

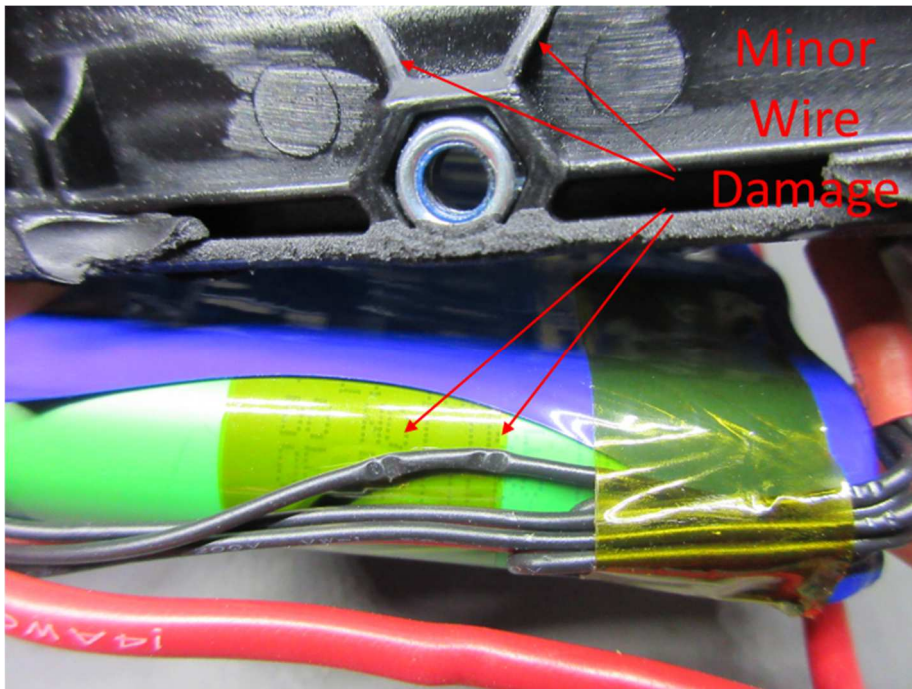
Minor wiring damage noticed on the battery balancing wires. This has not caused any issue.

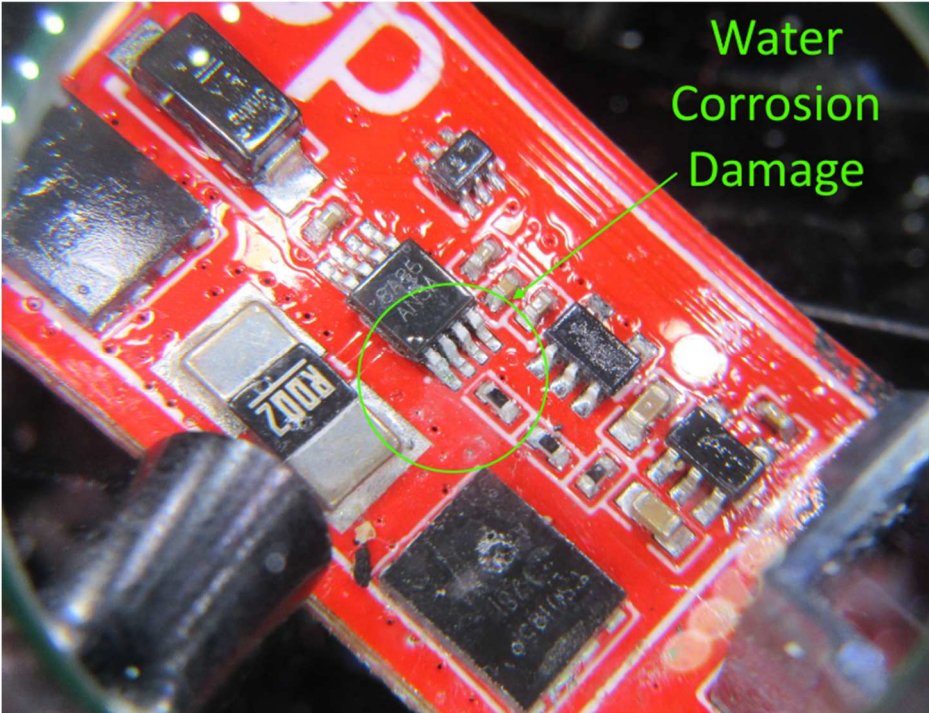
Water corrosion damage is most evident on the circuitry. Specifically the susceptible high voltage circuit connections. Conformal coating decayed.

The battery modules both exhibited water corrosion damage, congruent with the faults logged. Water ingress appears localized to the drain hole.

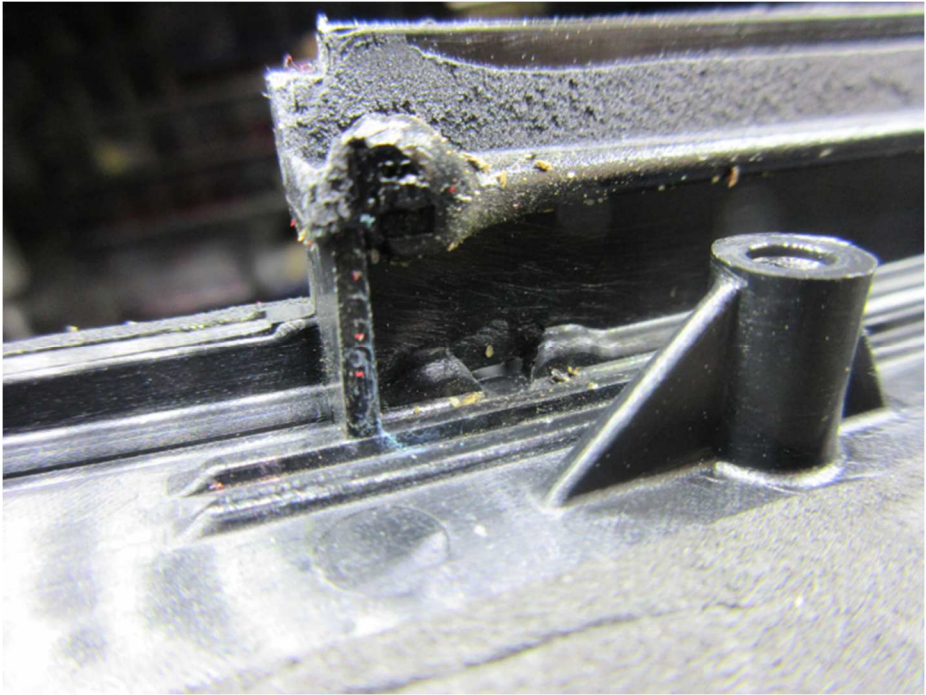
The water ingress appears to have occurred at the drain hole. The noticeable debris is isolated to this location. Water spray from this location direct faces the effected area on the circuit board.

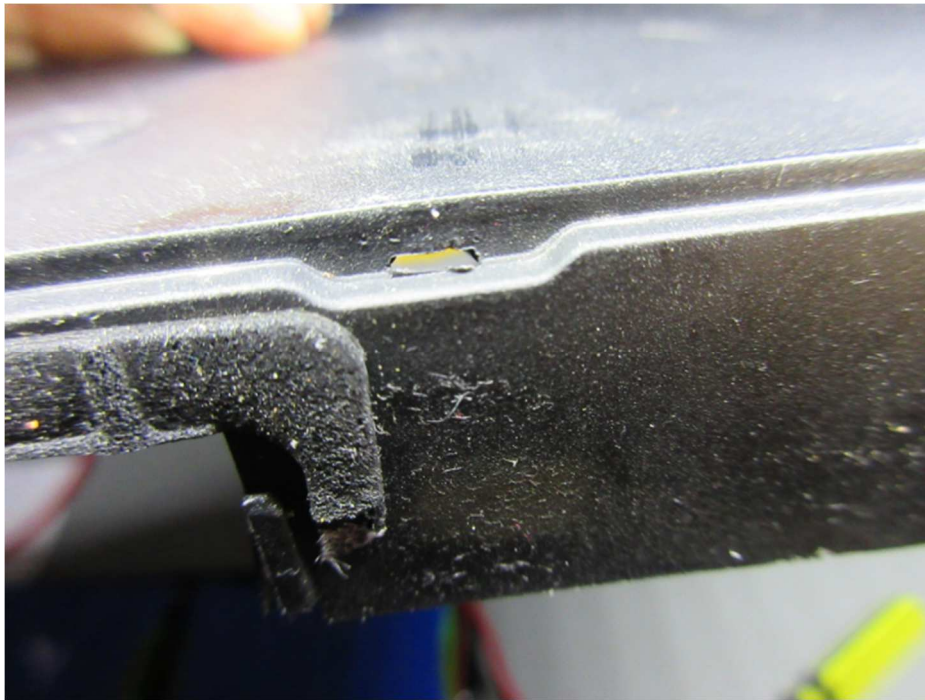
Pictured below is the external view of the drain hole.

Note, the torn gasket was from disassembly.

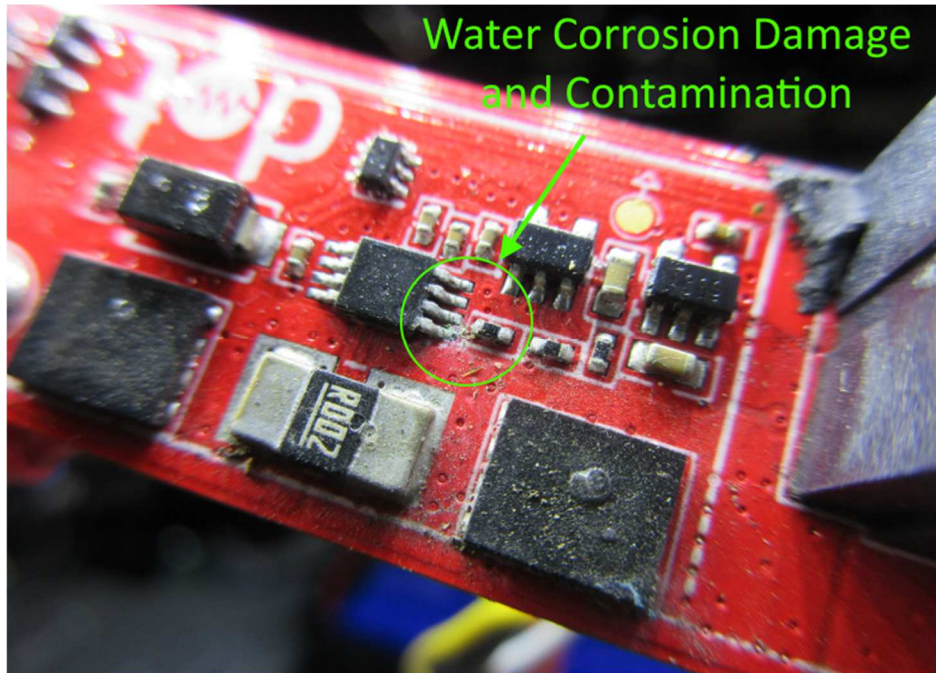
This battery module has identical circuit corrosion damage. There is more residual dirt contamination to this area than the other battery module.

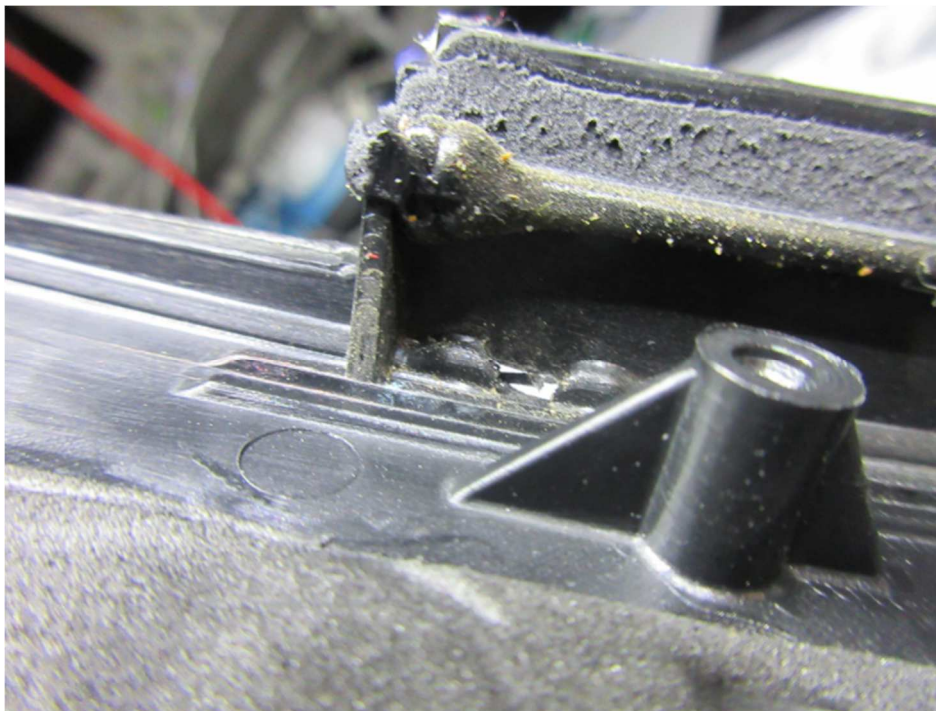
The water ingress again occurred at the drain hole. The residual dirt contamination is isolated to this area in the battery cover. The rest of the enclosure, PCB and battery pack are otherwise quite clean.
