# PRODUCTION INSTRUCTIONS

## BATTERY MODULE PCBA

**Date:** 10-7-2020  
**Revision:** 1.0  
**Author:** Tony Little  
**Product:** Electric Skateboard  
**Company:** Globe Brand

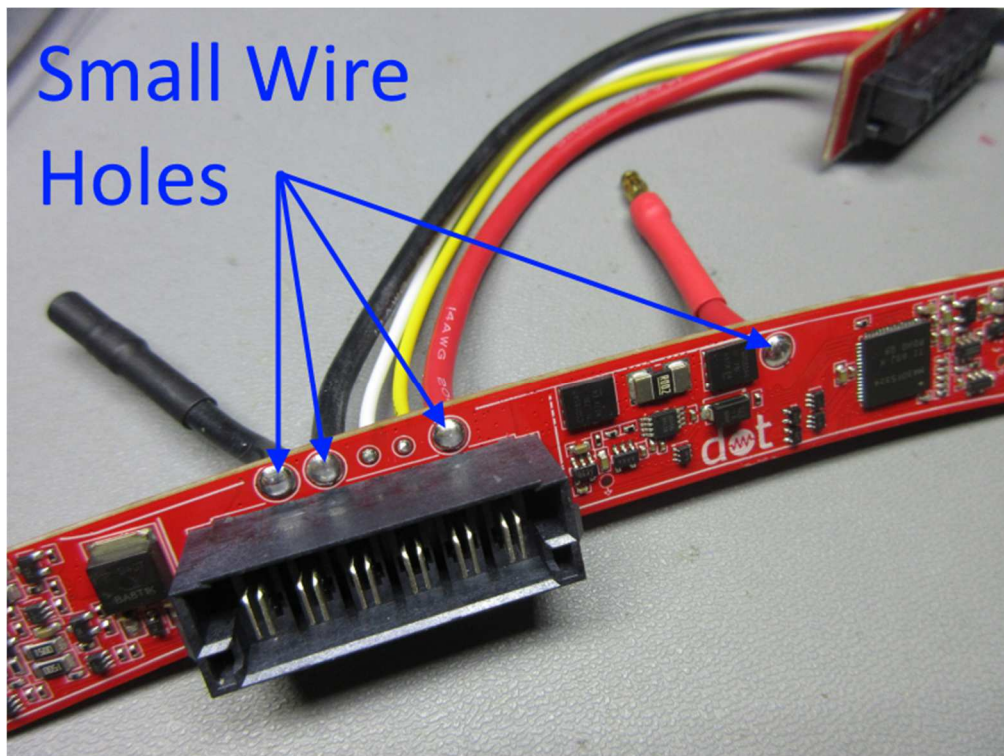
### 4.1 RECOMMENDED CHANGE – WIRE HOLES

The AWG14 wires on the battery module were not getting sufficient solder wicking in the through hole. This wiring has fine strands and there is less void in the wire cross section for solder to wick.

It is permitted to change the PCB drill file to increase the 4x 2.4mm plated through holes, to 2.6mm.

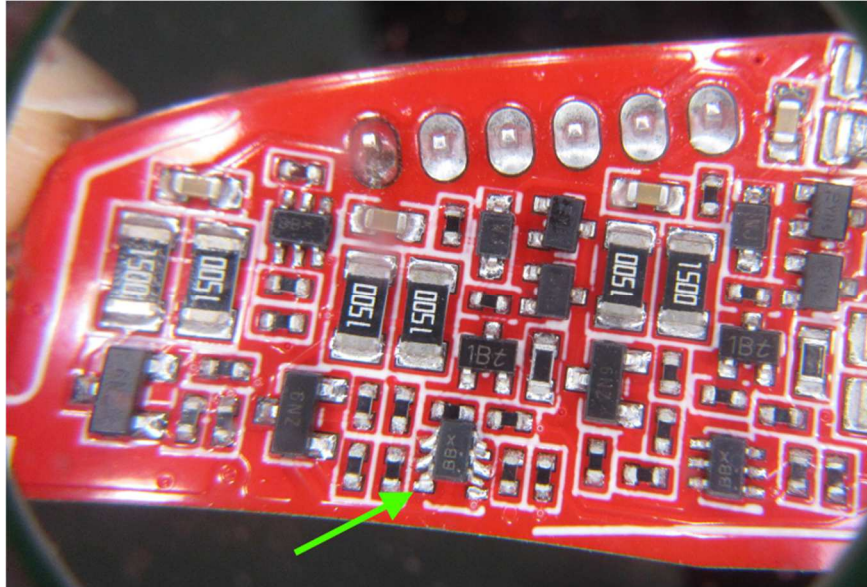
### 5.1 COMPONENT PLACEMENT

Component T3\_B2 (SOT363) was mis-aligned to same effect for several boards.

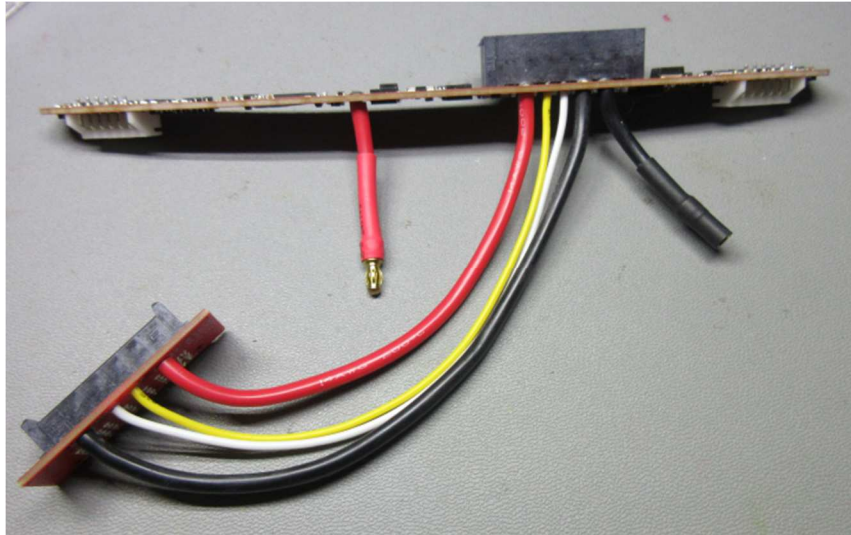
## 5.3 TINNED WIRING

Union supplied wiring. Tinned ends had insufficient stripped length. Kenly advised Union need to revise stripped length to 2.5mm.

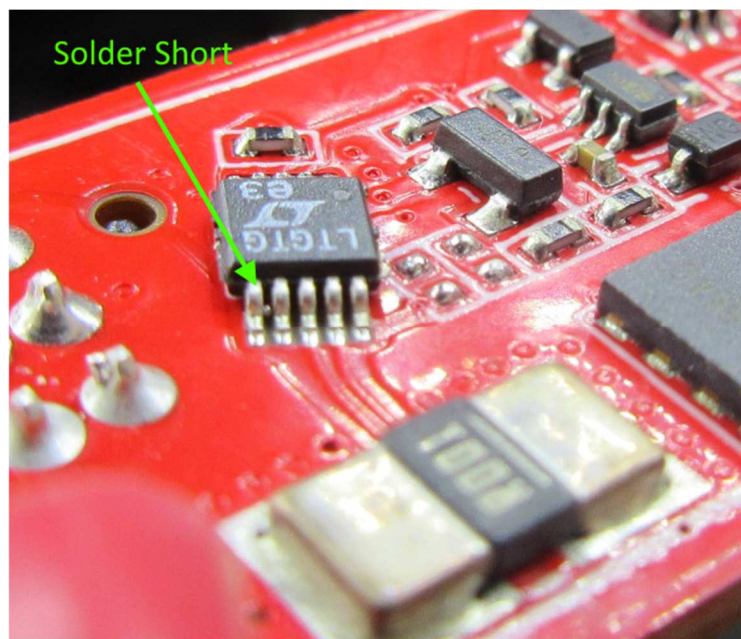
### 6.1 IC9

A low number of IC9 (LTC4368IMS-1#PBF) failed initial testing. Only 1 was found with a solder short. There is some concern two reflow cycles and two wave soldering cycles may have contributed to the device failure prior to use.
