PRODUCTION INSTRUCTIONS

MAIN CONTROLLER PCBA

Date: 10-7-2020
Revision: 1.0
Author: Tony Little
Product: Electric Skateboard
Company: Globe Brand

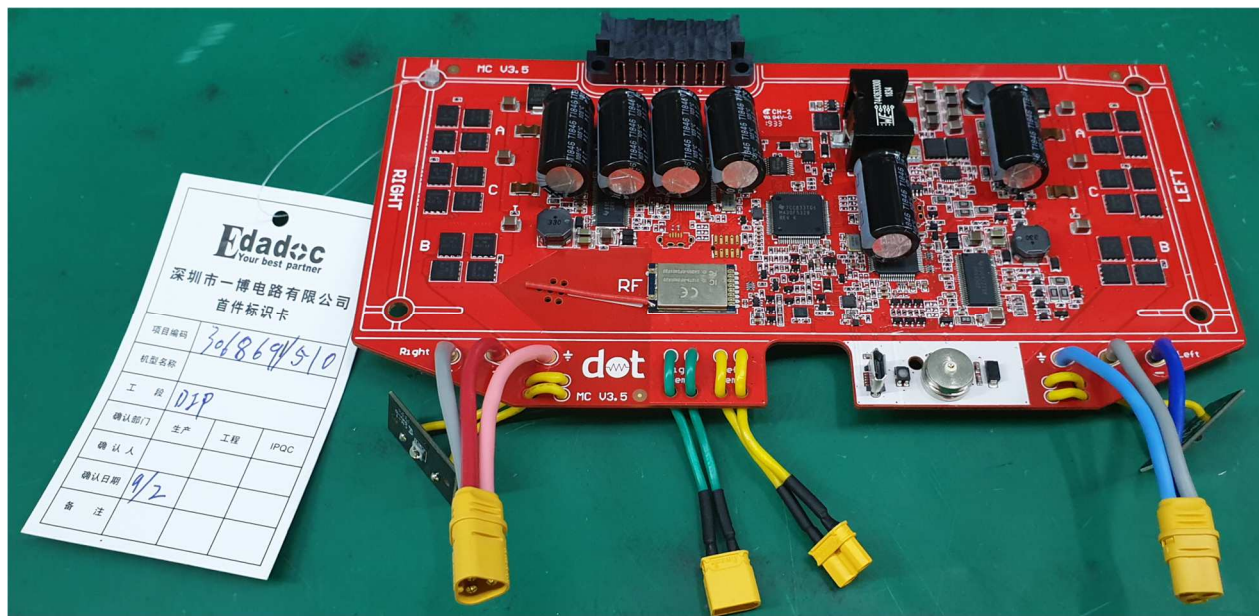
Heatsinks not fitted.

Heatsink supplied separate.

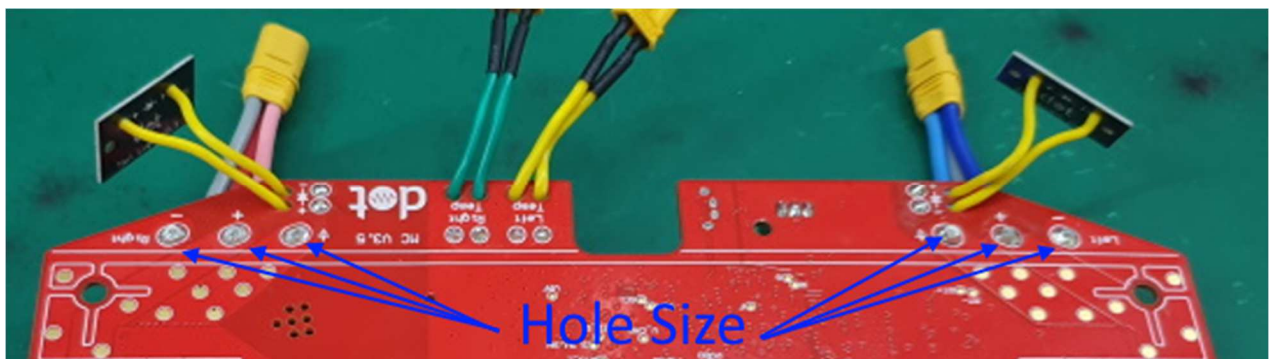
4.1 RECOMMENDED CHANGE – WIRE HOLES

Comport wiring was not previously to the correct tinned specification. Tinned wiring did not fit in the 1.9mm holes. Production required wires to be trimmed.

It would be recommended to revise the drill file for PCB manufacturing to increase these 6 plated through holes to 2.2mm. This will reduce the chance of tinned wire re-work and improve solderability for correct specification multi-strand wiring.

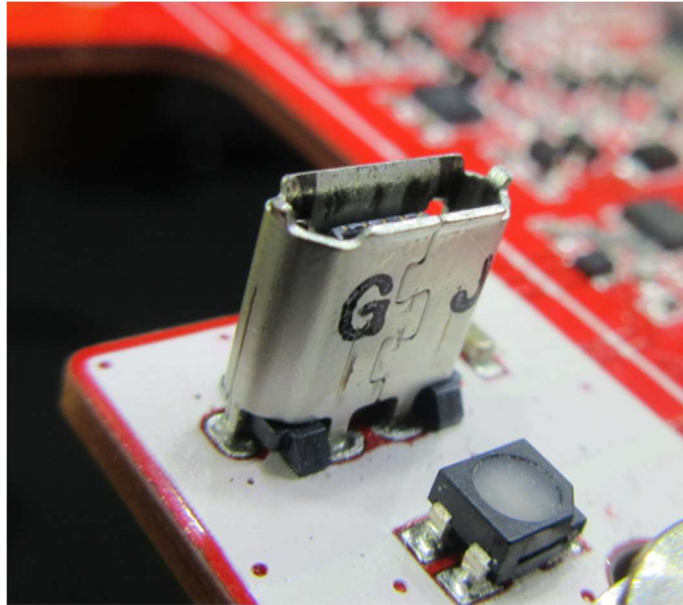
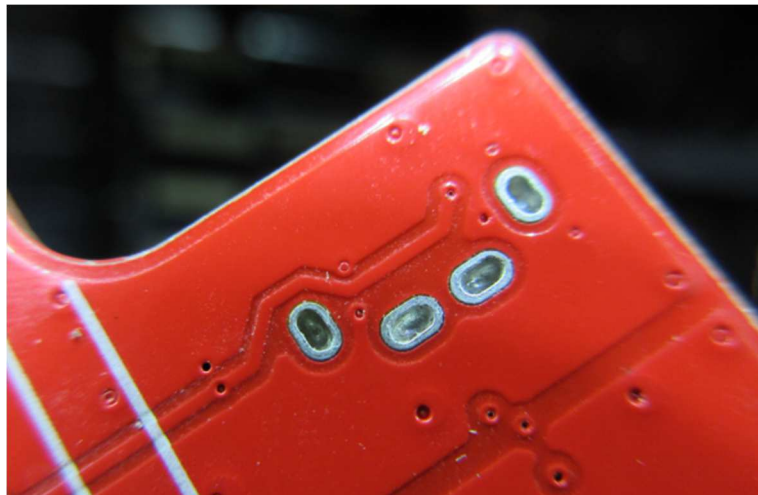
5.1 CN12, USB CONNECTOR SOLDER

The solder fill for the USB chassis through hole mounting is insufficient. USB connector retention is less than required.

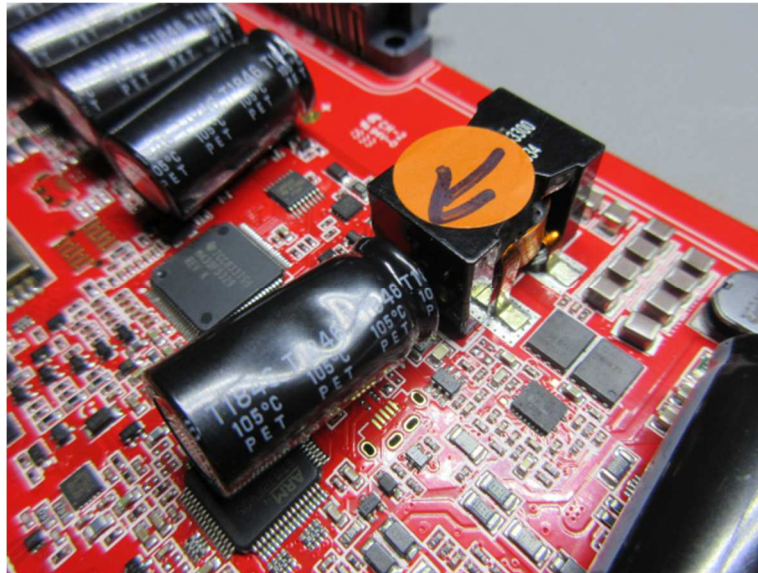
5.2 CAPACITORS

Ensure capacitor damaged is avoided.

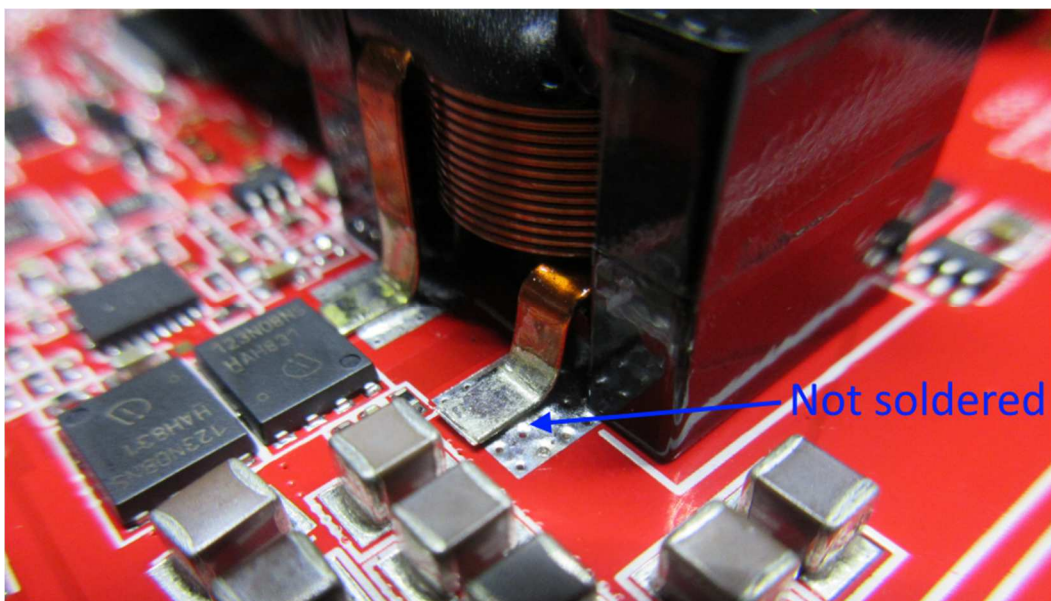
5.3 INDUCTOR L3

Large surface mount inductor requires visual inspection to ensure terminals are soldered.

Example below show terminal left unsoldered.

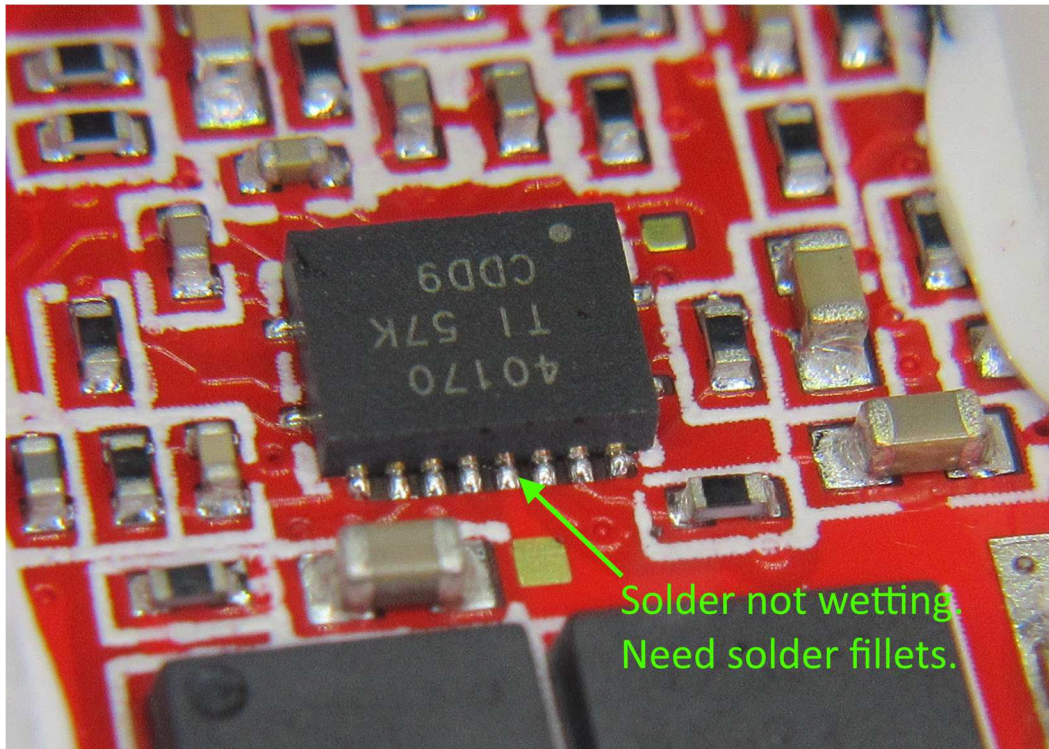
5.4 IC2, TPS40170RGY

There has been a production issue associated with IC2 that has resulted in an unacceptable 6.5% failure rate. Looking for where to minimise potential failure causes. There is some concern the soldering may contribute to the failure. It is common to find this IC does not have solder wetted to form a proper fillet to the terminal sides. Moisture / shelf-life may contribute to the low solder wetting.

Could Union please consider how to improve IC2 solderability?

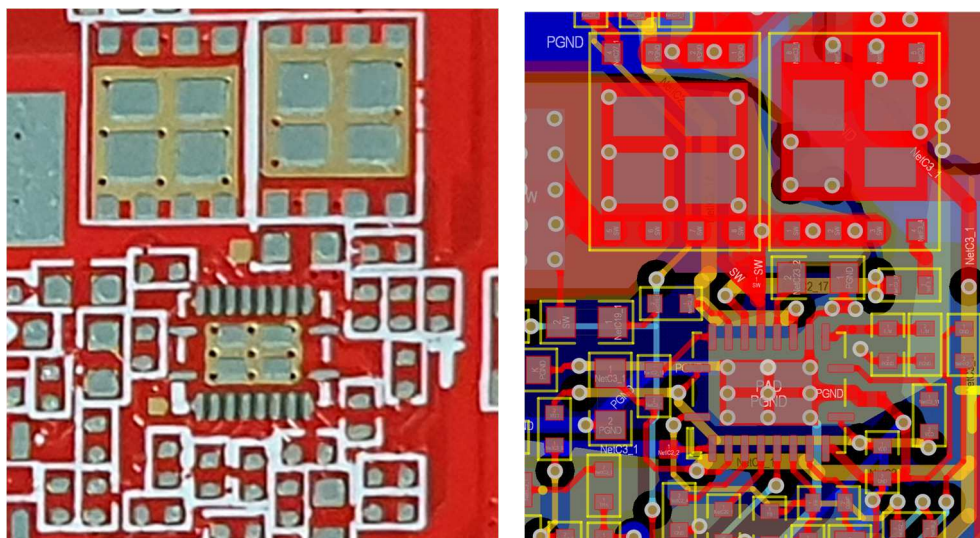
The solder paste design and resulting stencil printing looks good.

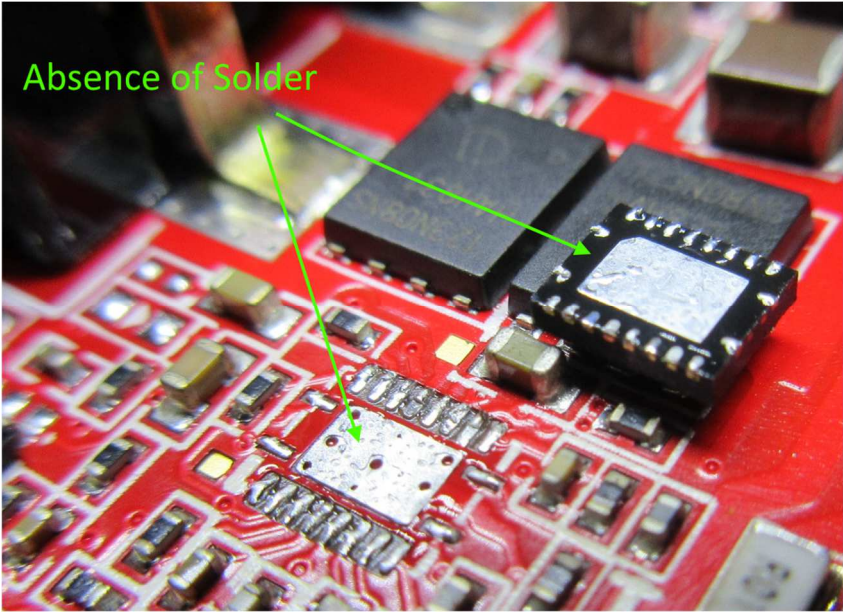
The 0.3mm vias may be wicking some center pad solder.

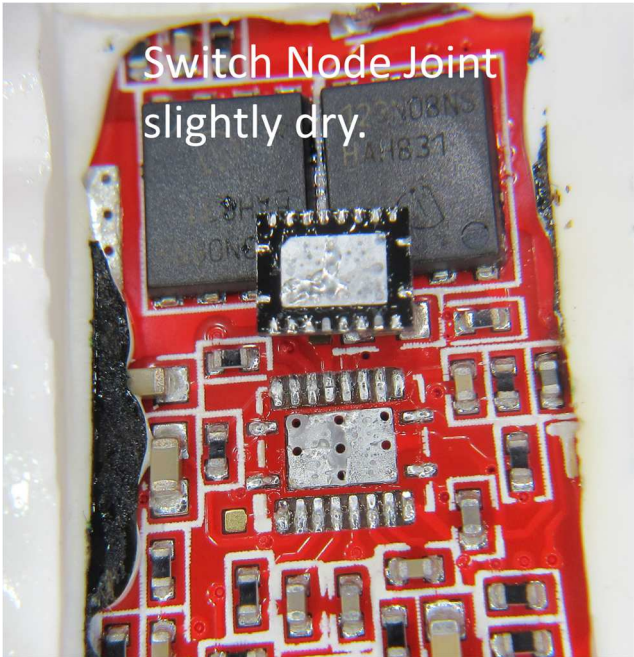
The top layer copper is 70um and the center pad has significant thermal heat sinking. Reflow infrared may have some shadow from the nearby large inductor. These both may reduce reflow heat for good wetting.

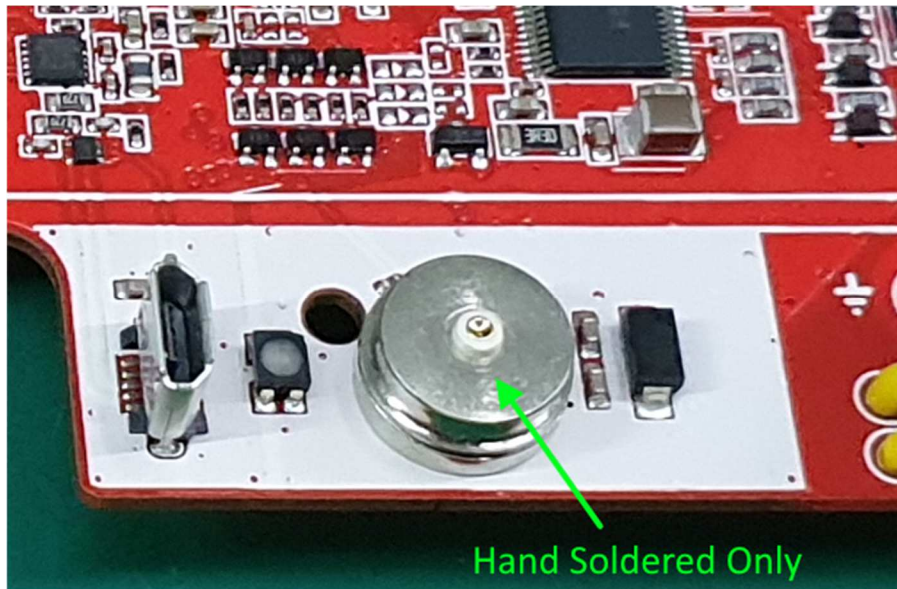
5.5 CN7, MAGNETIC CONNECTOR

Important reminder... connector must be hand soldered after wave solder process. **Do not wave solder.** The connector is magnetic and must not be subjected to high heat.
