PRODUCTION INSTRUCTIONS

REMOTE CONTROL PCBA

Date: 10-7-2020
Revision: 1.0
Author: Tony Little
Product: Electric Skateboard
Company: Globe Brand

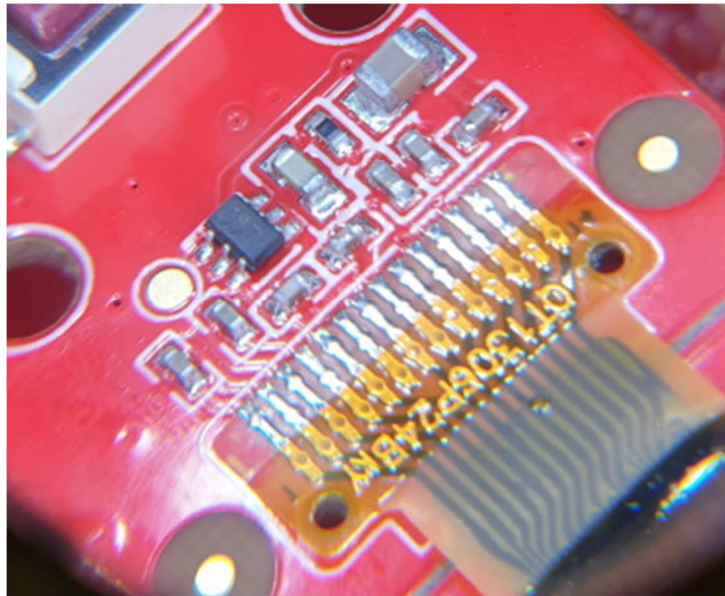
In previous production, Union provided feedback on the OLED tab soldering position. The OLED tab overlays the footprint exactly. It is not offset to allow soldering inspection at the edge. This offset could be accommodated by moving the tab alignment holes in the PCB.

Tab soldering in production was good.

The 1.0mm non-plated alignment holes were tight for managing tab alignment pins. It would be recommended to increase this hole size to 1.10mm.

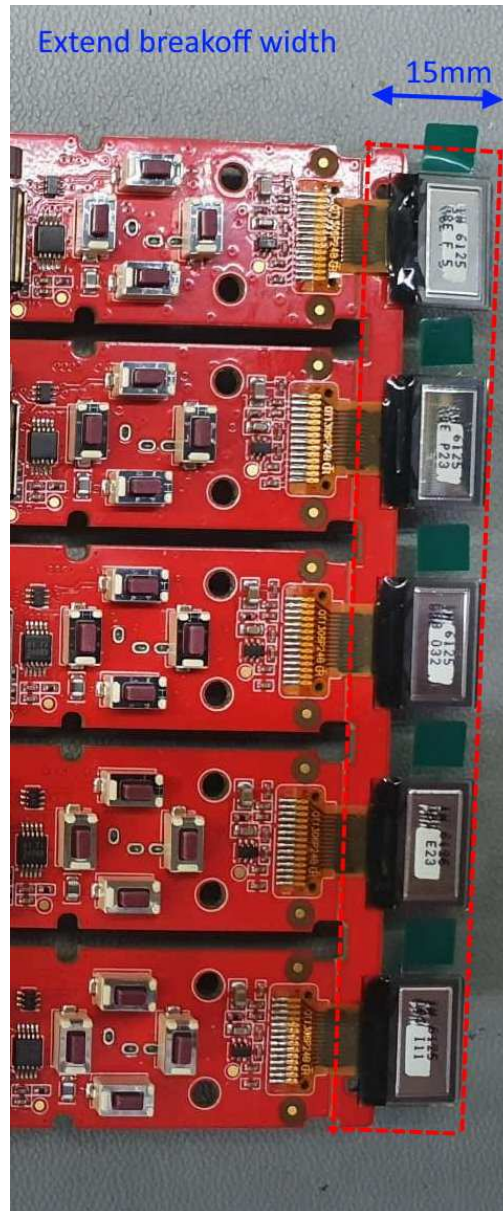
OLED damage had occurred from panel handling. The current panel used in production has 5mm breakoffs. The breakoff width needs to be increased to support and protect the OLED for handling and shipment. This tab must be 15mm.

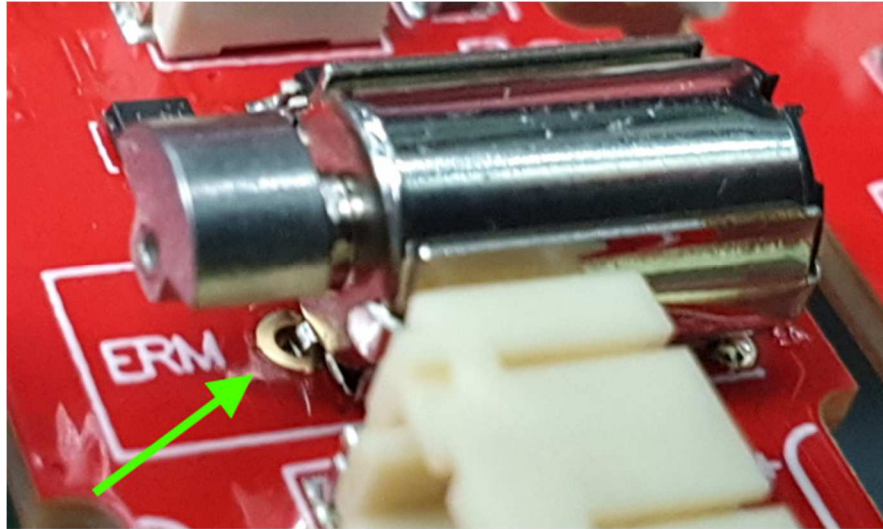
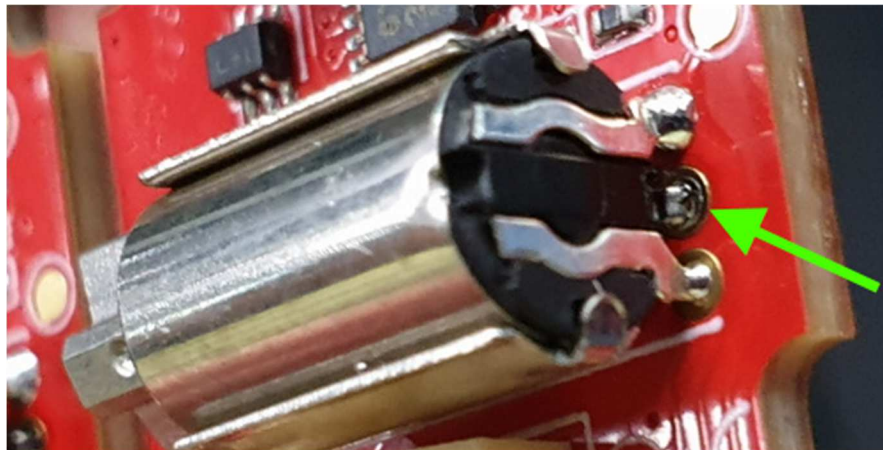
ERM soldering was a significant issue. The solder is not sufficiently wet in the through hole. This soldered joint needs to be improved.

Recommend production first uses higher temperature to achieve better through hole filling. Do not rely on re-work to achieve solder fill.

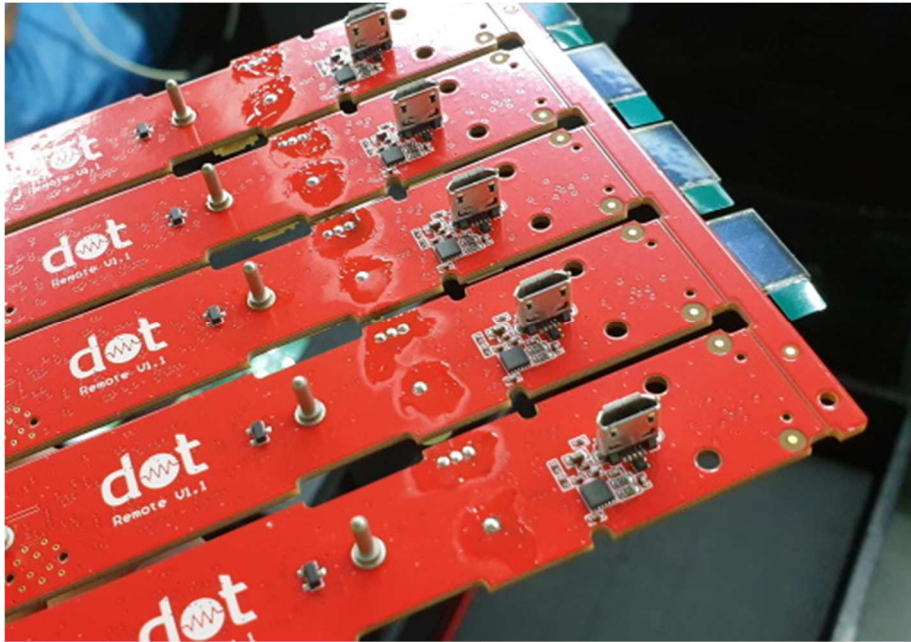
Union Circuits attempted to re-solder all these joints, however re-wetting the existing joint was not effective.

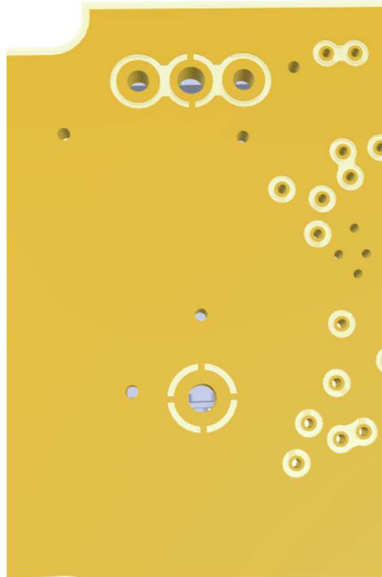
The copper pour on the PCB design is connected with thermal reliefs only on top and bottom layers. Internal layers have pad geometry for all 4 through holes, but no connection. Future PCB revision could remove pad geometry from internal layers only.

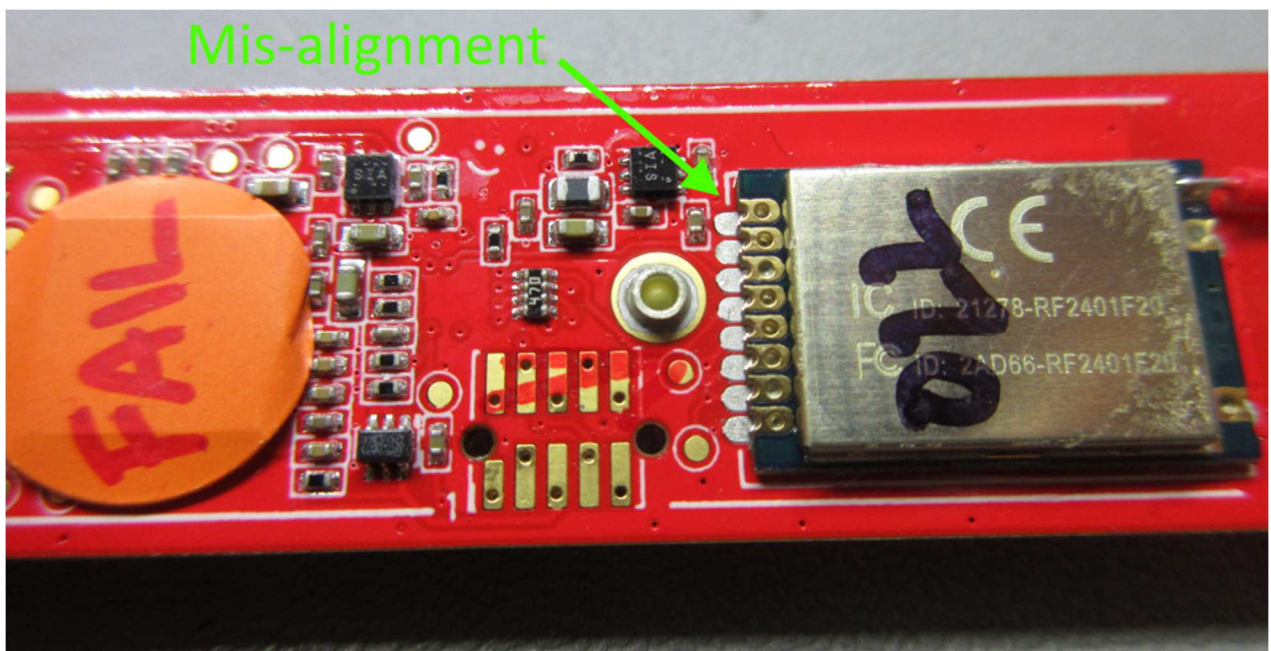
IC7, RF2401F20

Footprint mis-alignment of this module resulted in failed boards. Alignment error was a production issue.

This must be improved, as many examples had poor soldered alignment.

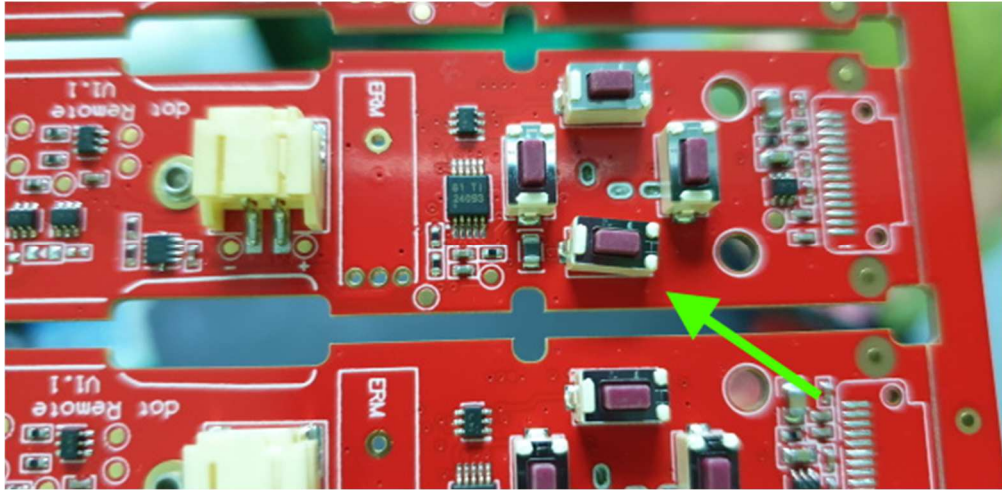
Rare issue. Tactile button misaligned.

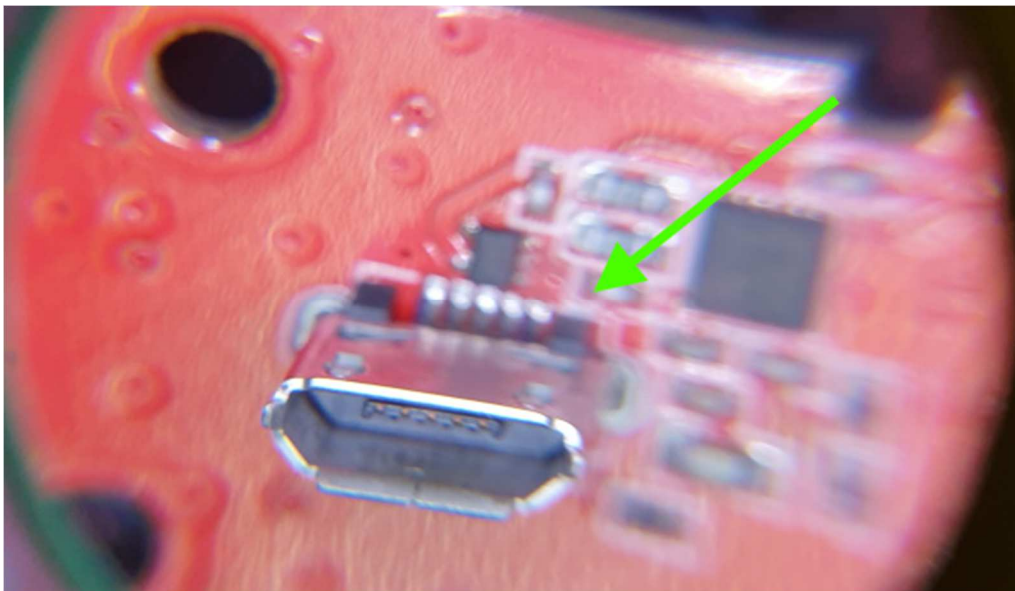
Placement error resulted in re-work for USB connector. Check placement prior to reflow.

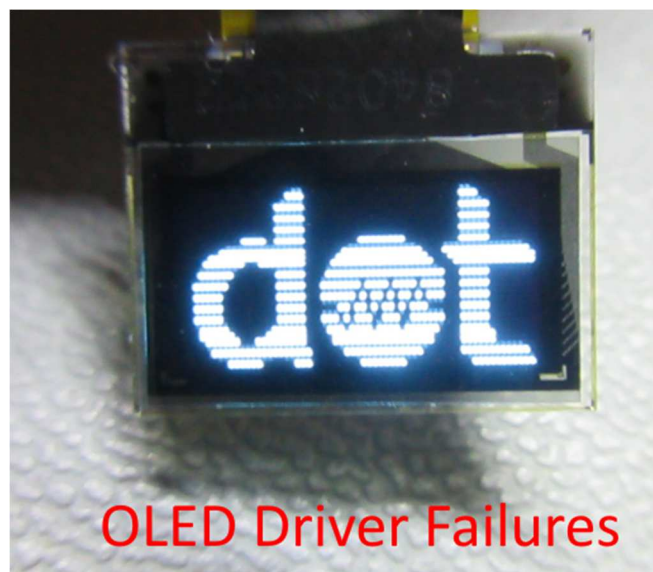
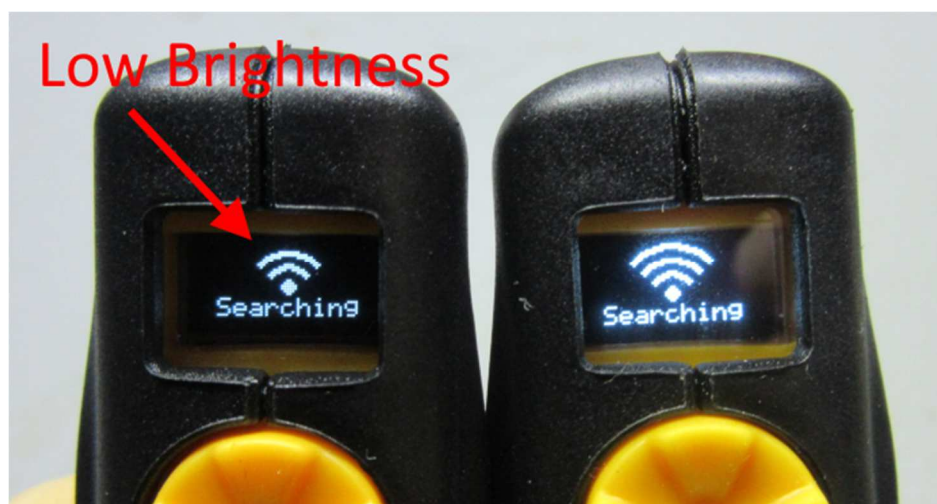
Several OLEDs were not functioning correctly. Lines missing in graphic display or low brightness.

Communications is by serial interface and soldering issues could not cause graphic line failures.

Low brightness was not a circuit issue. There were no solder issues. Display unresponsive to contrast commands. In all cases, replacement of OLED fixed issue.
