PRE-PRODUCTION FEEDBACK

Date: 23-12-2020
Revision: 1.0
Author: Tony Little
Product: Electric Skateboard
Company: Globe Brand

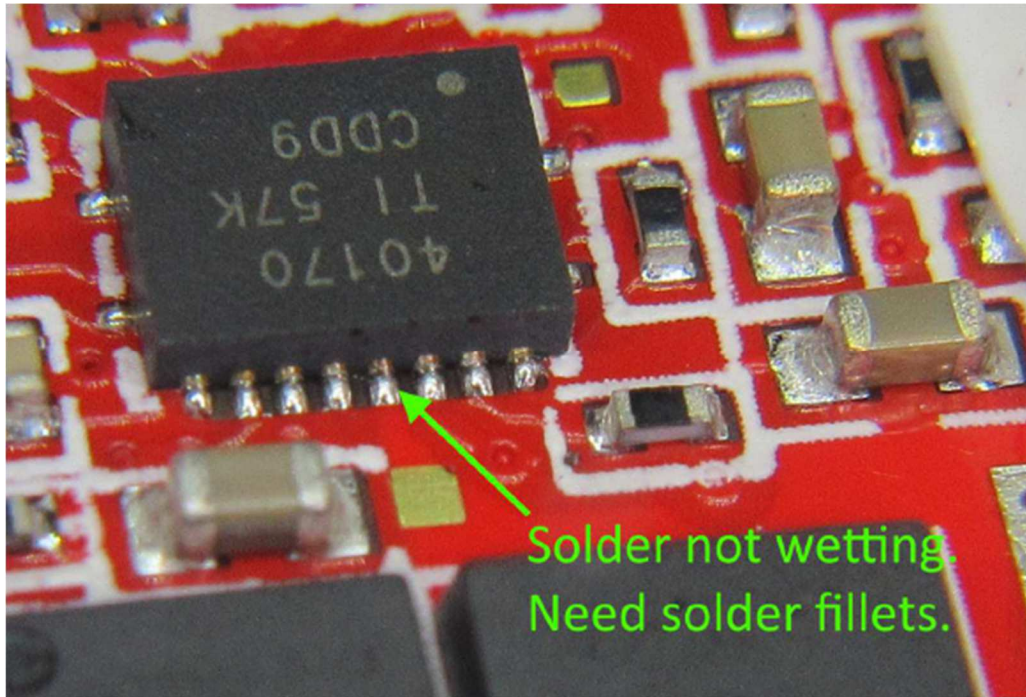
Previous concern has been the poor solder wetting on IC2.

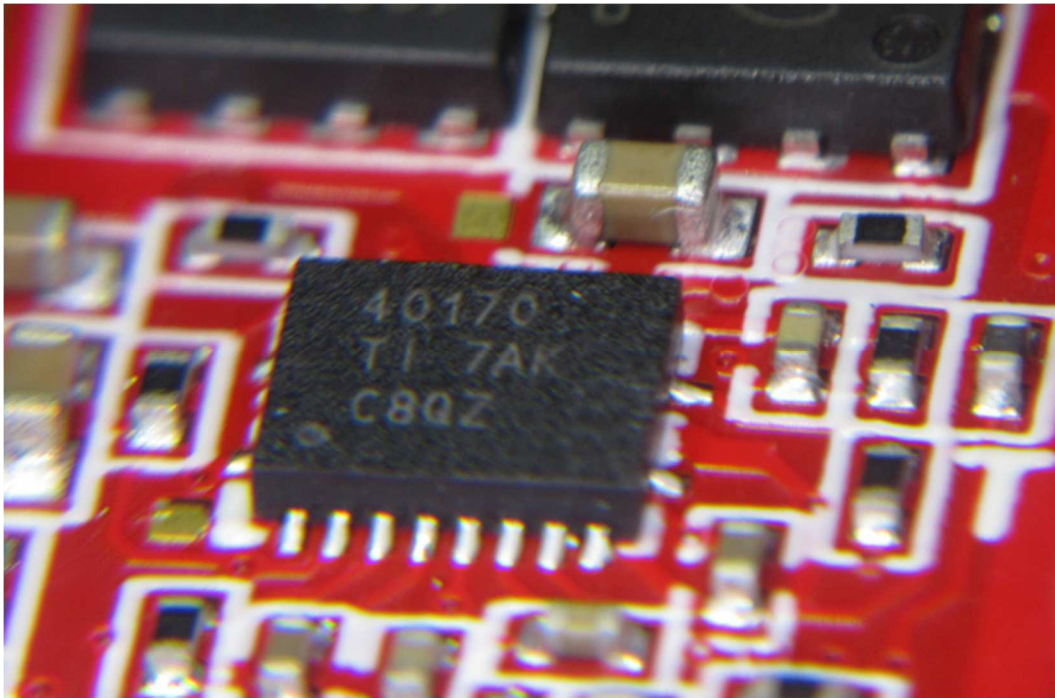
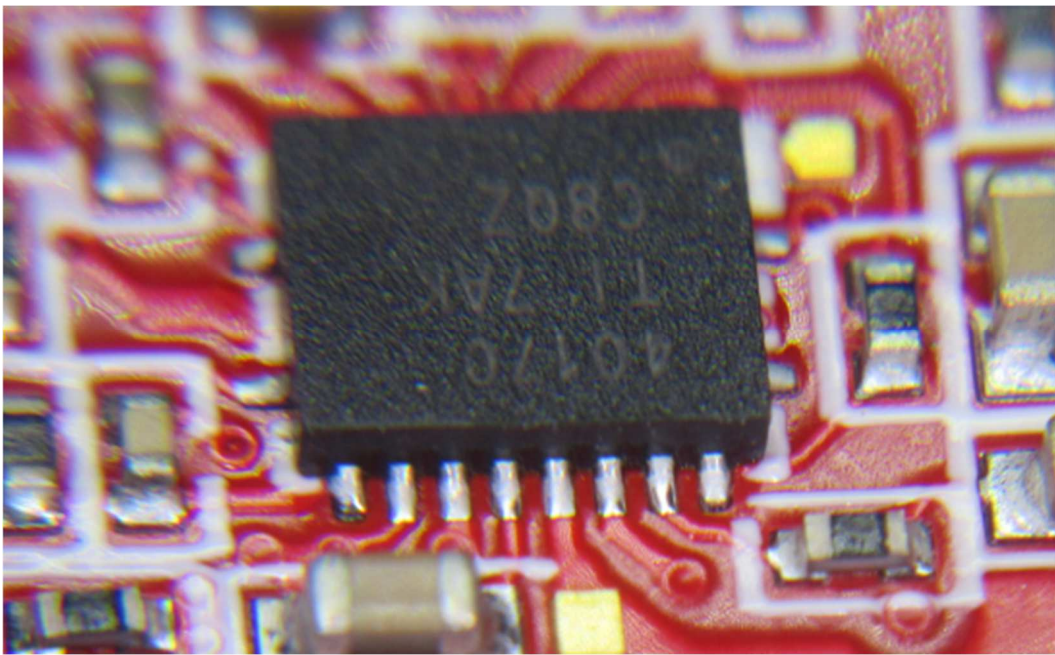
Union applied addition flux prior to reflow, which has resulted in a significant improvement.

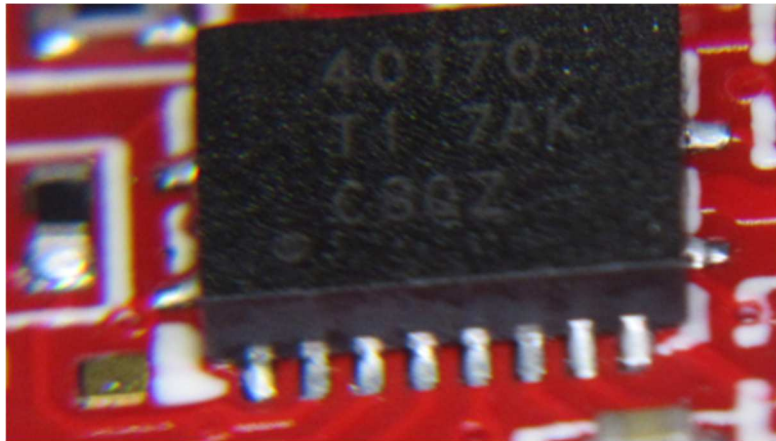
The worst example from the set of 5 is shown below. Possible indication of production variation.

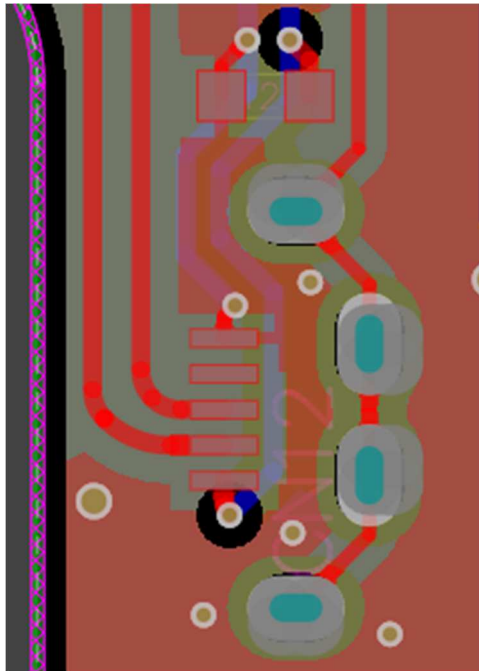
The paste geometry update as shown below. Paste increased beyond mask perimeter for chassis pins.

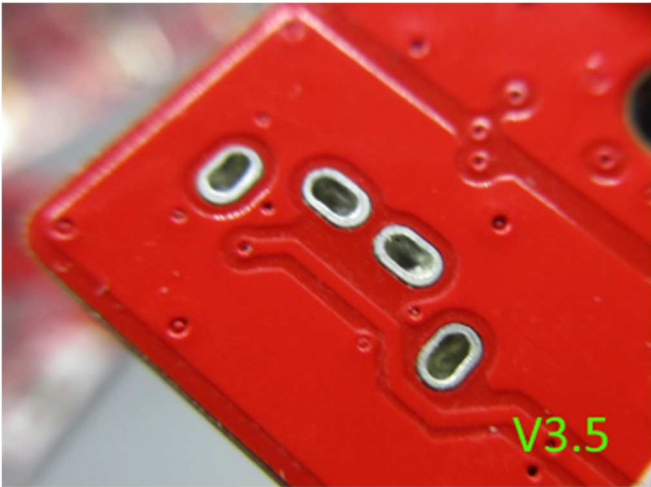
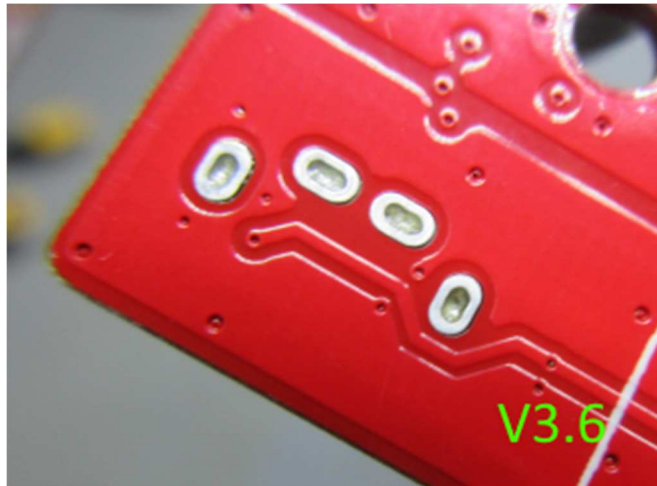
The improvement in solder fill is quite noticeable. Below shows V3.5 in comparison to V3.6. This may both improve USB connector retention/strength as well as make Jesse happy.

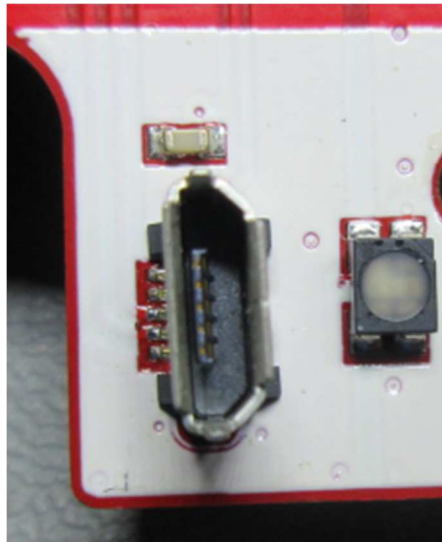
All USB connectors are well aligned.

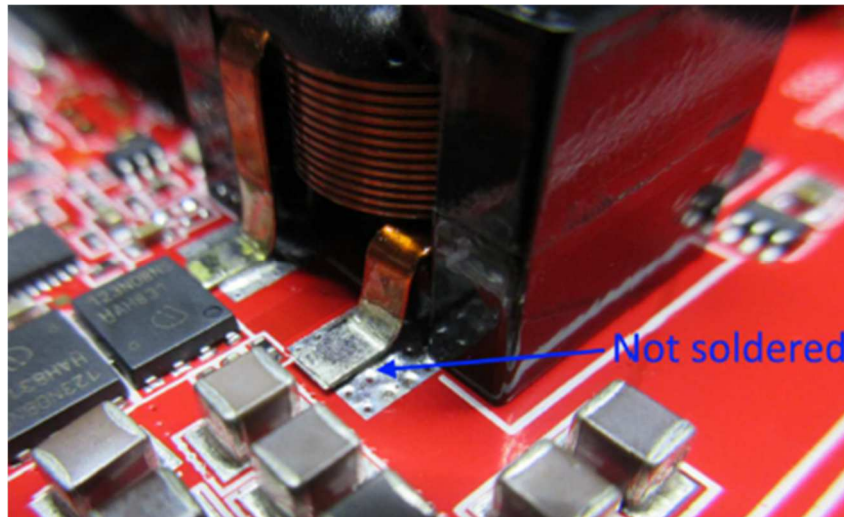
Several prior production faults were due to soldering issues with the large battery charger inductor. Both joint and inductor mis-alignment issues. Footprint used was as specified by the manufacturer.

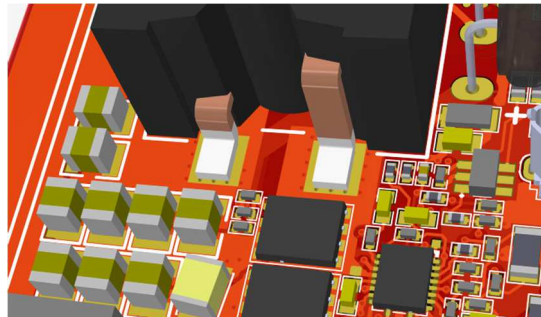
The PCB footprint design was updated with a reduced mask area, while maintaining paste beyond mask perimeter.

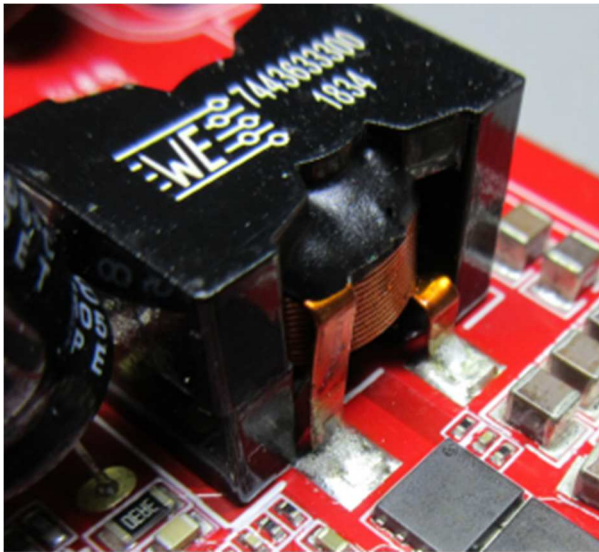
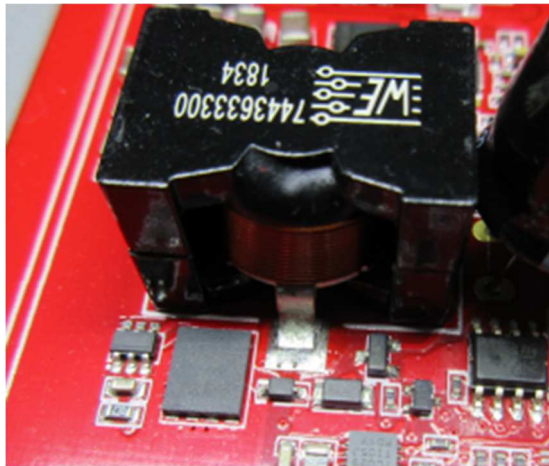
Significant improvement in solder fillet/volume observed. Change most evident.

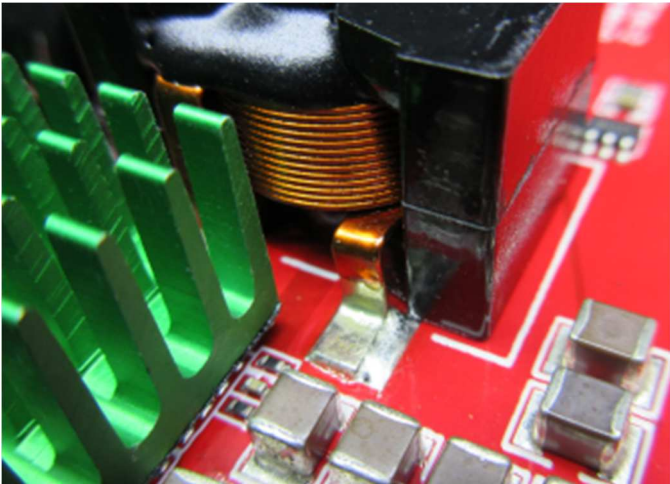
Worst case example below. Mis-alignment considered minor.

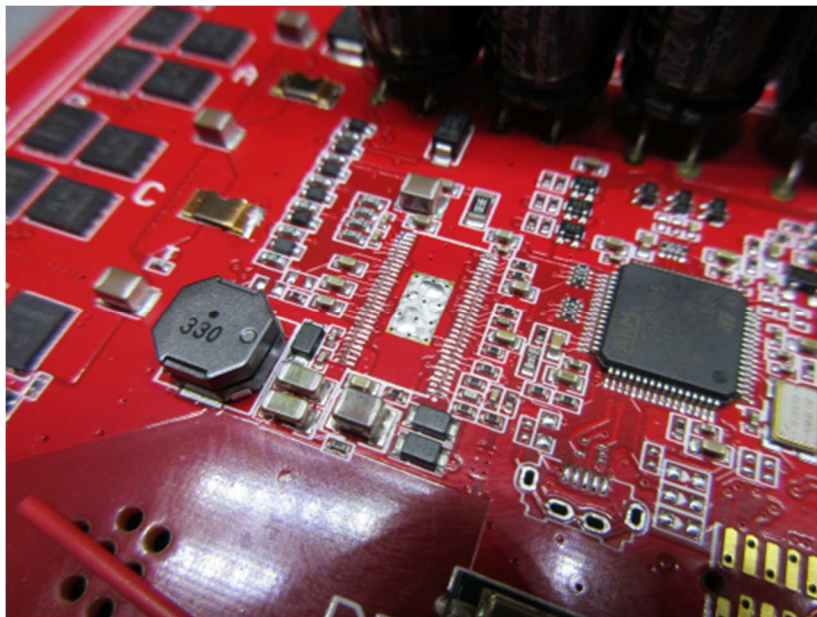
2.2.1 FFFFE022

Right VESC has a motor start issue. Jolts from certain phase angles.

Engaging brake causes jolt and no brake for a period.

Log file captured right VESC over current fault.

Fault not yet determined.

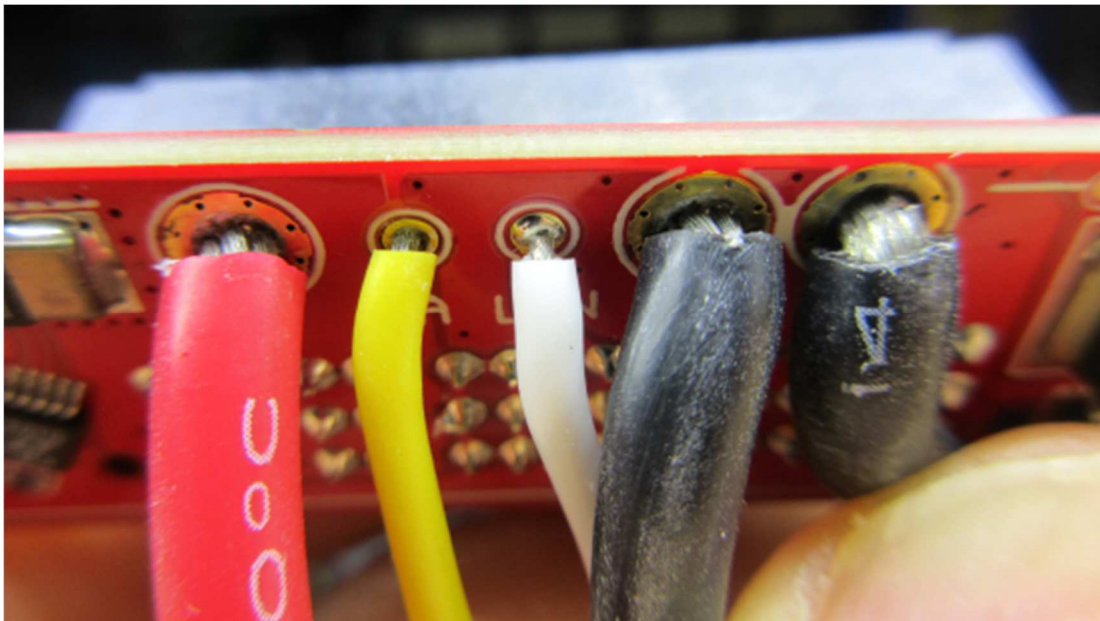
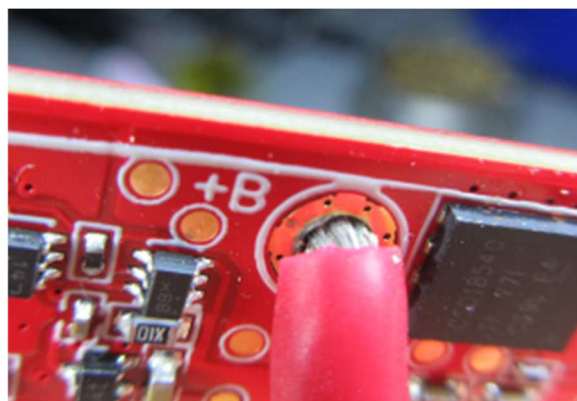
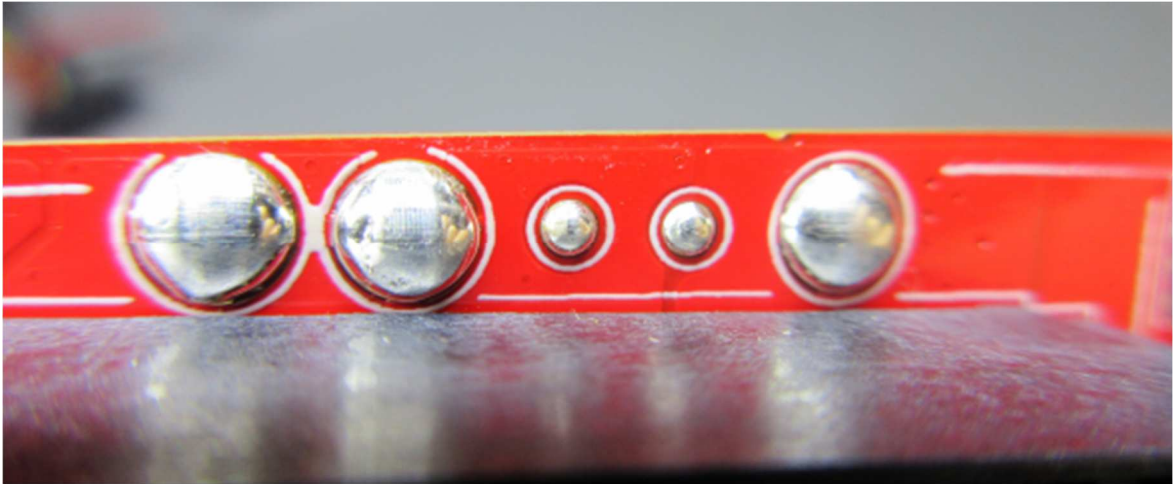
The wire soldering has historically not been at the desired level, however has never been a functional issue. The wiring holes were increased slightly at Unions request to improve the through hole fill and filleting on the opposite solder side. The land area was also increased slightly.

The through hole is getting sufficient fill for the functional requirement. Operator soldering speed is likely pushed too fast. Hot air pre-heating would also be preferable.

Although still not at the desired level, there is no historical functional issue to pursue further changes.

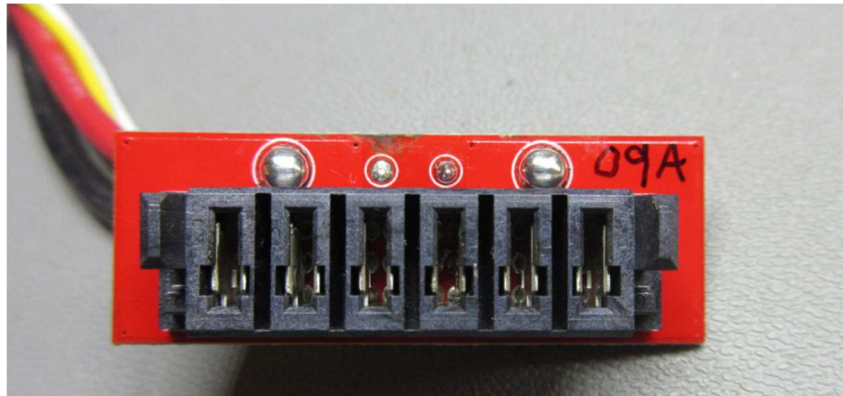
3.2.1 BBBB009A

Inspection found the front connector to have solder wicked into terminal contact. This causes a fitment issue for full connector mating.

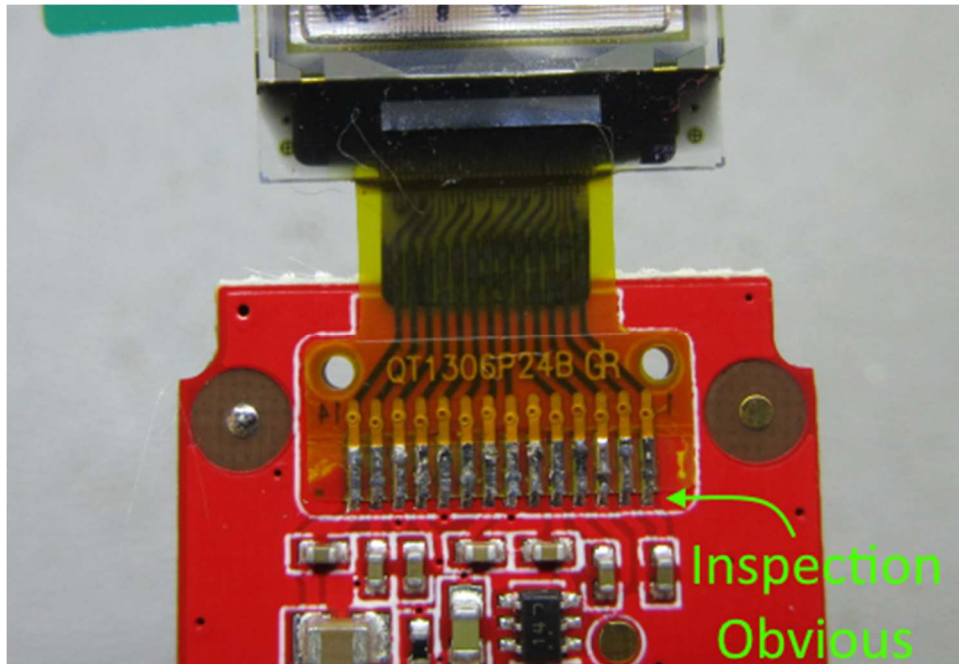
OLED alignment holes moved 0.25mm and increased to 1.1mm diameter. This is to improve tab soldering inspection and jig alignment fitment.

Samples would have been prepared without a jig for alignment, which is noticeable. Given due consideration, change gives the desired obvious soldering edge inspection.

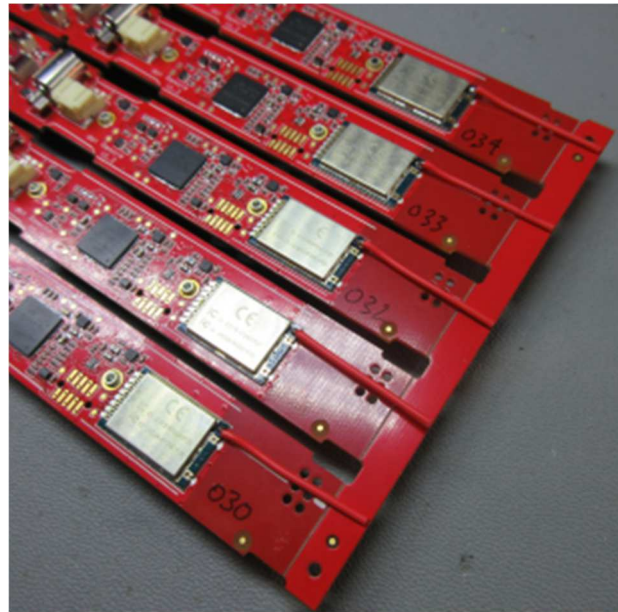
The extended panel breakoff is just enough to avoid a lot of antenna displacement while handling and being packaged.

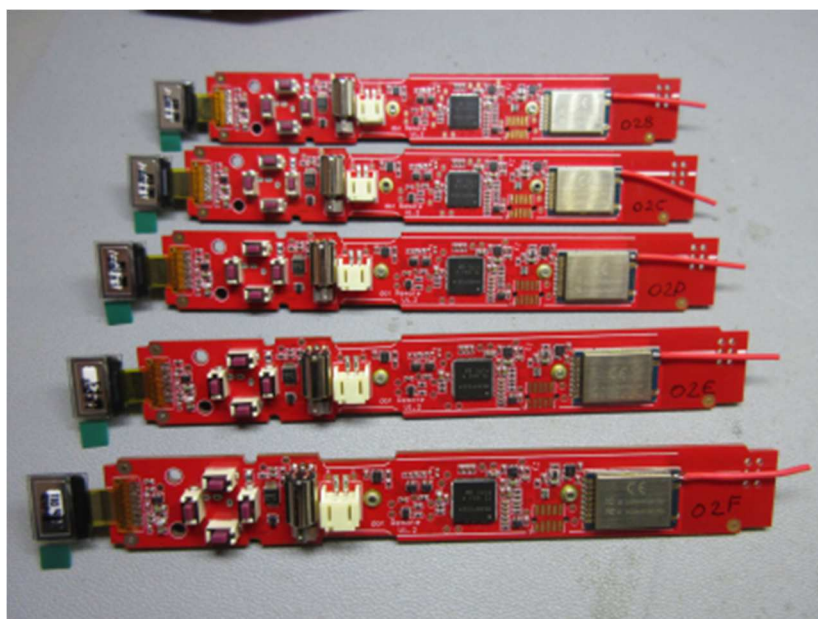
De-paneling easy. The OLED end should be broken off without touching the OLED.

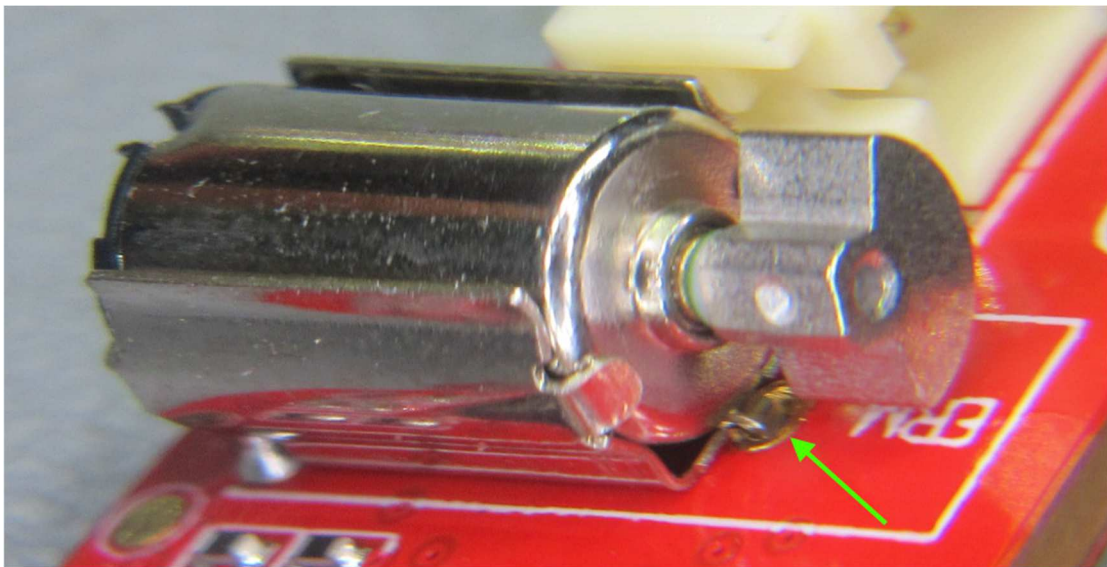
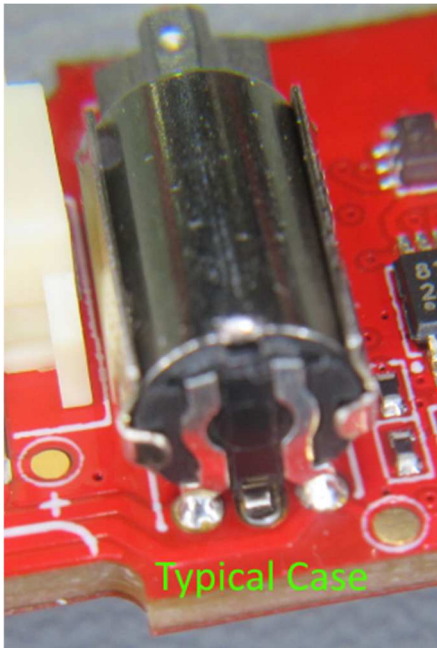
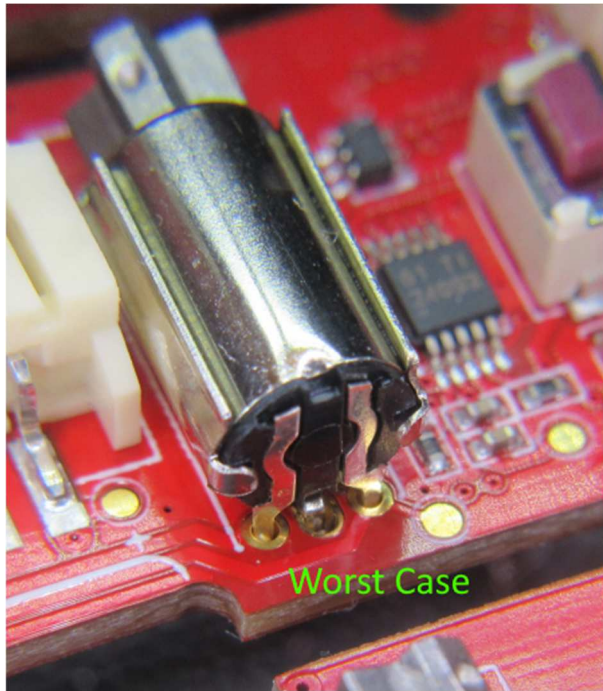
The soldering to the ERM frame pins is still insufficient. The PCB design was tweaked to provide more thermal relief and a greater opening. Those holes were changed to slot to improve solder flow. The likely soldering issue is more related to the short length of the pins, along with the high thermal bleed to the chassis.

The pins to the electrical connections have significantly less thermal bleed. The soldering is good, although one was borderline. Given production history, there should be no reliability concern given the ERMs are continued to be glued to the PCB.

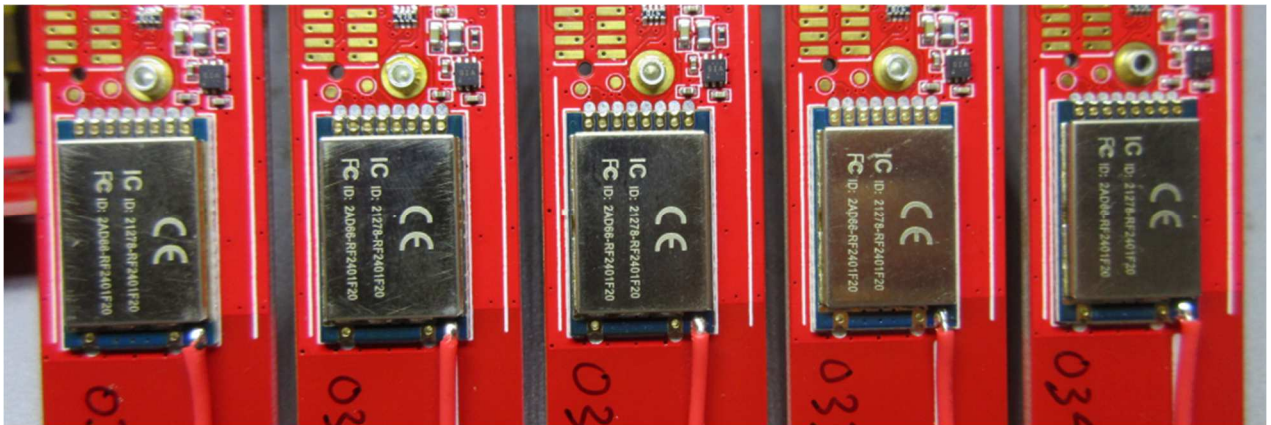
Reflowed alignment is good.

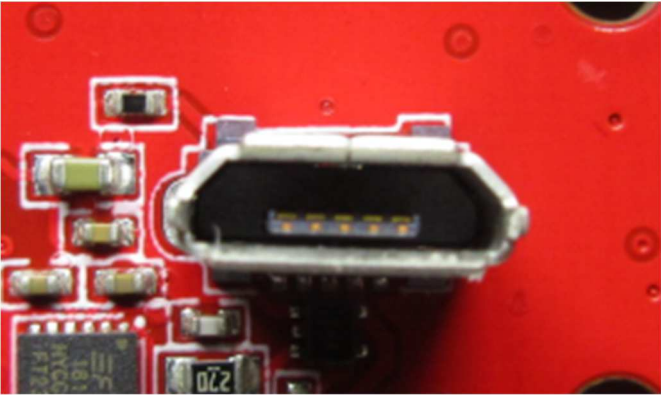
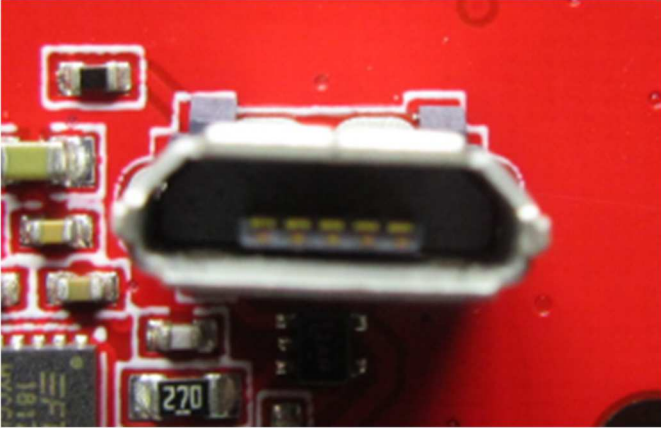
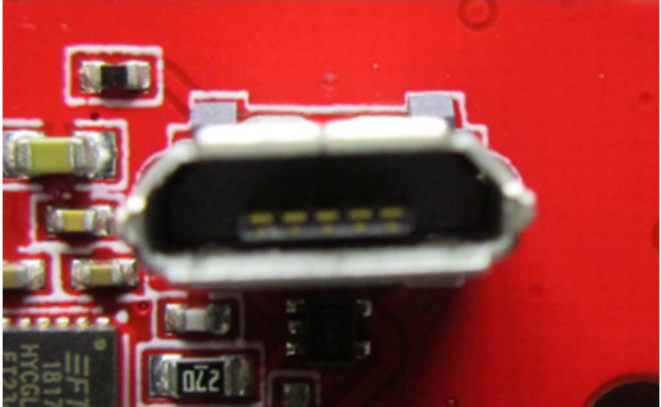
Units FFFF030, FFFF02C (worst example), FFFF02D.

7 units had very good USB connector. The 3 below were not ideal.

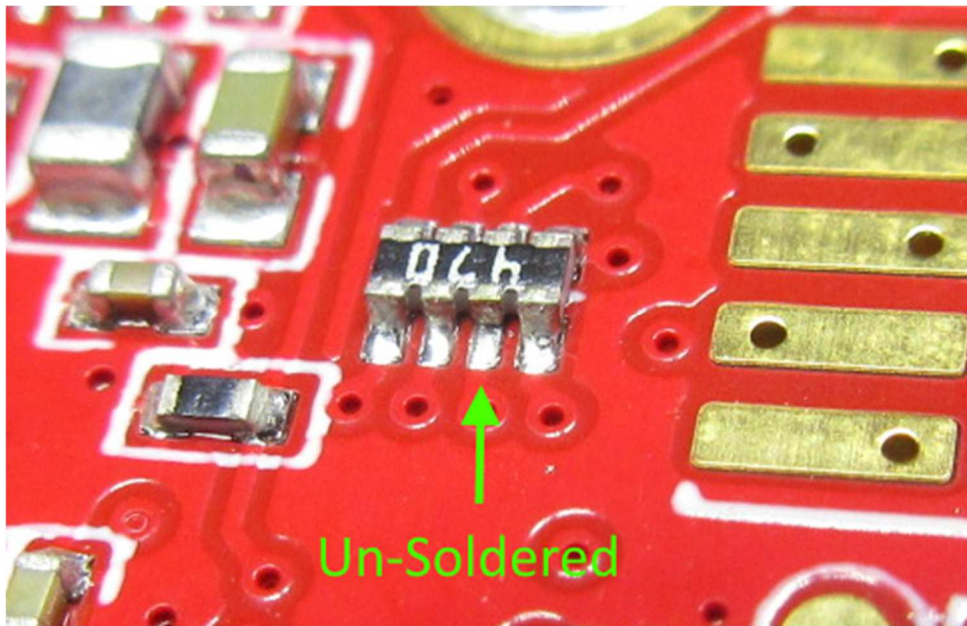
4.7.1 FFFFF02B

Wireless not functioning.

Found R25 with un-soldered contact.

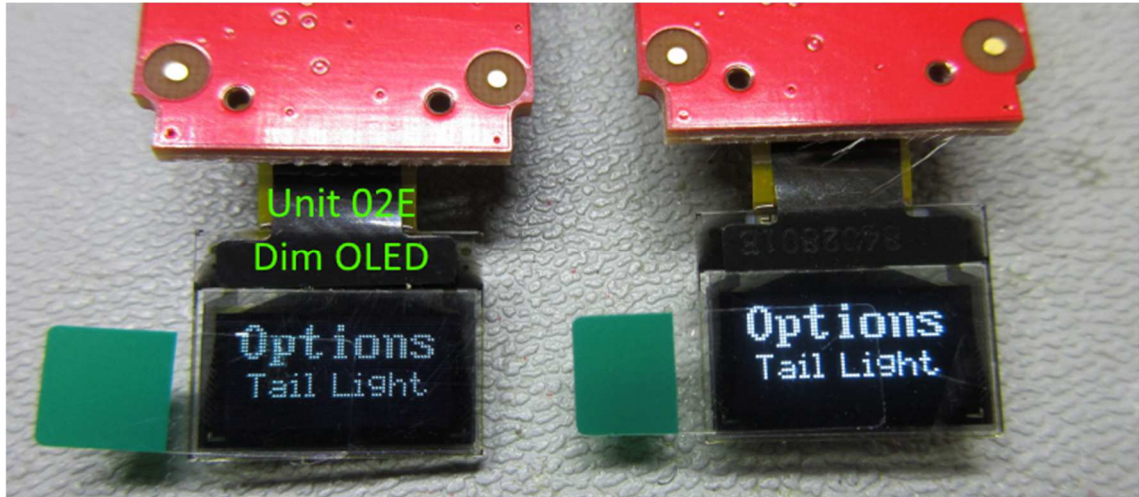
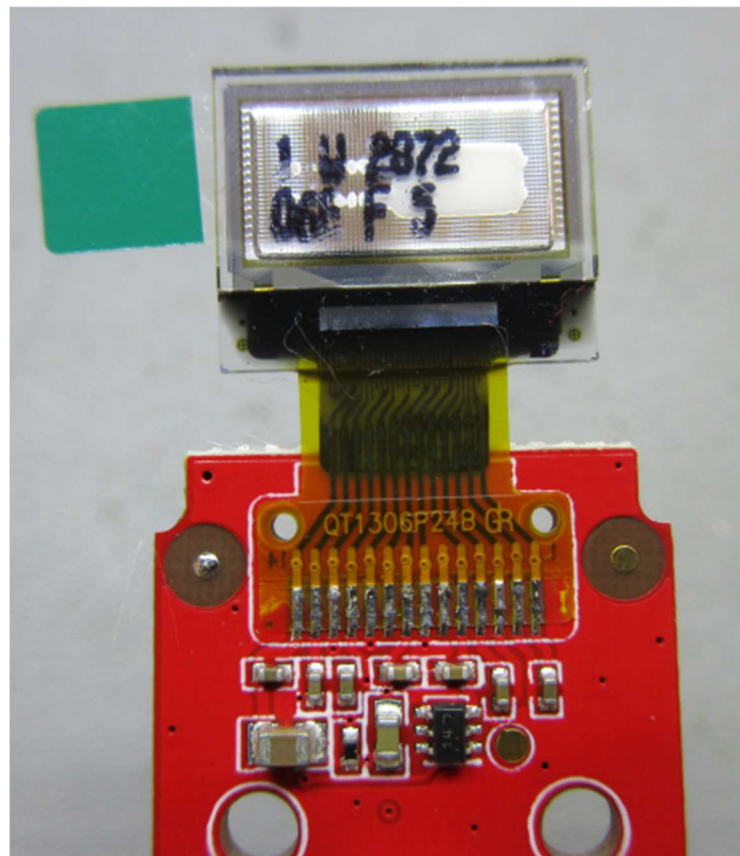
4.7.2 FFFFF02E

OLED Dim.

Replaced OLED. Brightness correct.

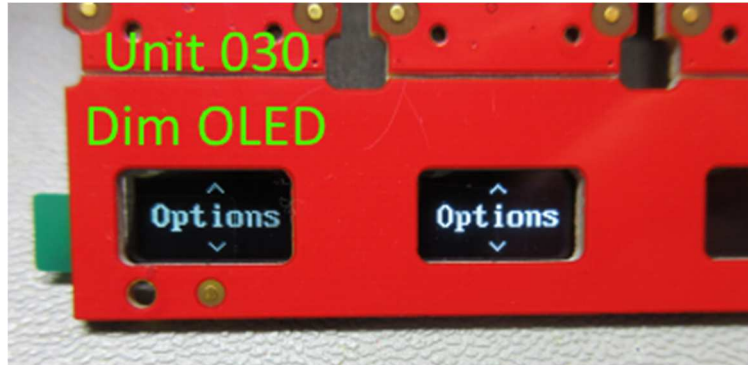
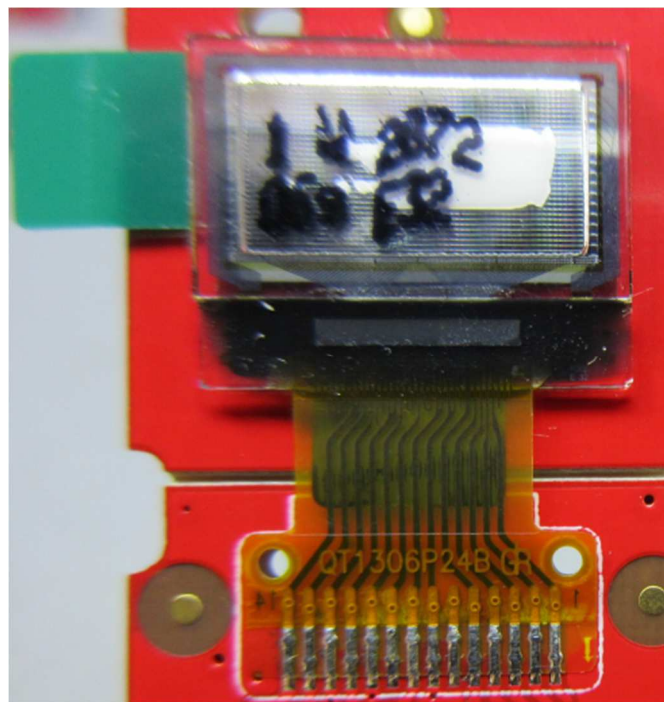
4.7.3 FFFFF030

OLED is dim.

- VCOMH = 7.49V
- VOLED = 4.02V
- VDD = 2.498V
- C1 = 1.42V
- C2 = -4.45V
- IREF = 4.70V

Re-soldered tab with flux. OLED is still dim.

Replaced OLED. Display brightness as expected.
