BATTERY MODULE DROPOUT INVESTIGATION

Date: 23rd April 2021
Revision: 1.0
Author: Tony Little
Product: Electric Skateboard
Company: Globe Brand

5 boards were investigated for power dropout issues. 2 Compact and 3 Transporters.

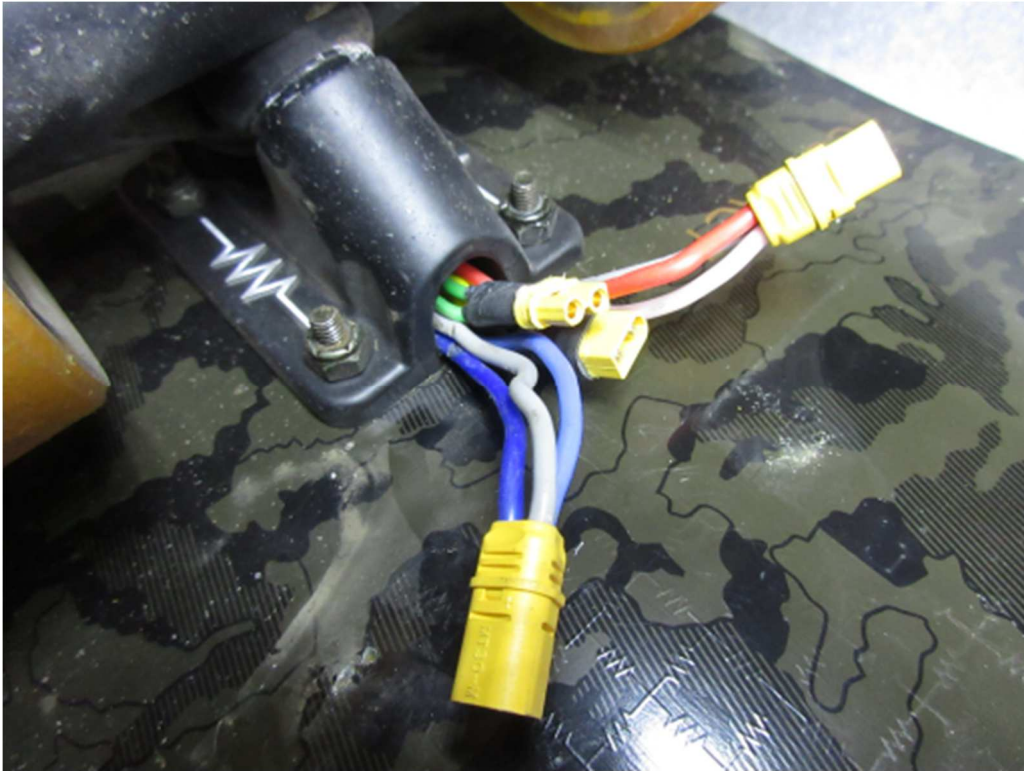
Cables in hanger move with expected freedom. Not removed. No wiring damage or defect evident from external inspection, other than minor insulation dents.

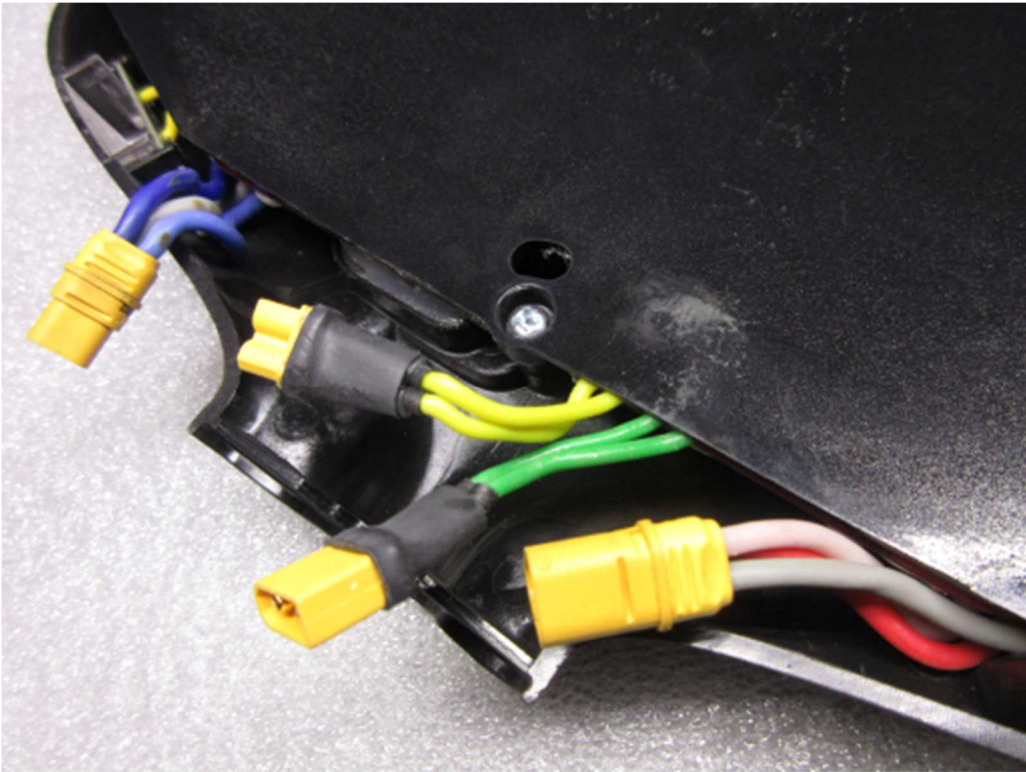
MC wiring looks in very good condition. Nothing to suggest a motor temperature sensor wiring issue.

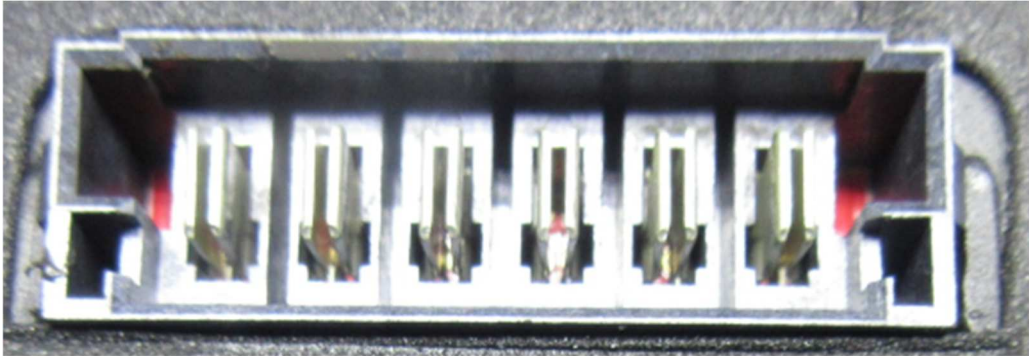
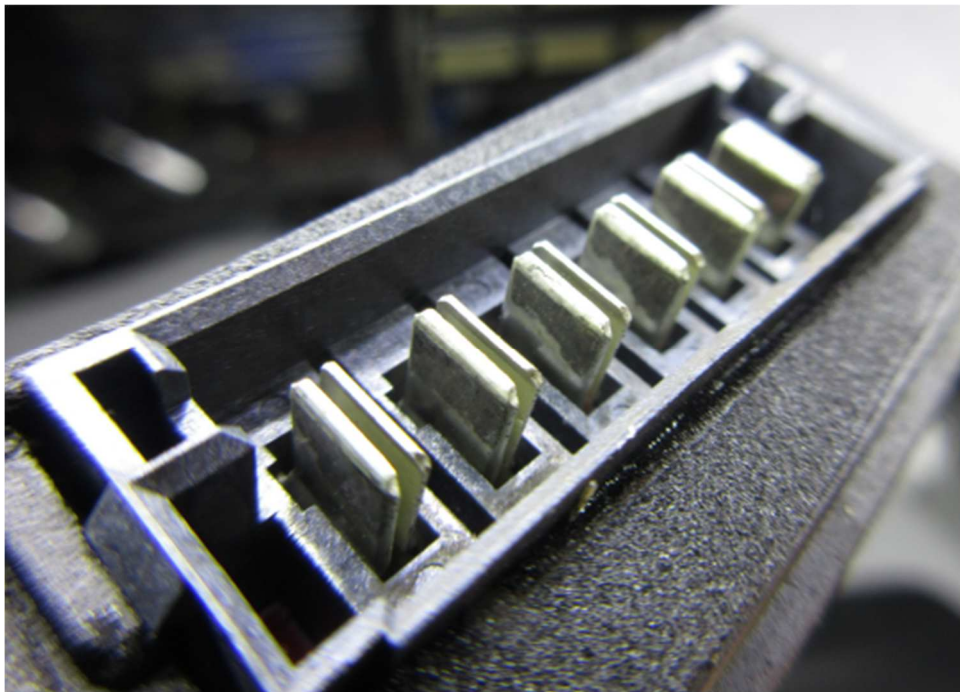
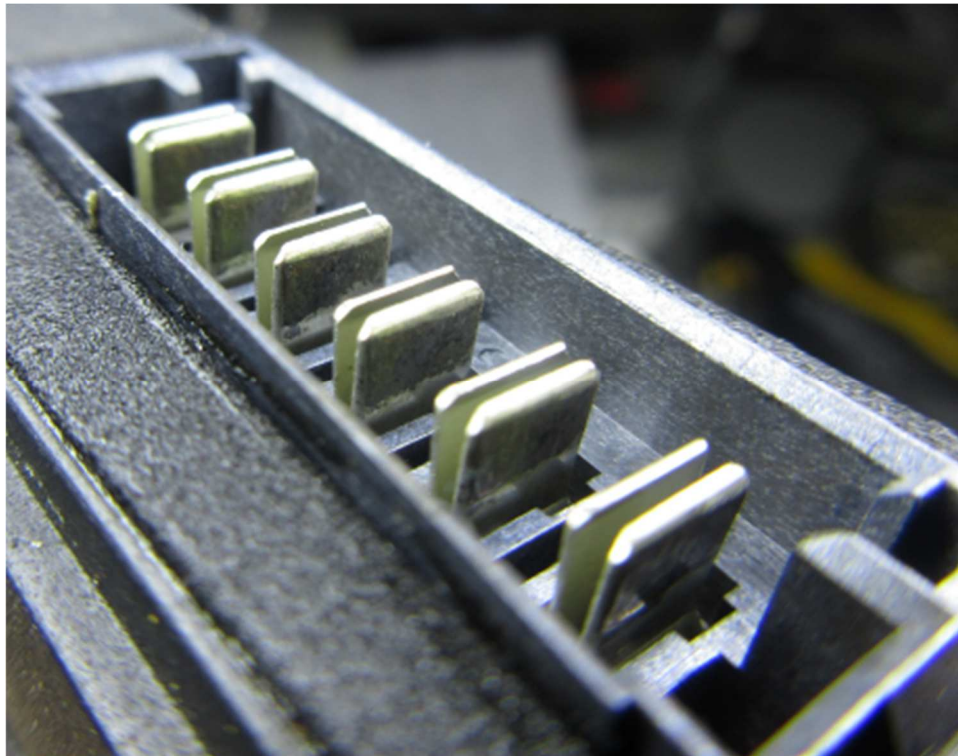
3.3.3 BATTERY CONNECTOR, 3149595736 / BBBB0458

Terminals straight, no di-electric grease.

Excessive wear for only 65km riding.

Distribution of wear marks are quite even and equal in abrasion on both sides. Slightly more abrasion on the bottom edge of the battery (road facing). This battery was in the front position on the board. The adjacent battery connector terminals showed comparable wear. Difficult to photograph given the surrounding shroud.

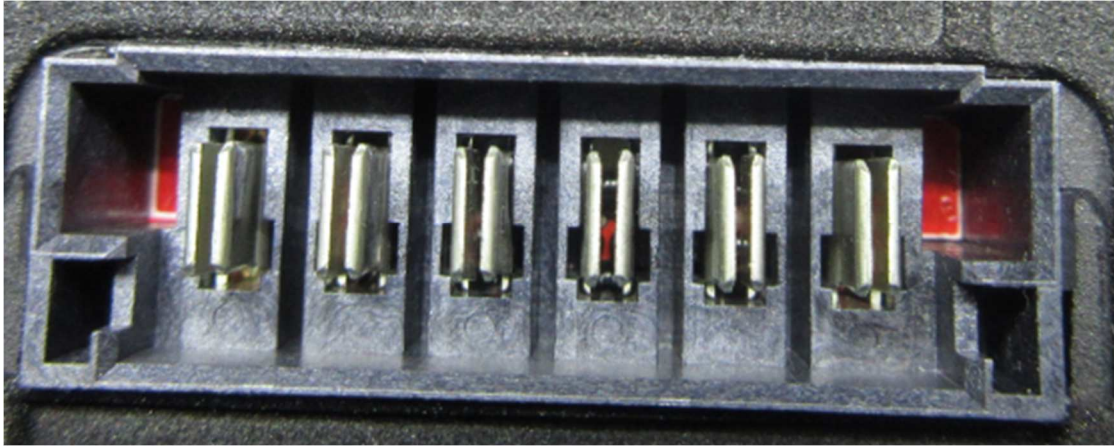
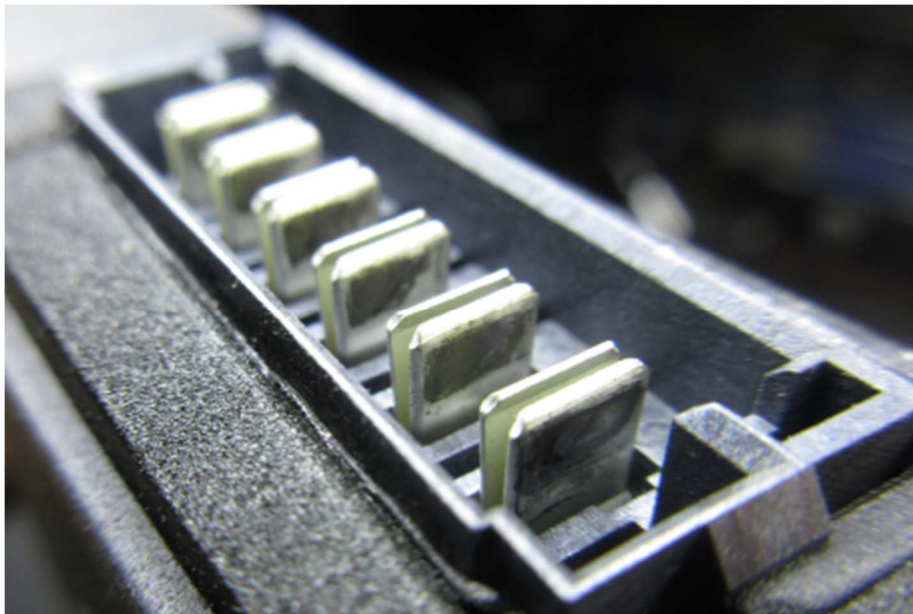
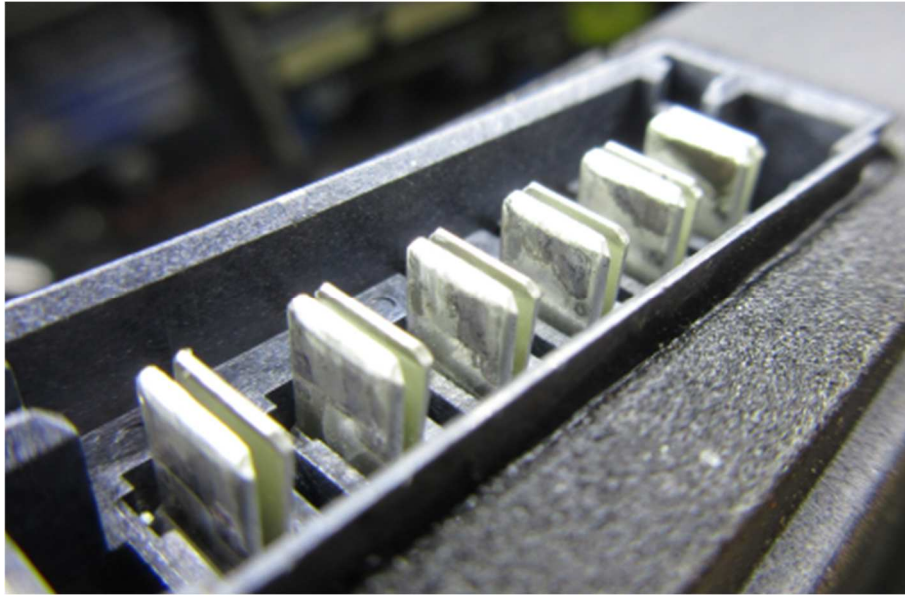
Terminals straight, no di-electric grease.

This battery was adjacent to the main controller. The wear is noticeably un-balanced. More wear on one face of the terminals than the other. Un-even wear across the blade surface. Contact wear is more triangular.

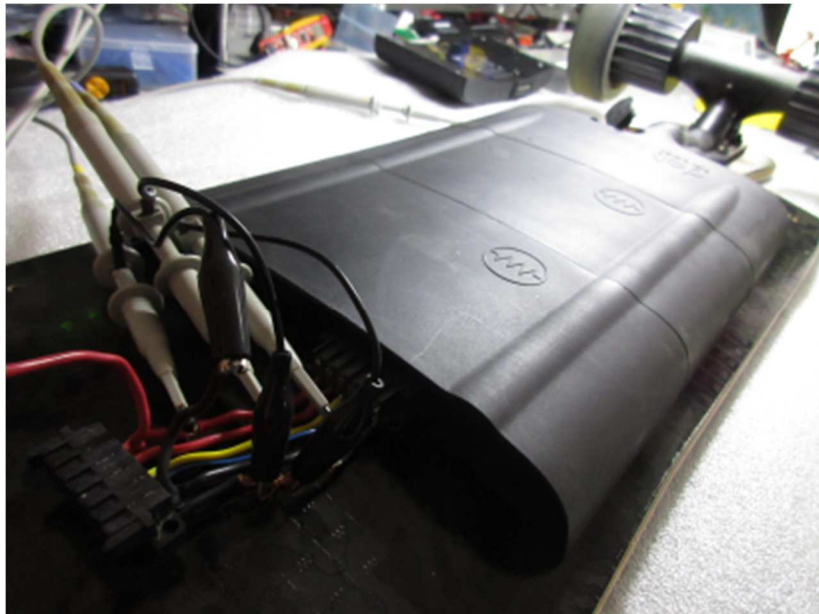
VBus and VAux are present. **VAux is not at the expected or required level, <3V**. LIN bus is present and at the required level. Batteries are non-responsive.

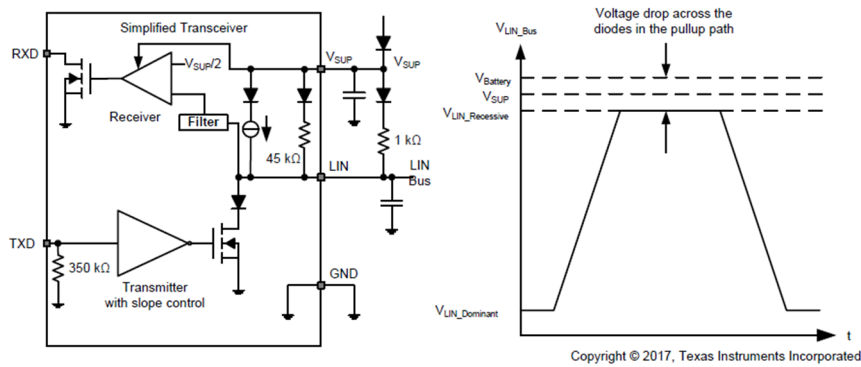
Master dominate level observed at 1.1V. This is very close to the 1.2V specification threshold. Dominant level not influenced by data traffic load. Second battery come online for the first time. Probe checked for ground and DC coupling setting.

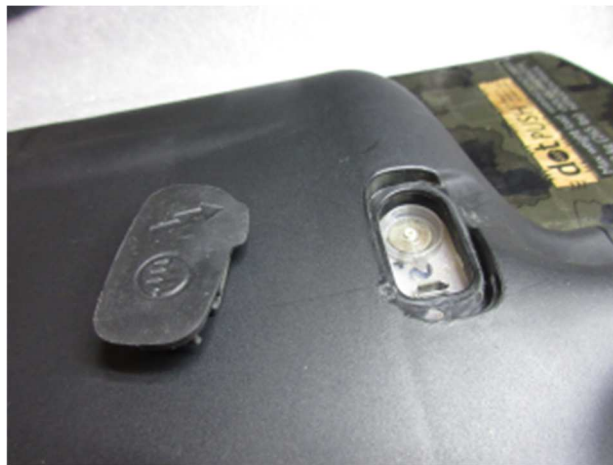
The USB socket is damaged. USB has to be held to one side to establish connection to dot-hub.

Board needs a new charge port cover (tether missing) and two new module bolts (sockets chewed out).

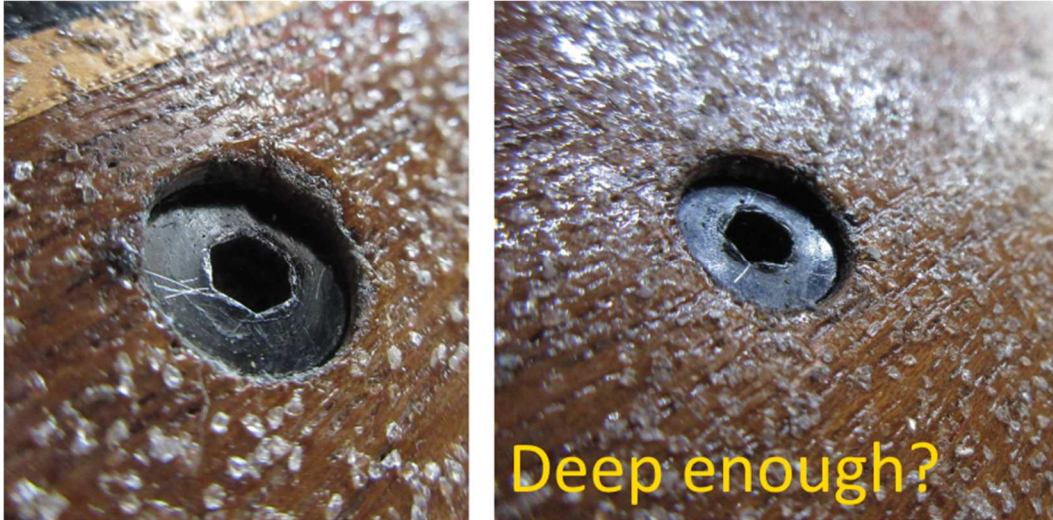
These deck bolts have been screwed in SUPER HARD.

The deck bolts are contaminated with an unexpected hard material (thread lock?). It is not known if this may weaken or damage the Nyloc material. The bulk of the material is on the upper thread and useless for retention. It is recommended to consider whether this practice is acceptable from a service perspective in relation to warranty. Particularly if this is being applied unnecessarily by the dealer.

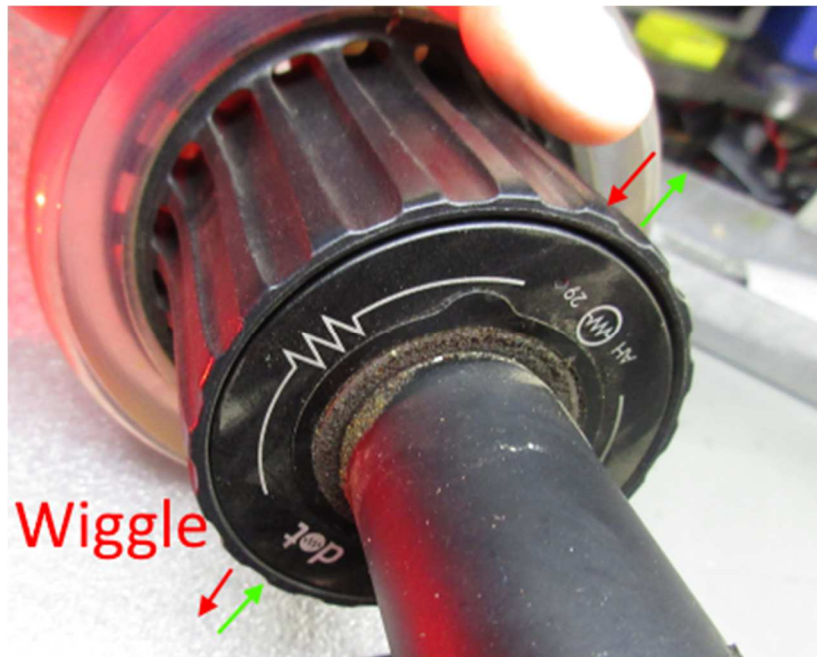
The LHS motor is TERRIBLE. Very noisy. Quite surprised WA sports note only states dropouts, not excessive motor noise. The wheel has wiggle room on the motor. Picture below show the gap pulling to one side.

The motor commutation was electrically checked. The motor is electrically operating as expected and not causing any fault. It is considered a mechanical failure and not considered relevant to this current investigation.

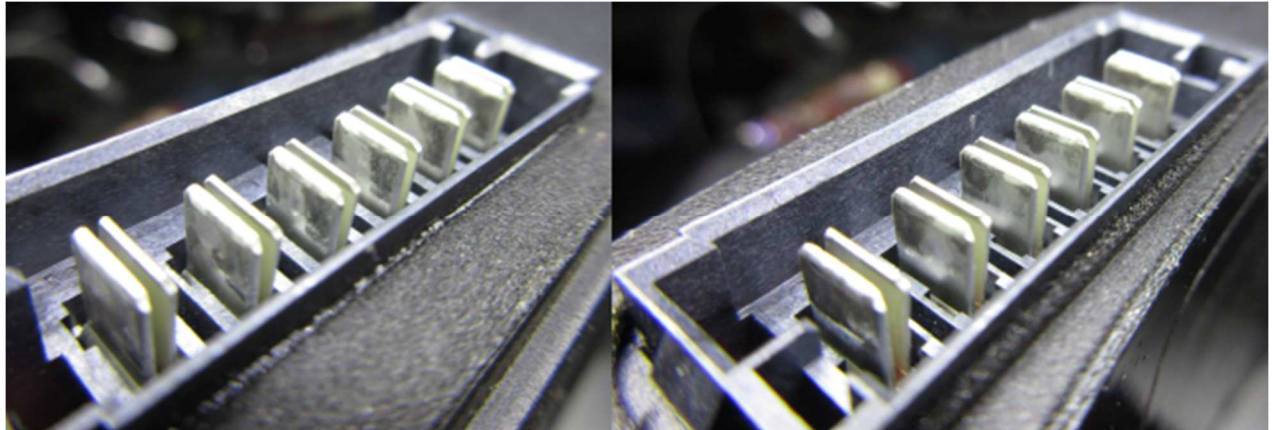
No di-electric grease.

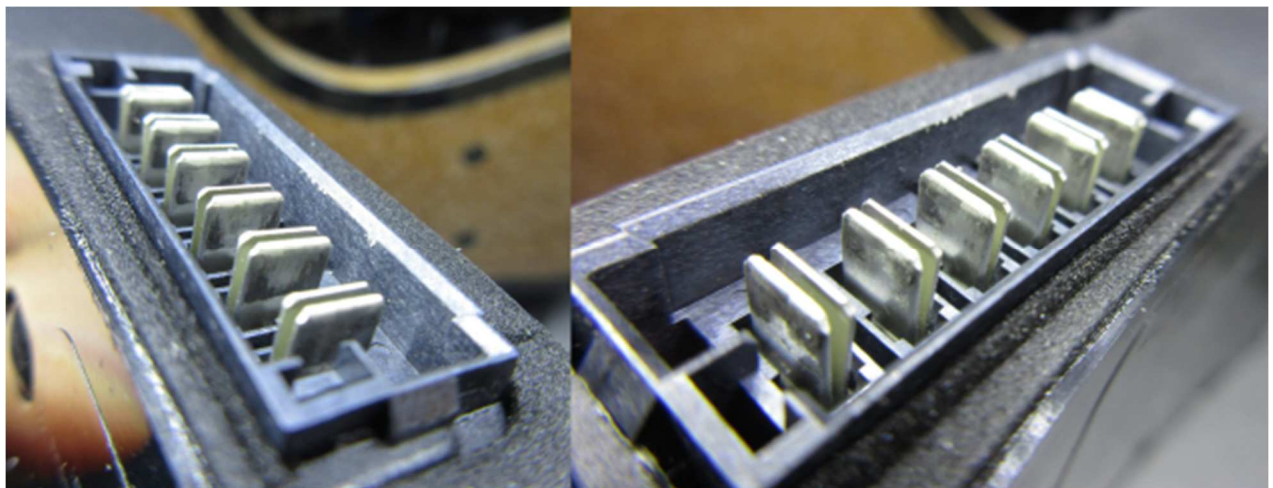
6.5.2 BATTERY 3149595837 – (POSITION 2)

Male connector has no di-electric grease.

One bolt was very difficult to remove. **Suspect bolt was over-torqued and Nyloc nut was free-spinning.**

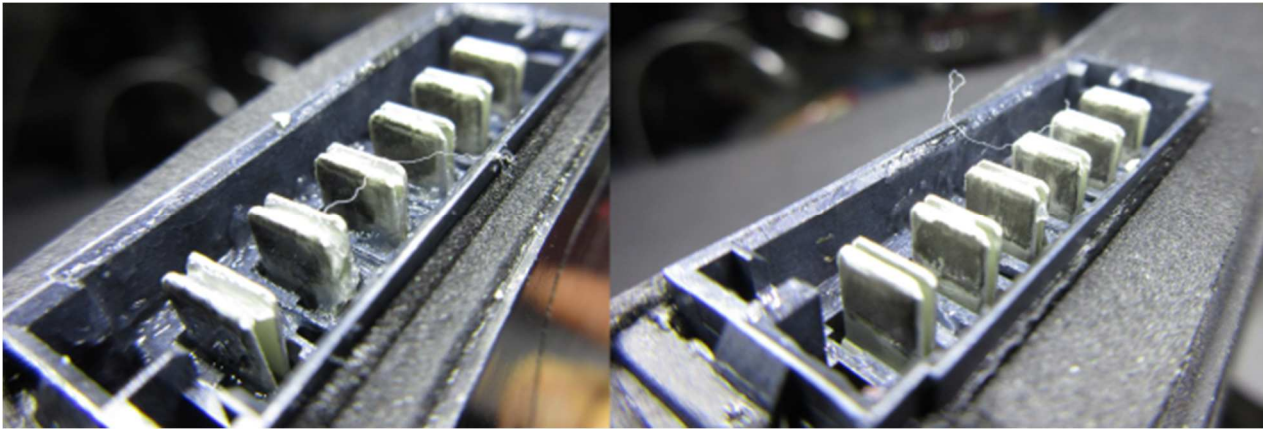
6.5.3 BATTERY 3149595724 – (POSITION 3)

Connectors greased. One terminal on female connector absent of grease.

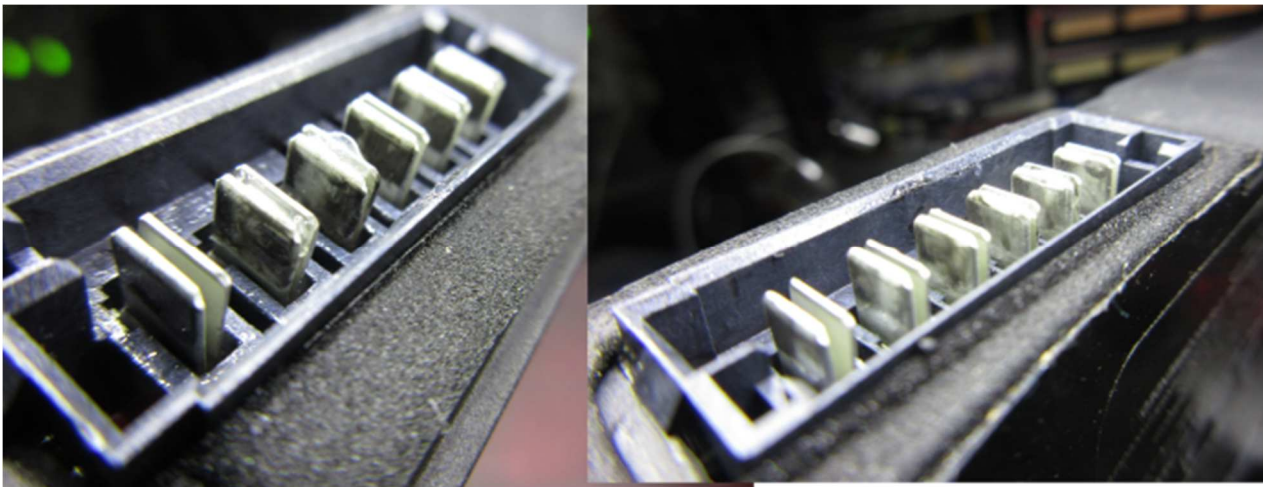
6.5.4 BATTERY 3149595733 – (POSITION 4)

Small amount of di-electric grease on male plug only.

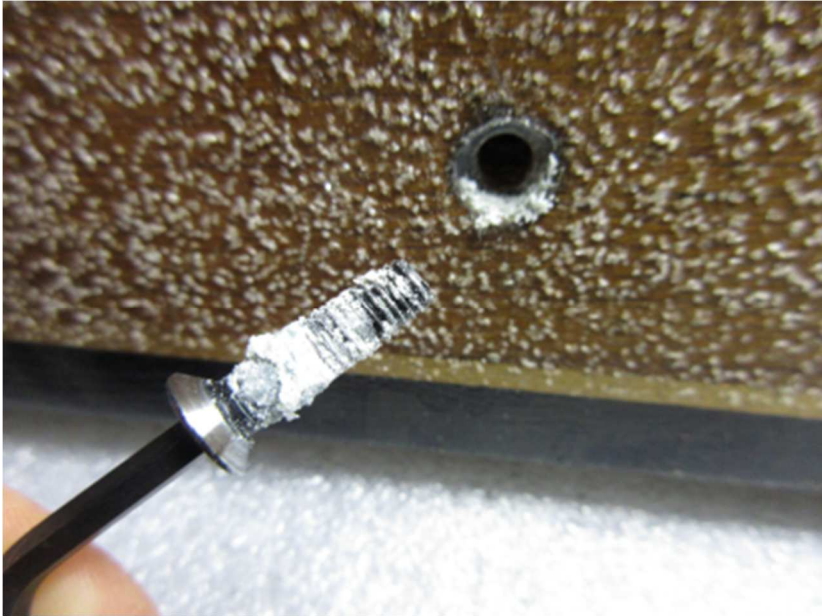
6.5.5 MAIN CONTROLLER

Bolts have a high amount of material applied.

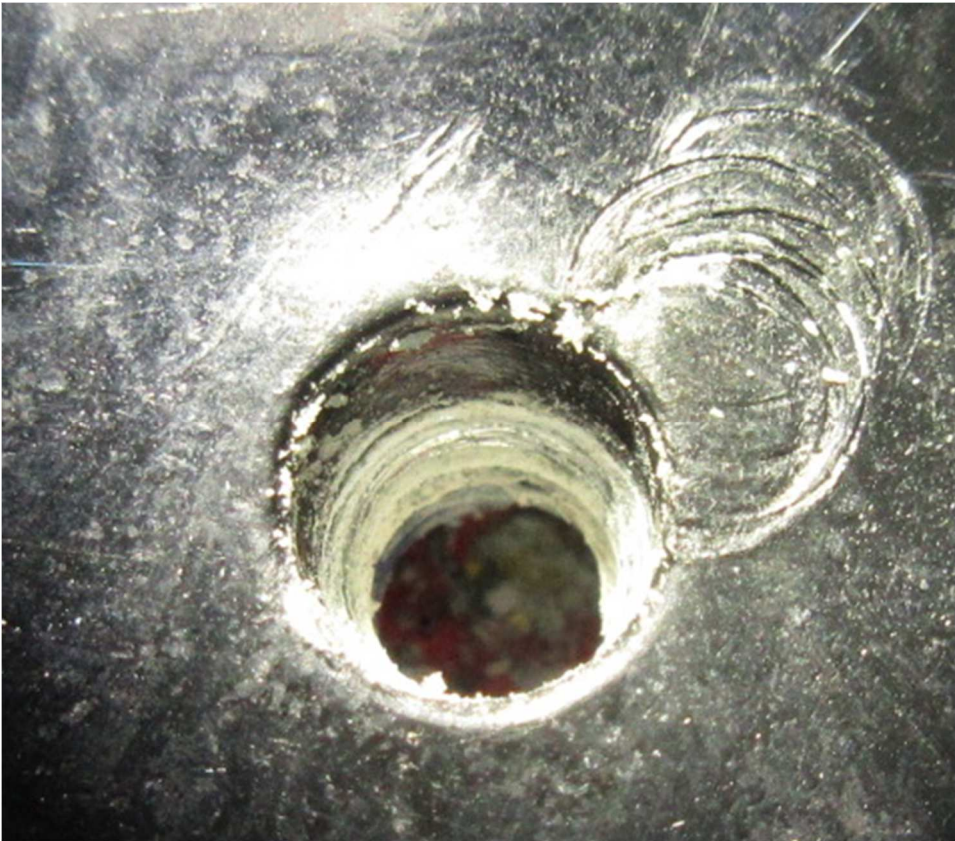
Noticeable debris inside.

The enclosure was not opened. Some of the debris was removed. No evidence of PCB damage from the screw.

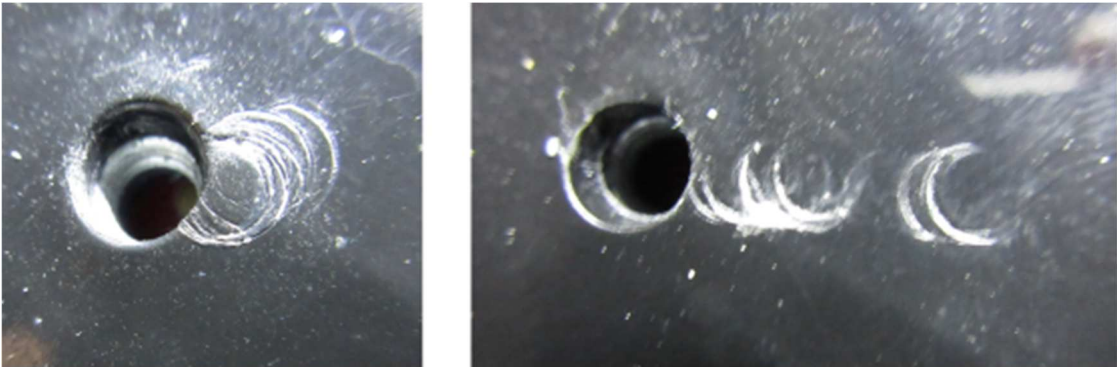
User must have had some difficulty fitting the main controller. Excessive bolt marks on the MC evident.

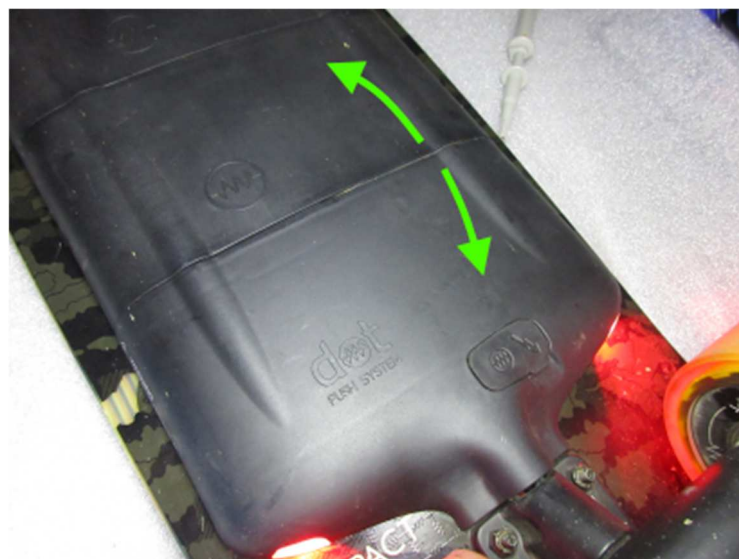
The board was highly sensitive to the first battery BBBB045A moving, specifically in the direction shown below.

The board would lose power consistently when only a minor rotation was caused.

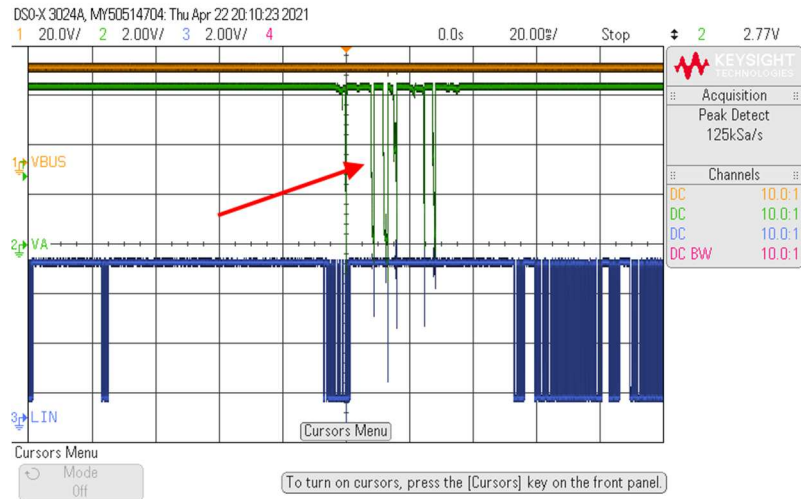
Examining the signals at the front most connector, it was quite evident the VAux signal was be disturbed. Slight movement would cause discontinuous power, however as shown below, the system tolerated this disturbance (LIN communications continued). The battery modules have a hold up time to accommodate this shown level of discontinuous power.

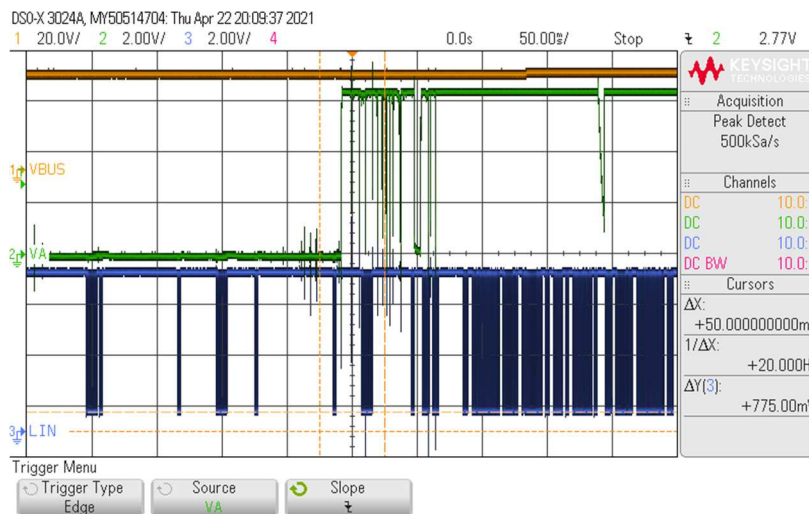
It was easy to cause far greater disturbances.

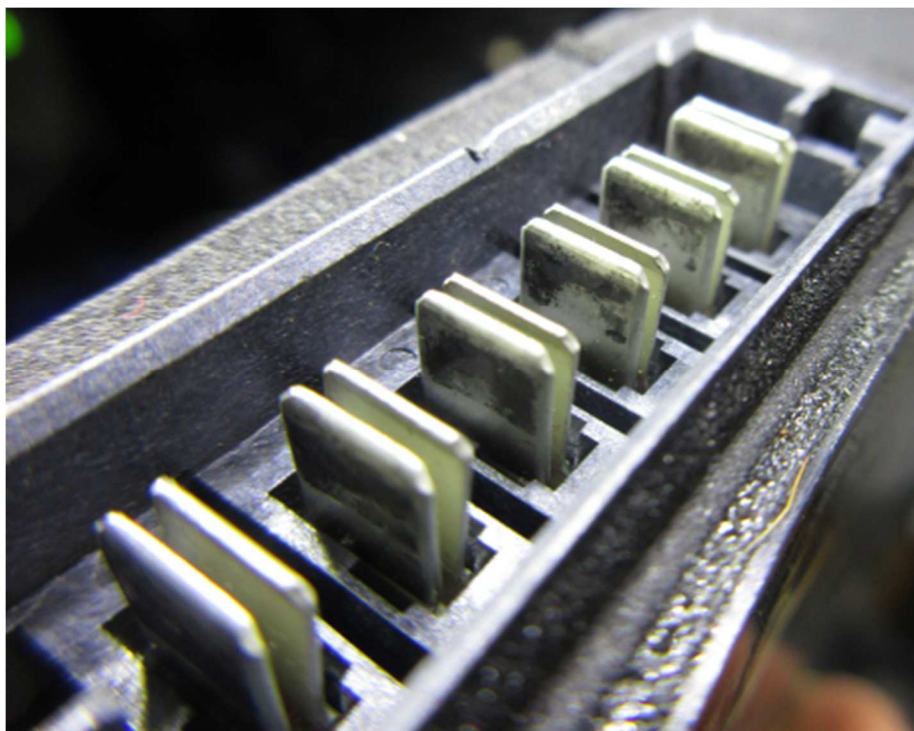
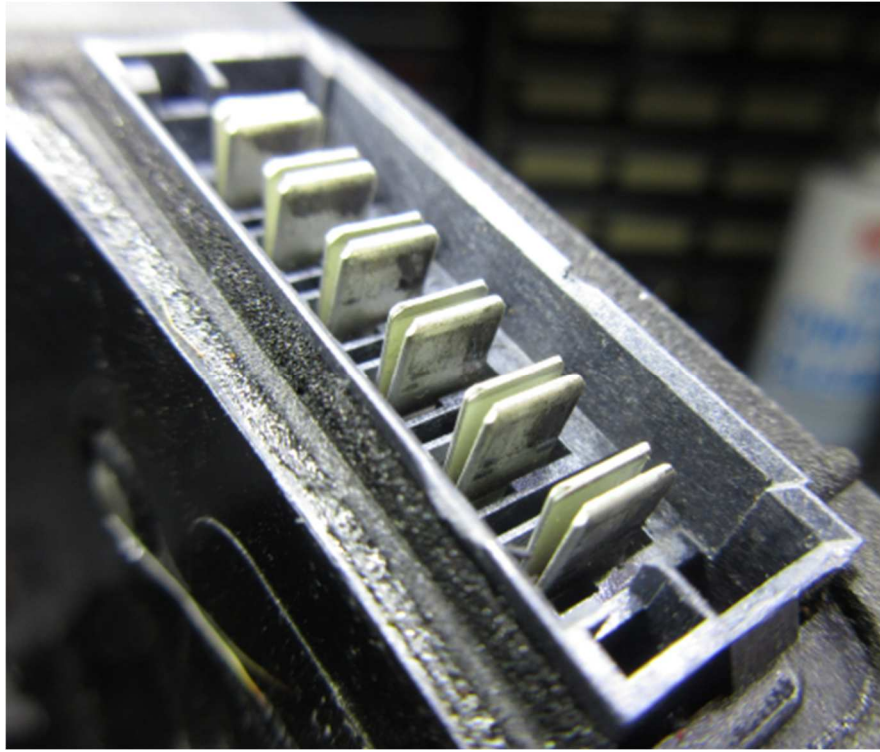
Quite noticeable terminal oxidization on the battery causing the dropouts.

A process for effectively re-conditioning the terminals hasn't been established. The male terminals were sanded with 1200 wet/dry paper. Both male and female were cleaned with contact cleaner. Di-electric grease applied. This connector servicing is not considered full restored. Likely with a better process, the result could be better.

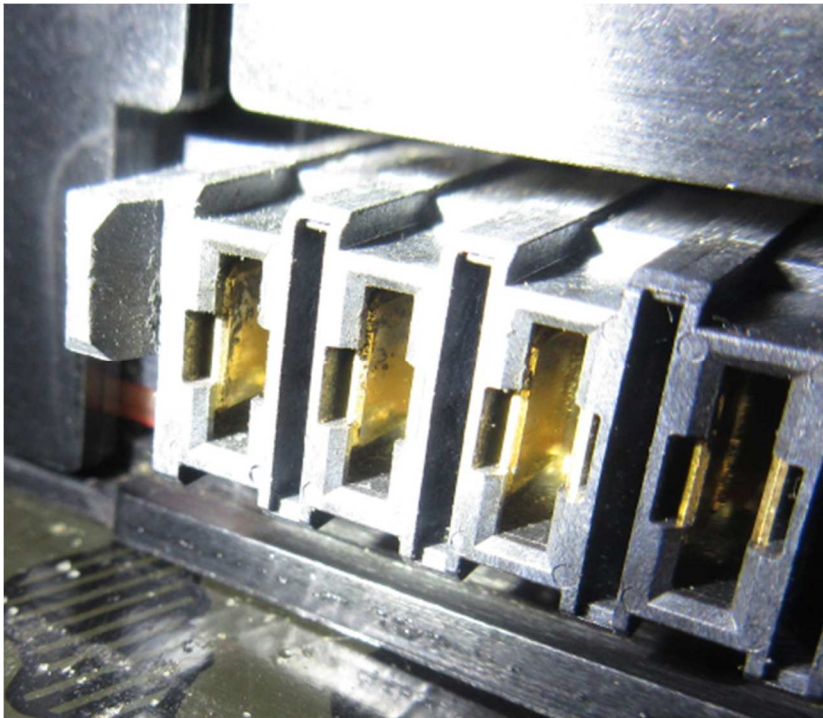
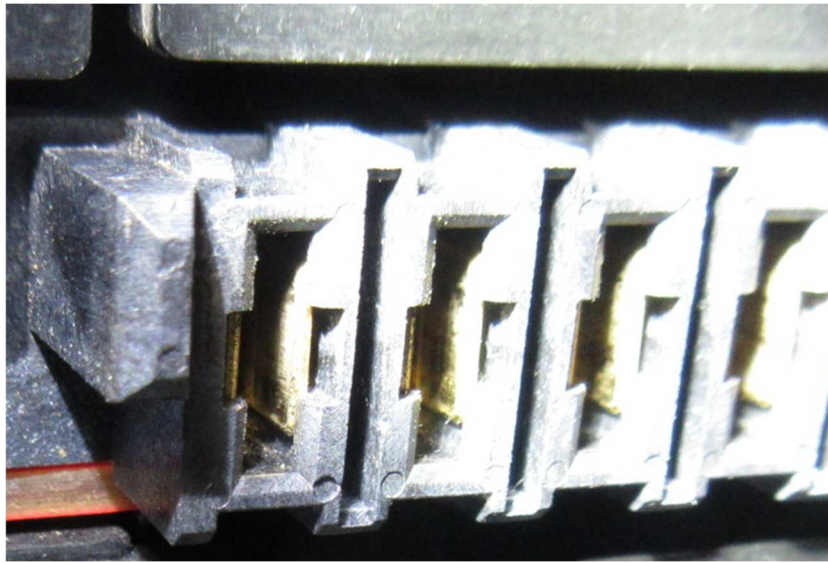
The associated terminal on the main controller was in better condition.

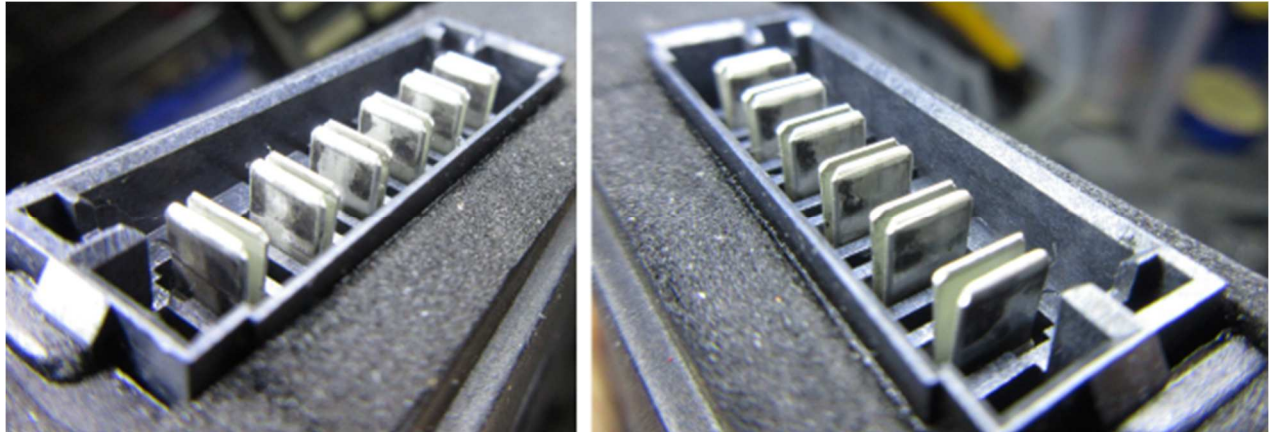
The image below shows the male terminals for battery 3149595733, AFTER CLEANING. This board has done 61km.

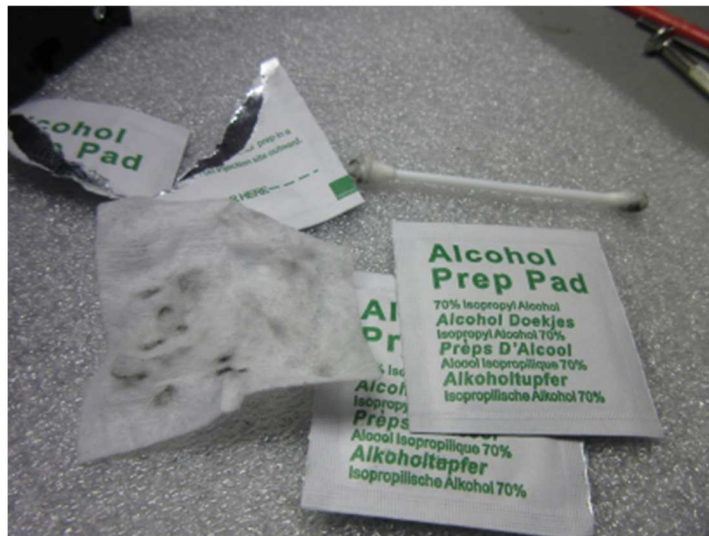
Isopropyl Alcohol pads and cotton buds was tested, as a cheap easy approach for the general user. This removes a lot of the contamination, however it did not remove the oxidized plaque.

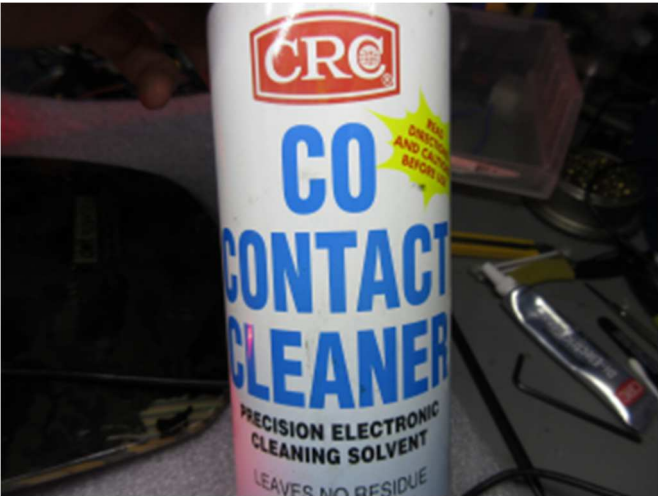
CRC contact cleaner failed to remove the oxidization.

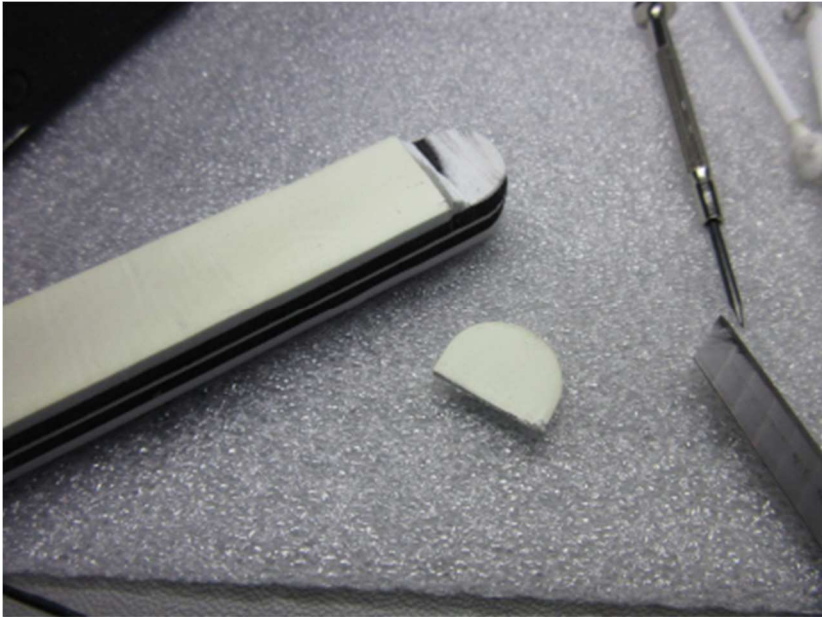
A padded emery nail file/polish was used. It was quick effective at polishing and removing the plaque, however very fiddly and time consuming.

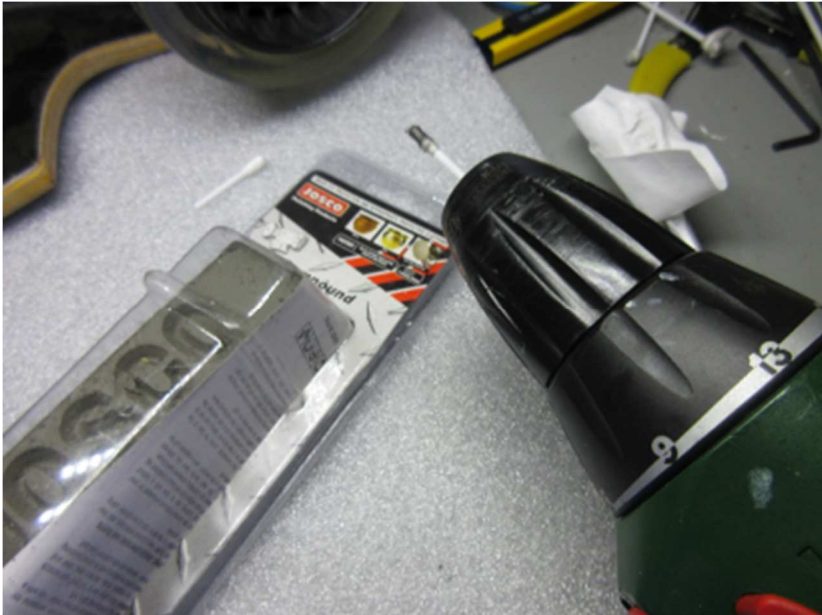
A cotton bud in a cordless drill with metal polishing compound worked reasonably. However, it was not a good approach due to the residual cotton fluff distributed in the connector. Perhaps a Dremel or similar tool has an attachment better suited.

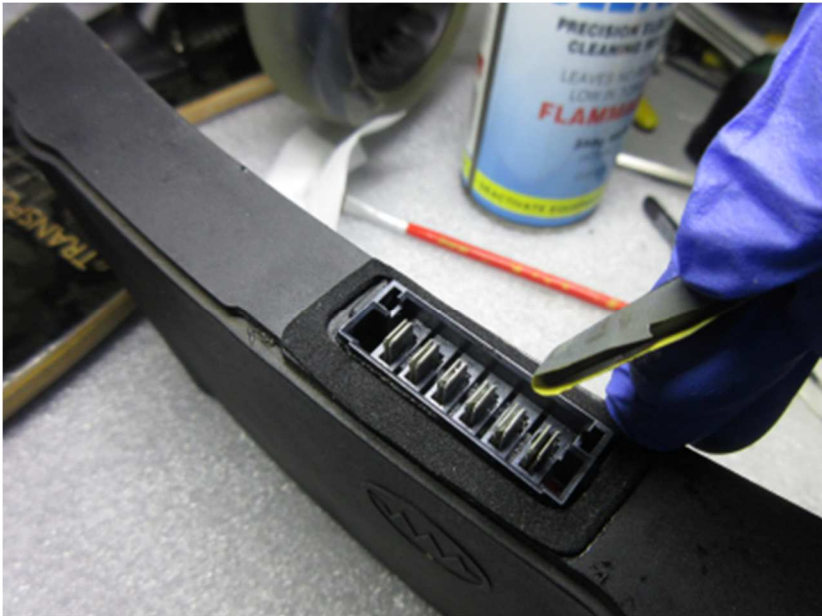
1200 wet/dry paper provided a reasonable approach to removing the oxidized plaque on the male terminals.
