ECLIPTECH INNOVATIONS PTY. LTD.

PROGRESS REPORT SEPTEMBER 2020

Product: Electric Skateboard

Company: Globe Brand

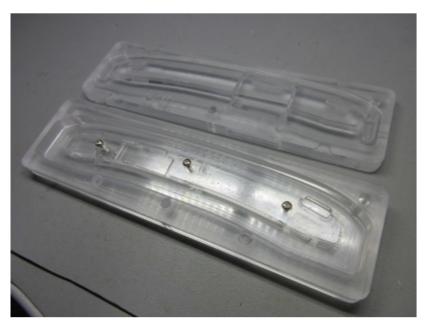
Minor adjustments made to increase frame mask durability and specifically prevent over filling on the rear from causing a fitment tolerance issue. Design was completed and the tool is ready. Waiting on resin supply intended for molding the production frame masks.

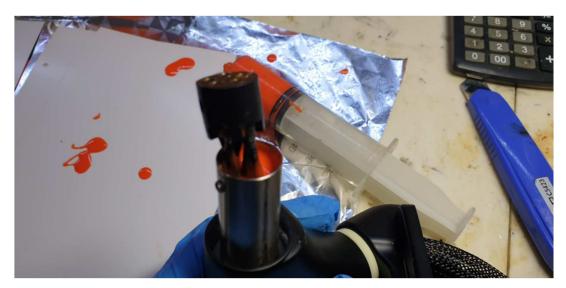
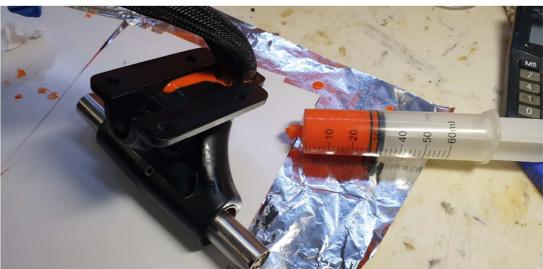
Water ingress into the hanger causes persistent wet motor issues. To support possible solution considerations, a hanger was potted with a resin to test feasibility.

<35g of resin was filled into the hanger cavity. The result was successful for filling. Numerous aspects were learnt from this trial. The specific resin and viscosity is an important criteria. The difficult aspect to consider is the production process needed to support this approach. In-particularly, current hangers already have the wiring conduit sealed with adhesive, which limits options. The motor seals also did not prevent leakage of the resin, which is not surprising given there was no pressure on the seals for them to work as intended.

Potting the hanger may be considered in-additional the X-seals being developed. The lack of availability on suitable resin limits options. In addition, the production process will likely be different between current sealed hangers and new production.
