MAIN CONTROLLER AAAA0079 INSPECTION

Date: 25th June 2020
Revision: 1.0
Author: Tony Little
Product: Electric Skateboard
Company: Globe Brand

Customer return. Charger failure.

2020-06-05 - Battery current sensor fault (water ingress?). Battery charger failed.

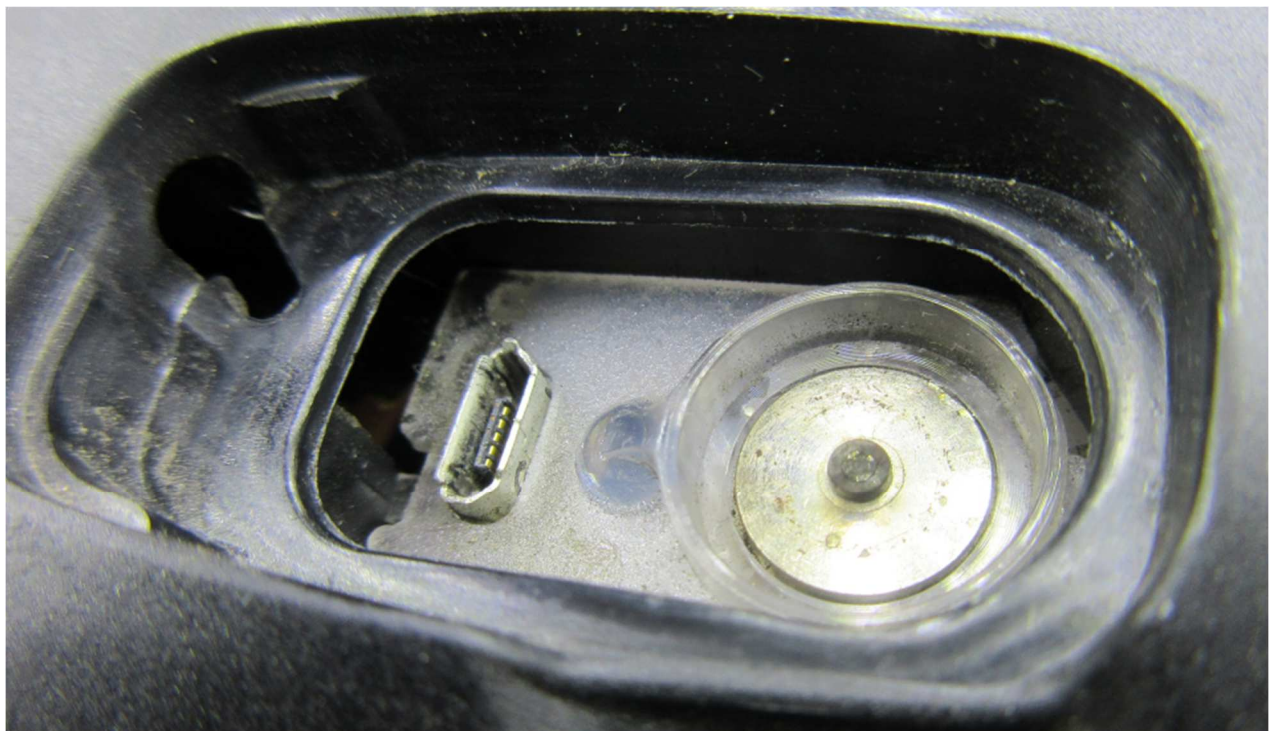
Charge port cover missing. Very dirty charging connector. Contact is pitted and surface damaged. It is not known if the contact damage is for dirt or water contamination while charging.

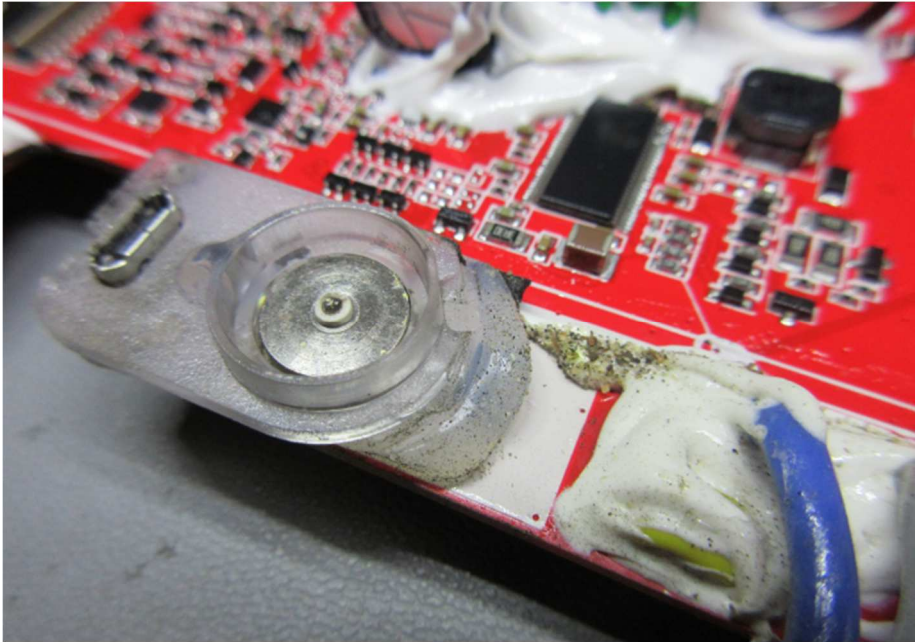
Noticeable dirt stuck to external glued surfaces. No signs of water ingress within the main PCB cavity.

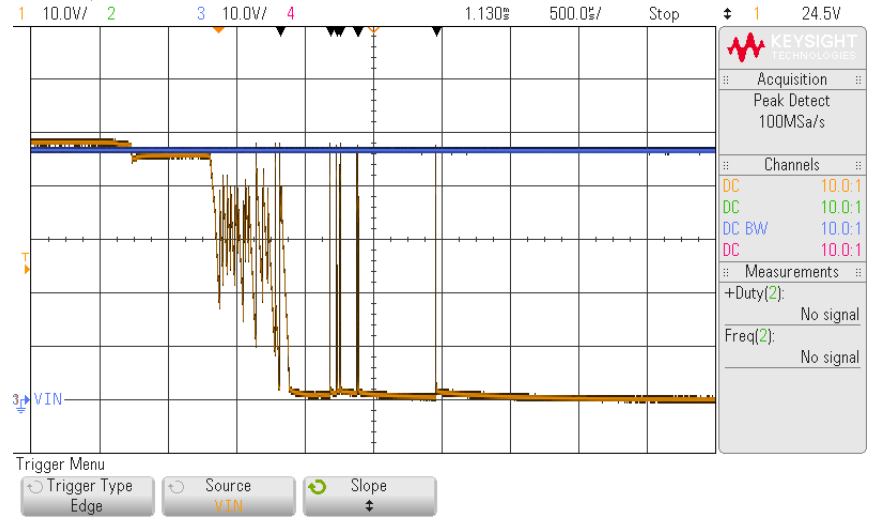
DSO-X 3024A, MY50514704: Thu Jun 25 17:10:40 2020

Very clean disconnection. Quite the contrast to the damaged receptacle.

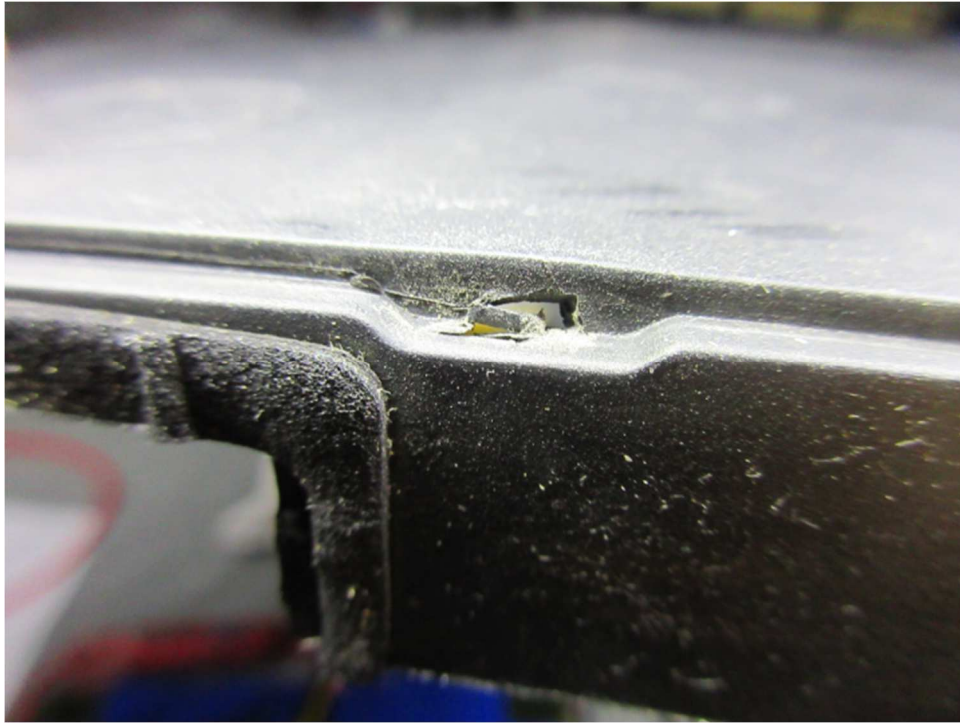
The water ingress again occurred at the drain hole. The residual dirt contamination is isolated to this area in the battery cover. The rest of the enclosure, PCB and battery pack are otherwise quite clean.
