PRE-PRODUCTION FEEDBACK

Date: 23-12-2020
Revision: 1.0
Author: Tony Little
Product: Electric Skateboard
Company: Globe Brand

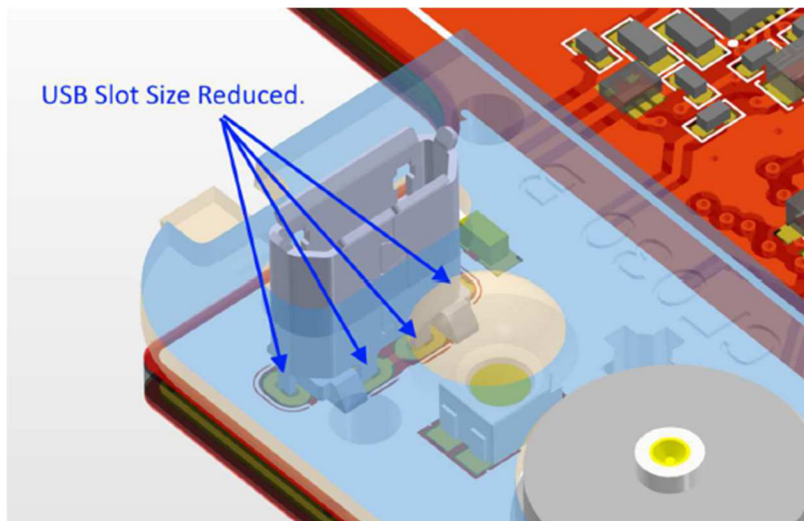
The same USB connector footprint update on the remote was applied to the MC. The changes were to improvement alignment and to increase solder fill.

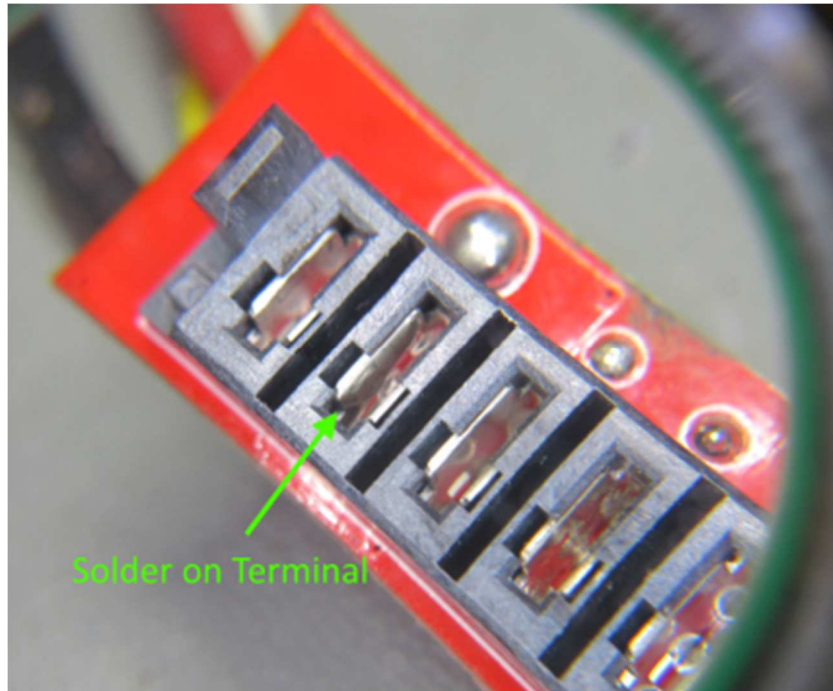
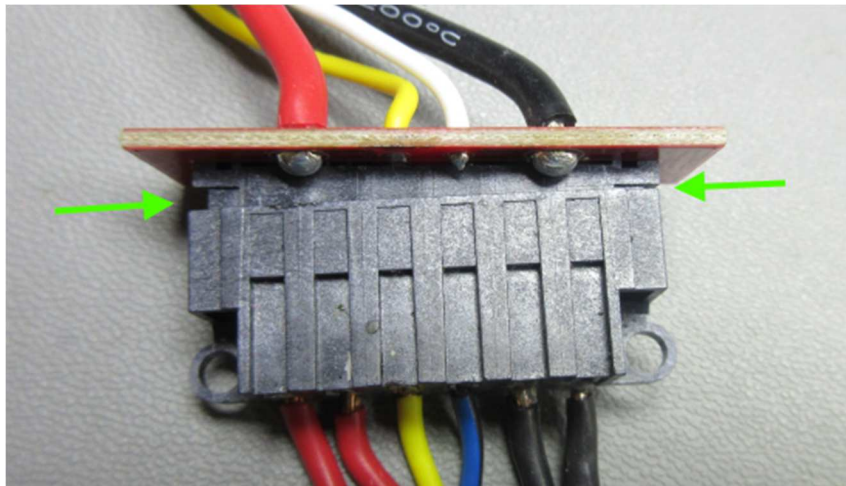
3.2.1 BBBB009A

Inspection found the front connector to have solder wicked into terminal contact. This causes a fitment issue for full connector mating.

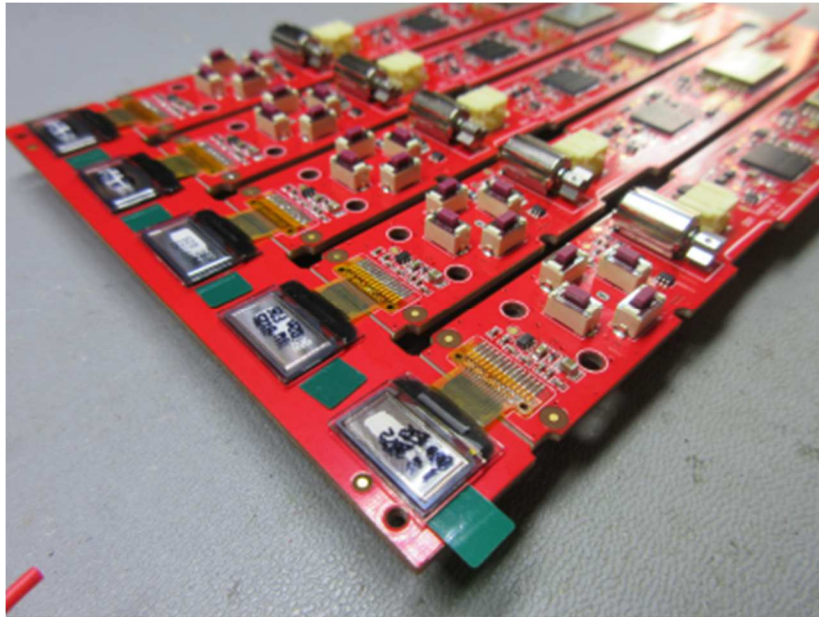
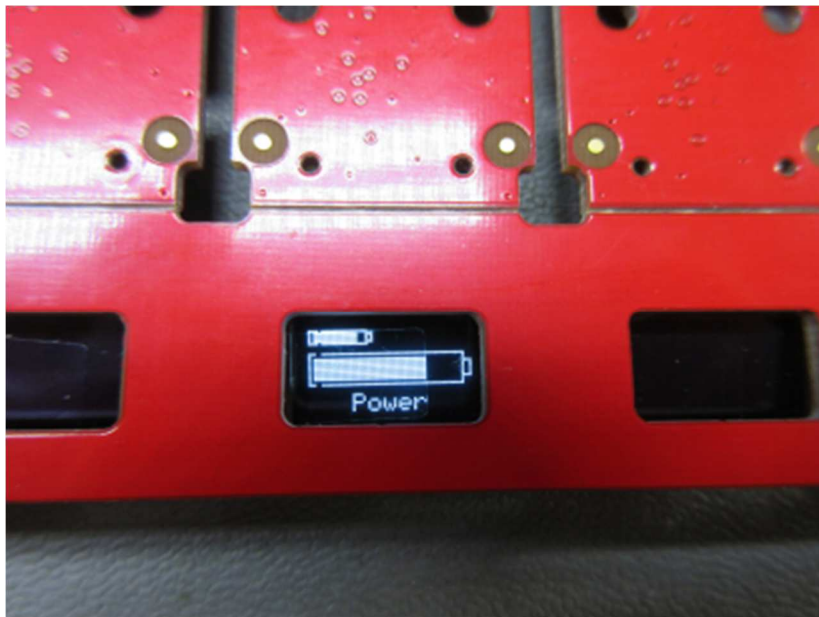
4.2 OLED PROTECTION

OLEDs have the desired additional support for handling and shipment.

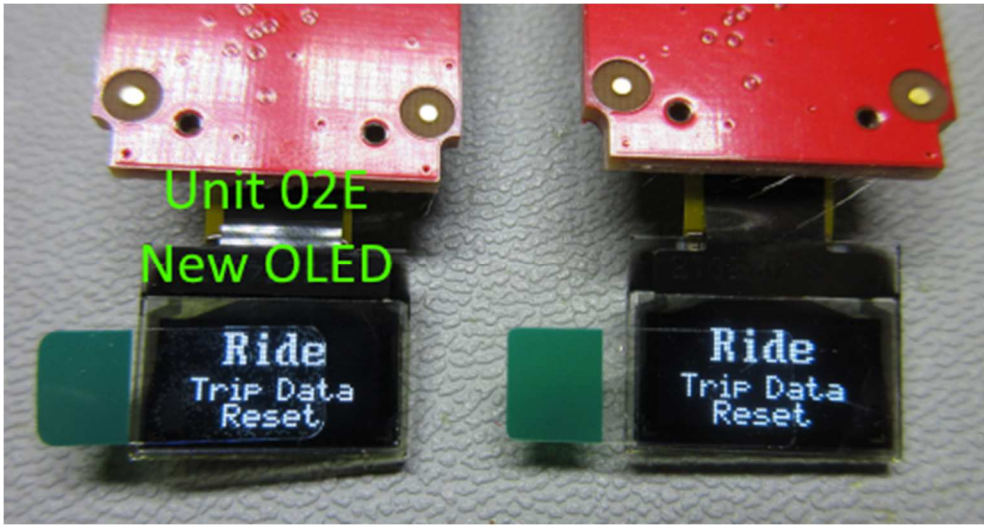
4.7.2 FFFFF02E

OLED Dim.

Replaced OLED. Brightness correct.

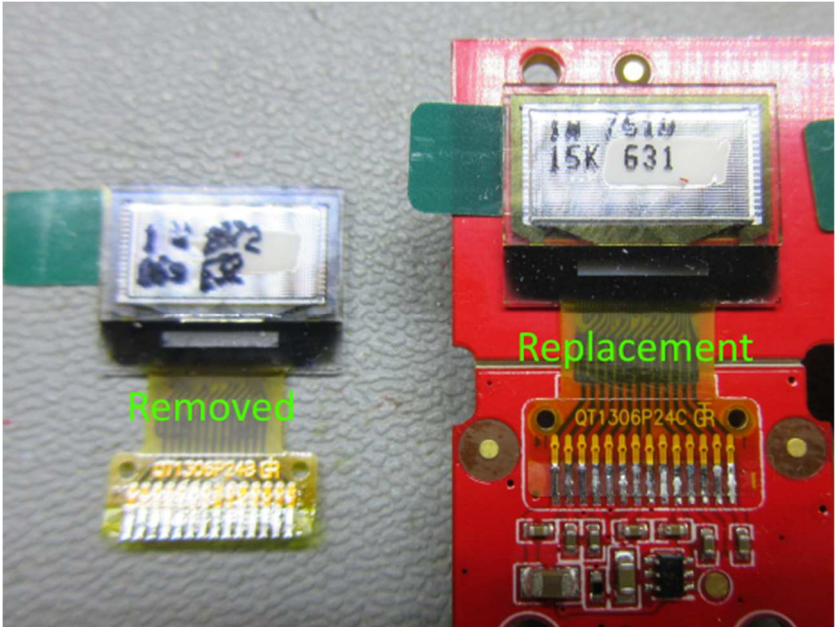
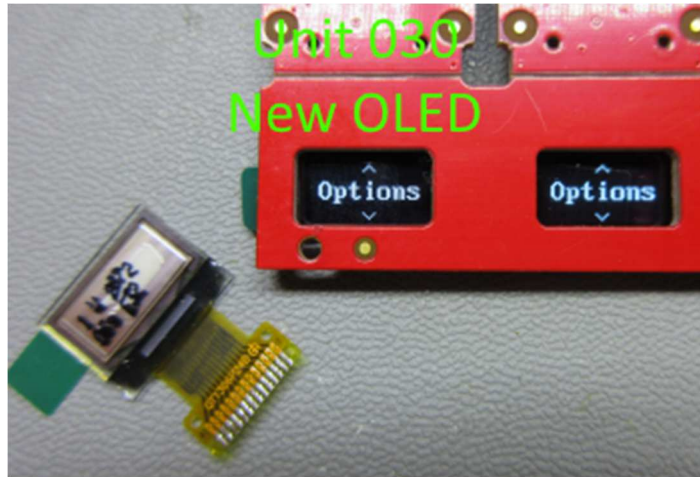
4.7.3 FFFFF030

OLED is dim.

Re-soldered tab with flux. OLED is still dim.

Measurements

- VCOMH = 7.49V
- VOLED = 4.02V
- VDD = 2.498V
- C1 = 1.42V
- C2 = -4.45V
- IREF = 4.70V

Replaced OLED. Display brightness as expected.
