BATTERY MODULE DROPOUT INVESTIGATION

Date: 23rd April 2021
Revision: 1.0
Author: Tony Little
Product: Electric Skateboard
Company: Globe Brand

5 boards were investigated for power dropout issues. 2 Compact and 3 Transporters.

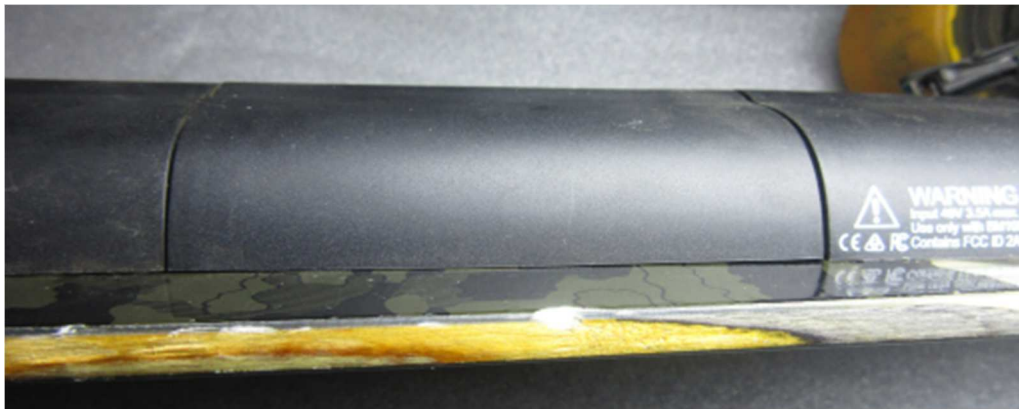
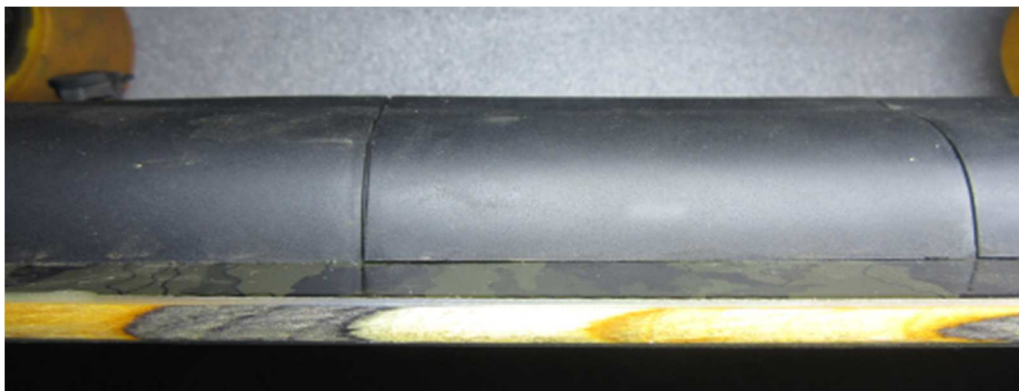
Modules are bolted flush to the deck.

The gaps between the modules is good.

MC to BM... 0.9, 0.9, 0.75, 0.85, 0.9mm.

BM to BM... 0.85, 0.5, 0.5, 0.65, 0.7mm.

Module mounting bolts were loosened 2 turns. Modules bumped to re-settle, then bolts tightened $\frac{1}{2}$ a turn in sequence. This was in an effort to ensure the least mutual mis-alignment during tightening. The gaps were re-checked. The process had negligible difference to the gap measurements.

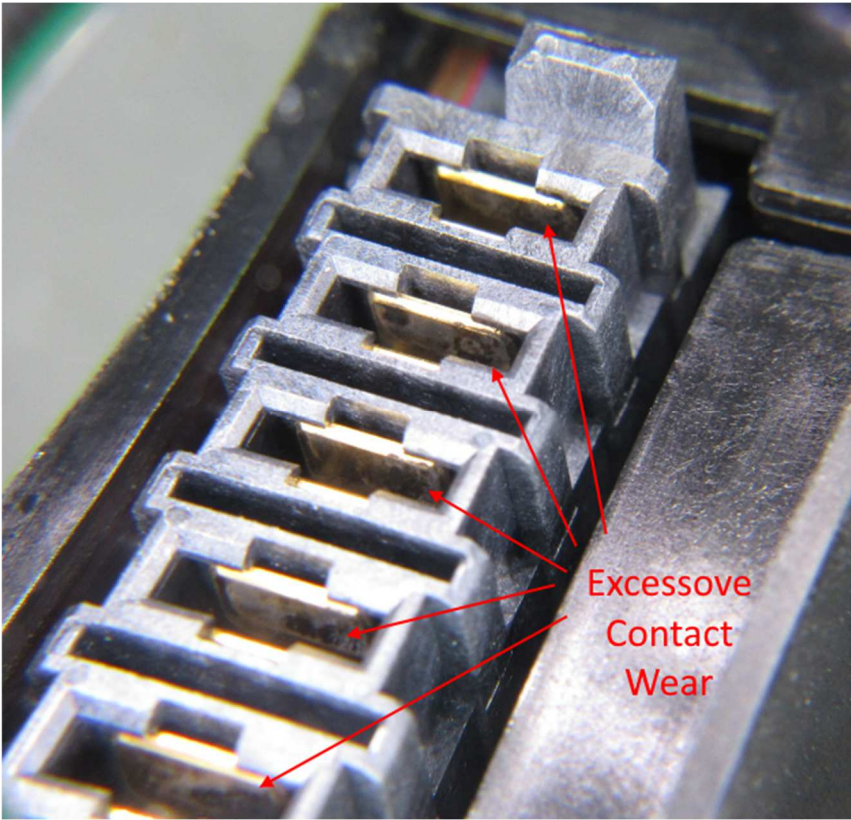
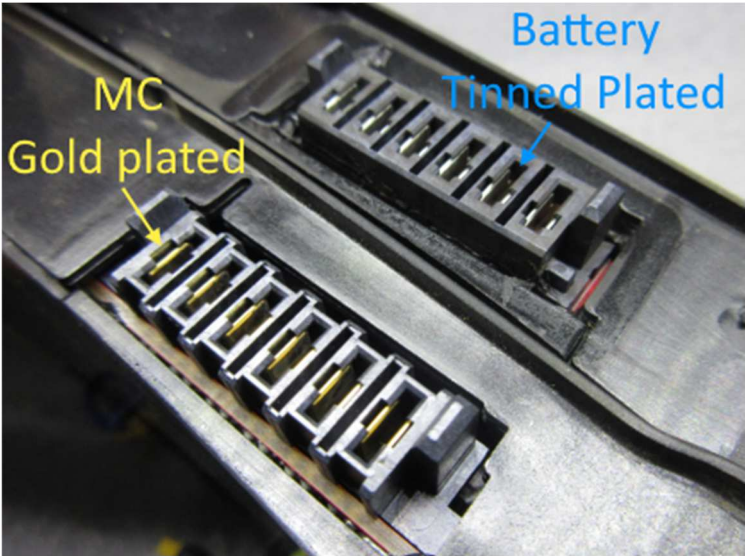
3.3.2 MAIN CONNECTOR

The MC connector is using the gold plated connector variant. Connector part specified MPS-06-01-01-L-RA-SD. Tin plated variant an option, MPS-06-01-01-T-RA-SD. However terminal wear is not significantly different. Possibly a fraction less.

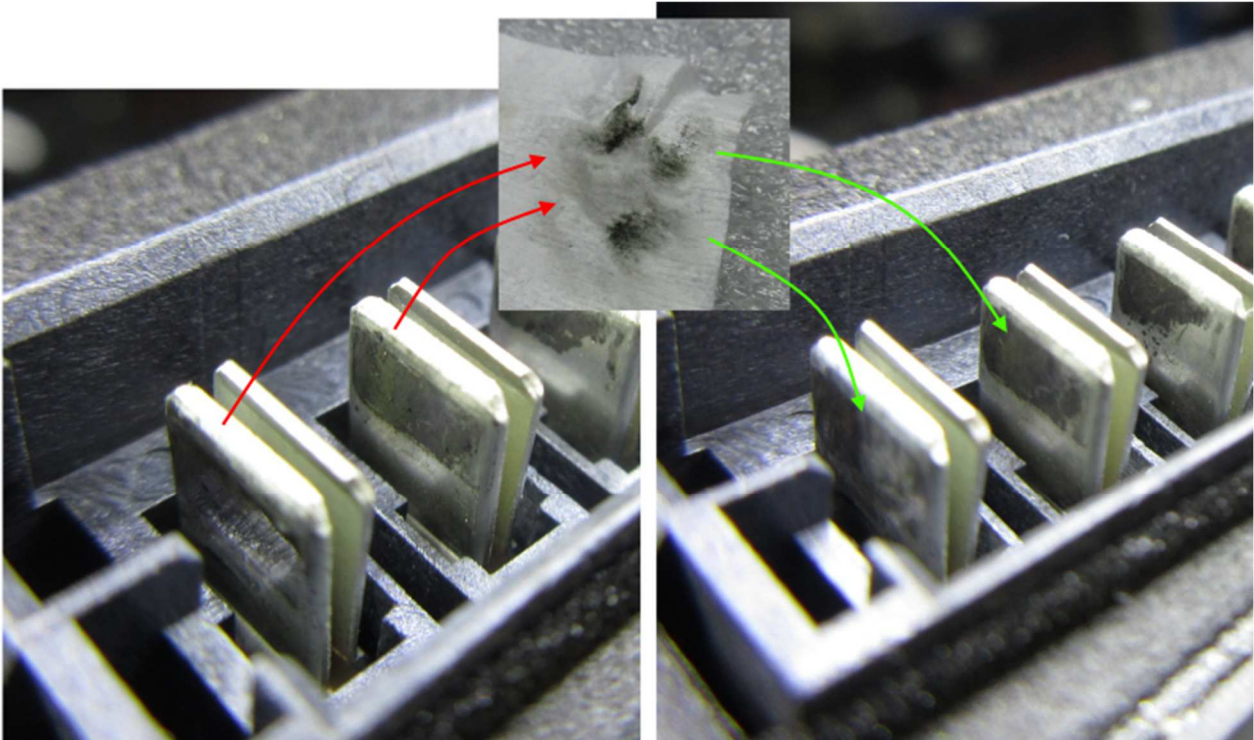
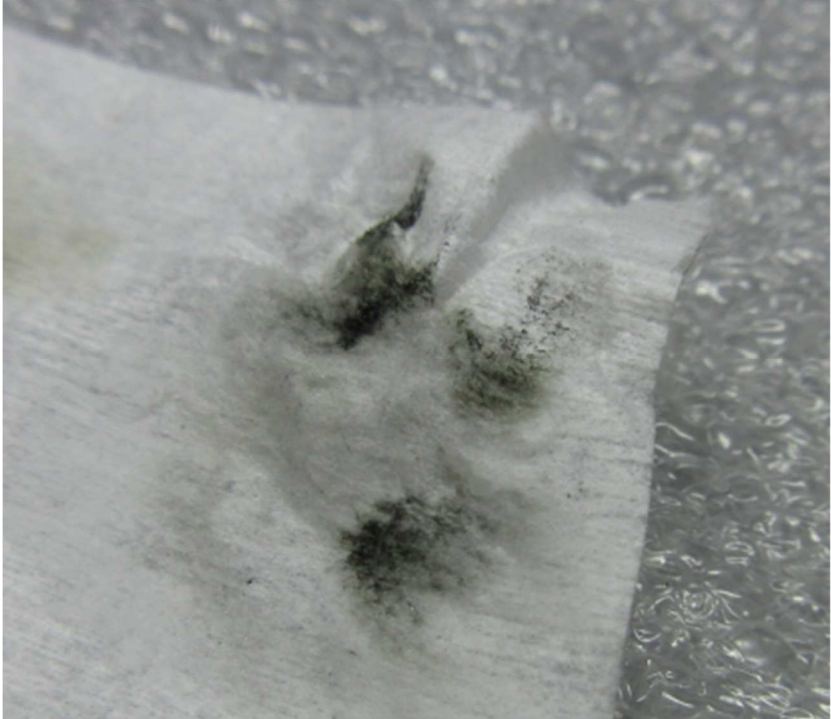
This battery was adjacent to the main controller. The wear is noticeably un-balanced. More wear on one face of the terminals than the other. Un-even wear across the blade surface. Contact wear is more triangular.

Cleaning two terminals shows little visual difference, however the removed residue is noticeable on the cleaning cloth.

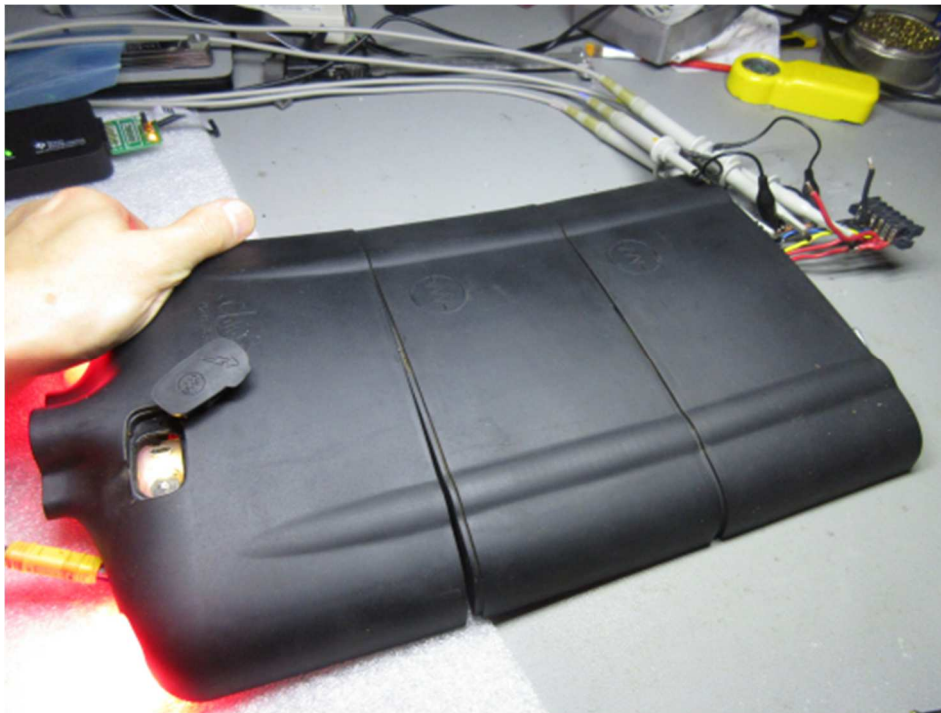
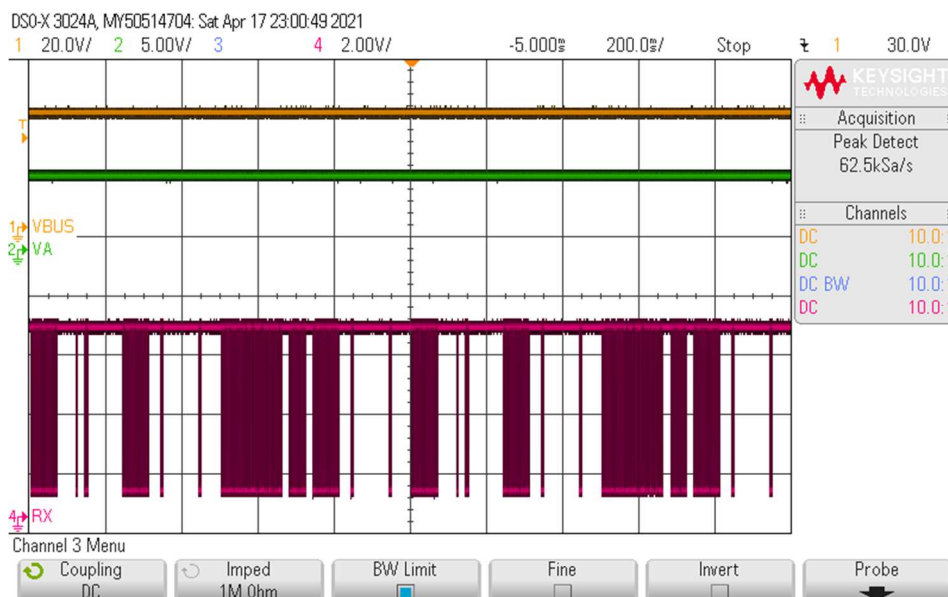
3.4 MONITORING MODULE MOVEMENT

Specific software was implemented to monitor the LIN Bus non-responses, reception errors and battery reset events. While also monitoring the front connector signals, the modules were wreched around with a variety of movements. Despite more than realistic articulation, no faults were generated from the movement. In addition, no noticeable corrupting noise was evident in the connections, as monitored from the front connector.

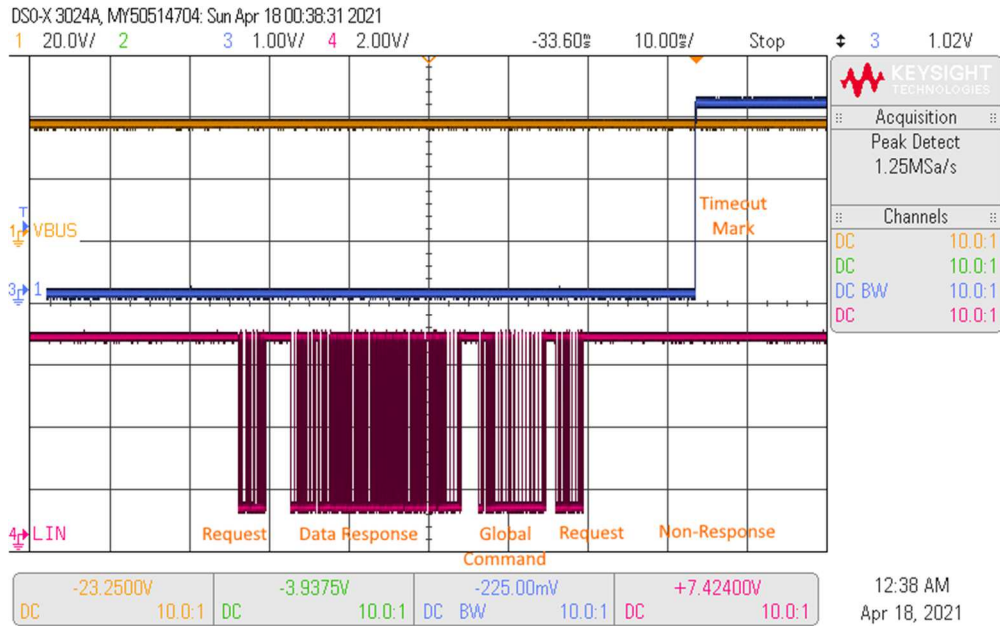
3.5 LIN BUS MONITORING

Rare instance of battery non-response observed to data request with preceding global battery command. 1 to 2 per minute. Idle time extended from 2.0ms to 2.5ms for future firmware. No further instance captured, 10+ minutes. Not deemed relevant to dropout investigation, as statistically insignificant to a timeout result.

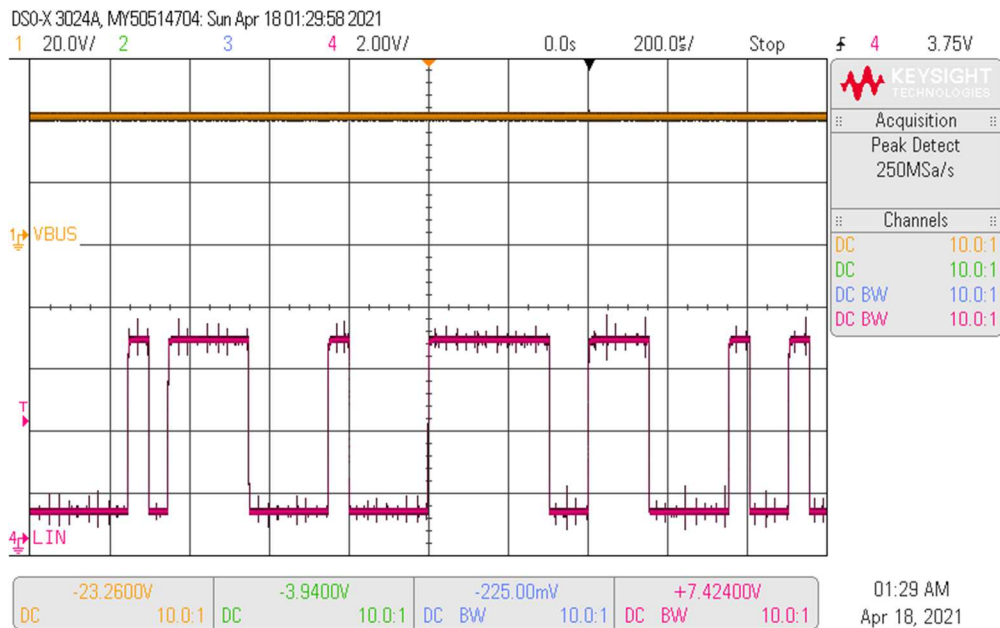
LIN Bus (below) captured with motors unloaded, maximum speed. Zero timeouts, zero packet errors. Signal quality very good.

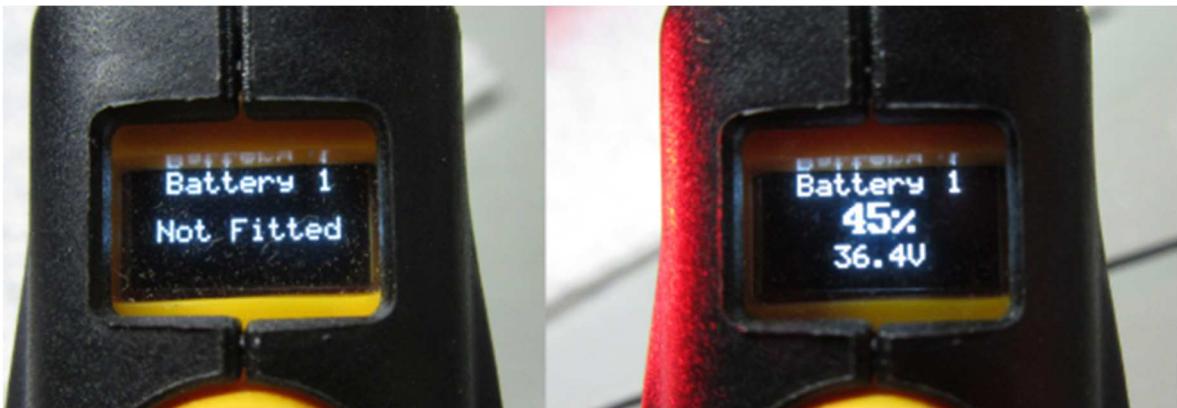
Monitoring remote battery info, board untouched, battery 1 dropped out. This persistent after going to sleep mode and powering back up, however without intervention, power was restored a short period later. Still only 1 battery responding.

Log registered a current sensor and amplifier offset error fault. Most likely due to loss of V_Aux stability.

Updated MC to V089 firmware. No LIN Bus timeout/errors occurring. Second battery not responding.

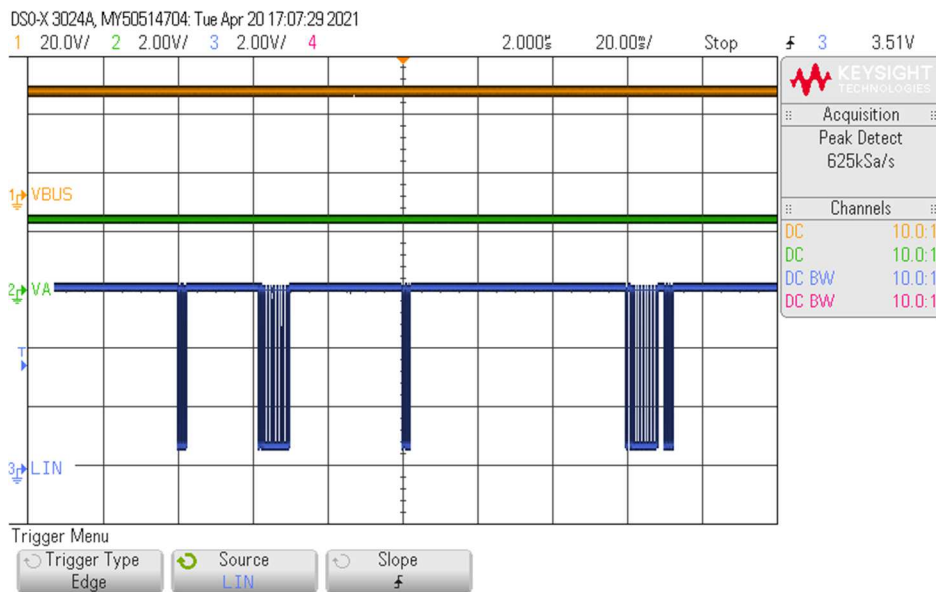
VBus and VAux are present. **VAux is not at the expected or required level, <3V**. LIN bus is present and at the required level. Batteries are non-responsive.

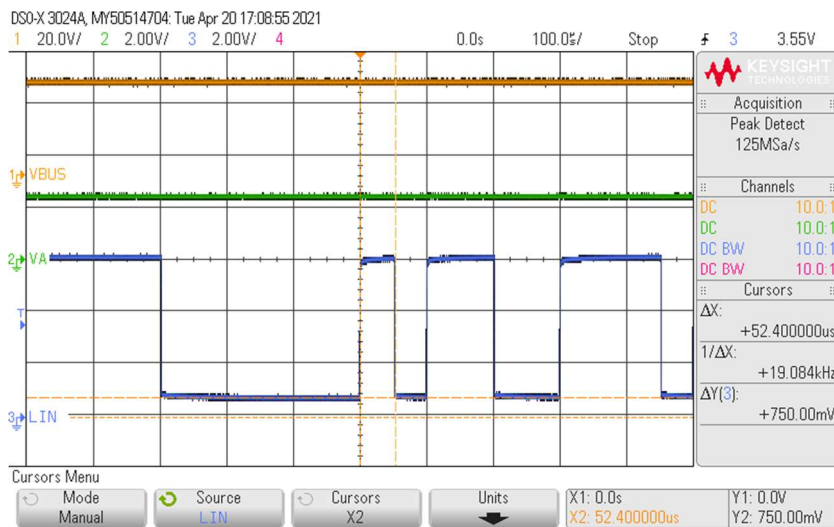
LIN Bus data rate measured at 19084Hz (high stability). Vhigh = 6.2V, Vlow = 0.75V.

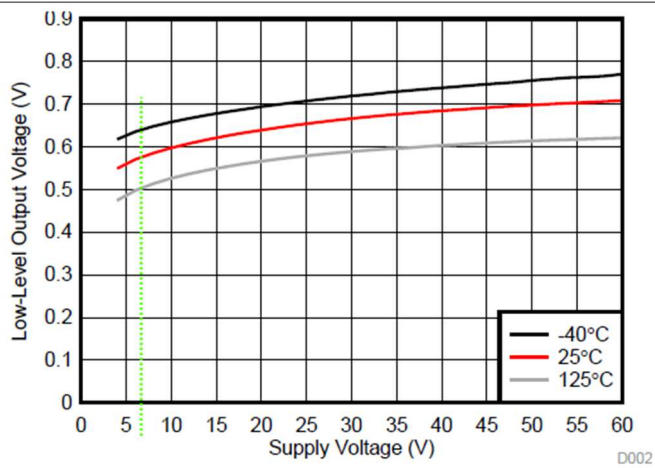
Low level well within specification, although further than found in expected deviation shown in typical characteristics.

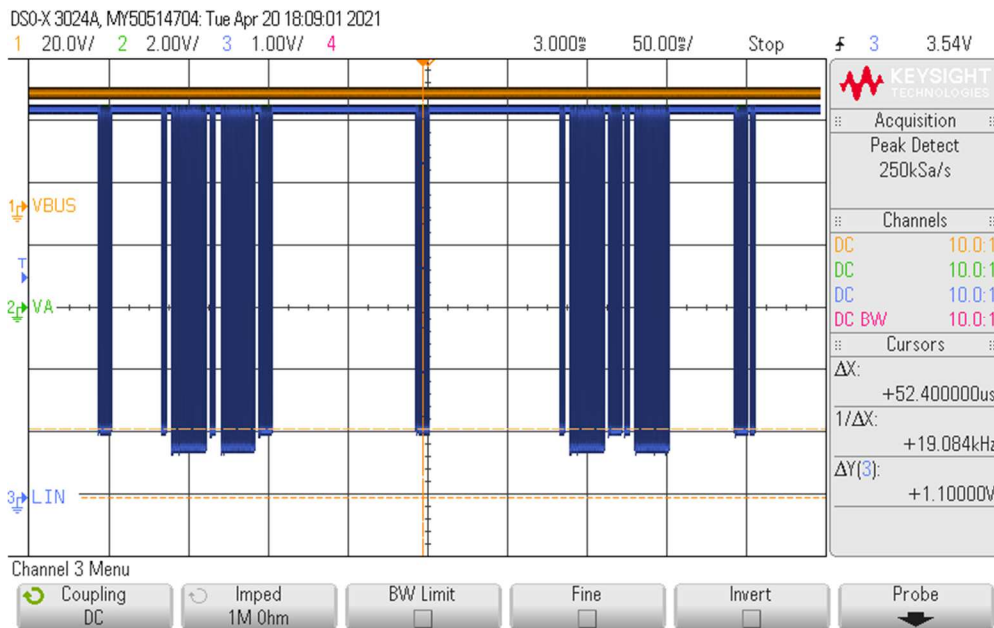
Master dominate level observed at 1.1V. This is very close to the 1.2V specification threshold. Dominant level not influenced by data traffic load. Second battery come online for the first time. Probe checked for ground and DC coupling setting.

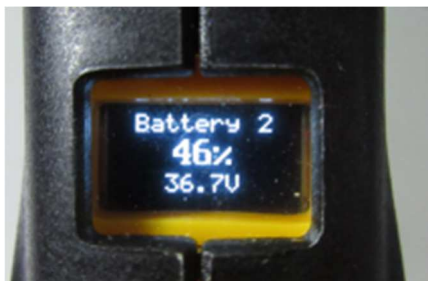
During investigation, the second battery become responsive. The most obvious change to the test environment is a shift in ambient temperature... > 5'C due to internal room heater running the last 30..60mins (wife's influence).

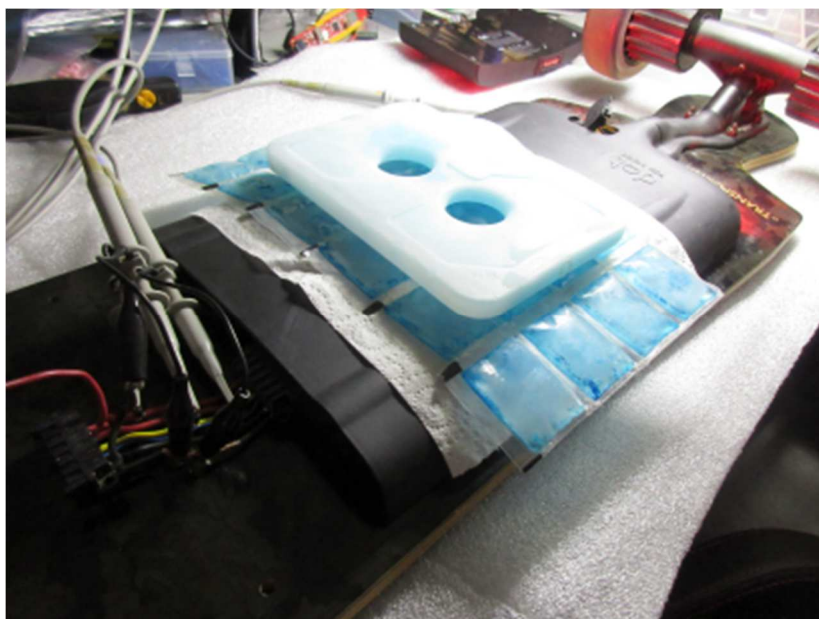
The second battery was subject to ice packs to reduce PCB temperature.

22.4'C → 21.1'C → 20'4'C → 18.8'C → 17.9'C → 14.9'C → 13.4'C → 13.0'C

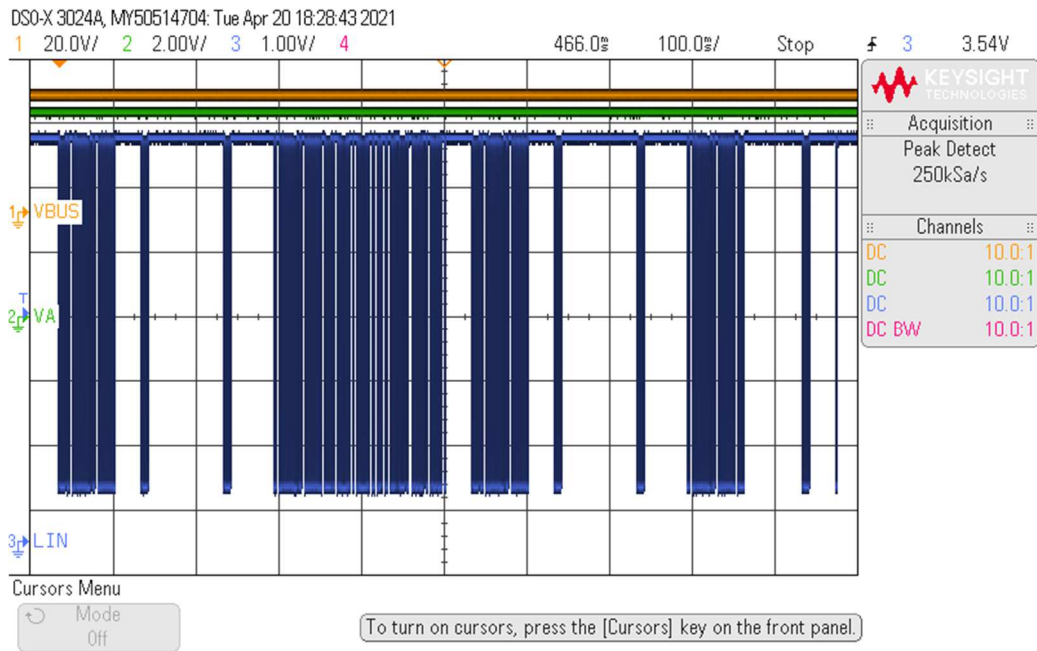
Dominant levels equalised at 8.1V with battery PCB temperature reduction. Note: USB monitoring during temperature test occurred. USB was disconnected at this point to rule out interference with the observation.

Throughout the extended period of reducing the temperature, there were zero LIN Bus non-responses, zero packet errors and zero dropouts. VAux at the expected level.

Dominant LIN state voltage level variance is not chipset related. Identical TLIN2029DRBRQ1 used on all modules. All driven by the same VAux supply level. Master has 1k pullup, slaves 47k pullup. All are subjected to the same bus load. Possible cause is an increase in impedance between MC ground and battery ground.

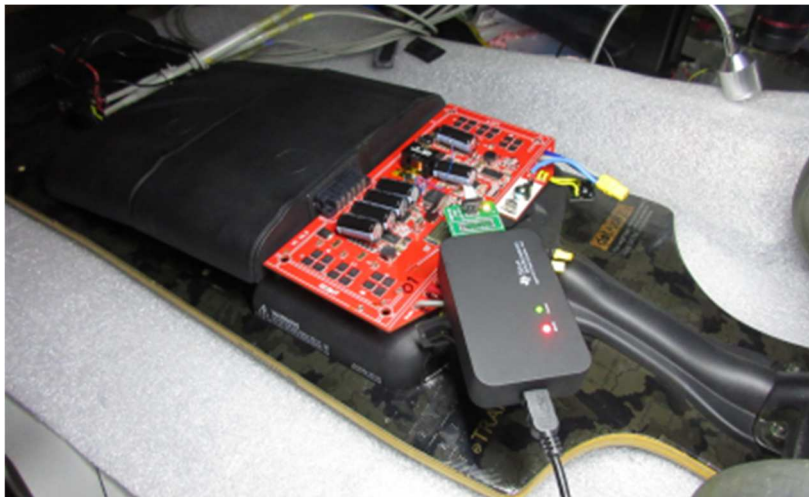
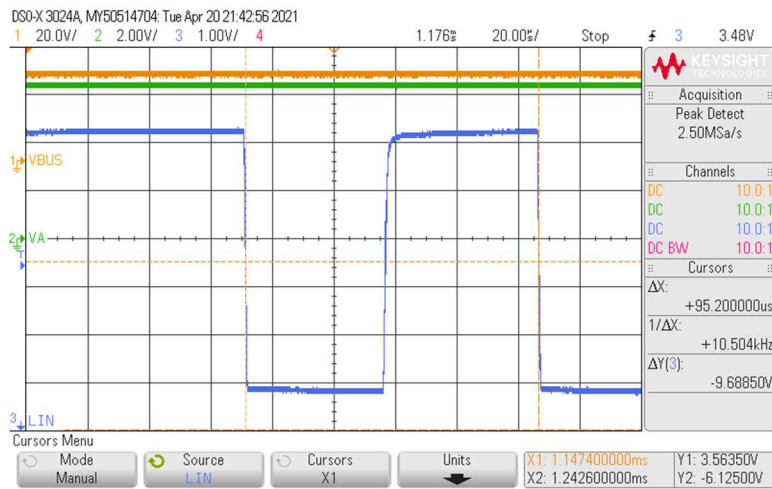
Alternative development MC used for LIN testing. Re-programmed to 20955bps. All 3 batteries loaded.

3149595829 / BBBB04B5 = Responding.

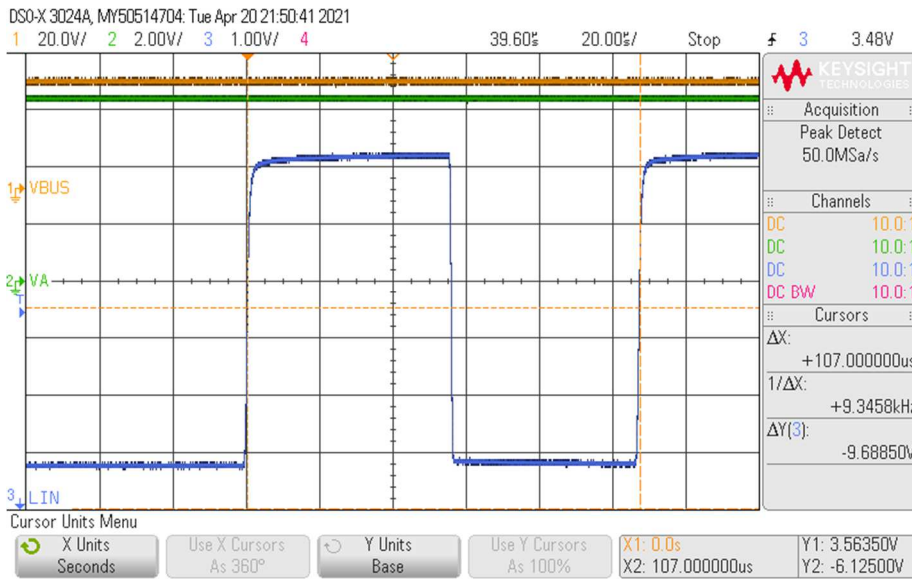
MC re-programmed to 18695bps. All 3 batteries loaded.

No batteries responding.

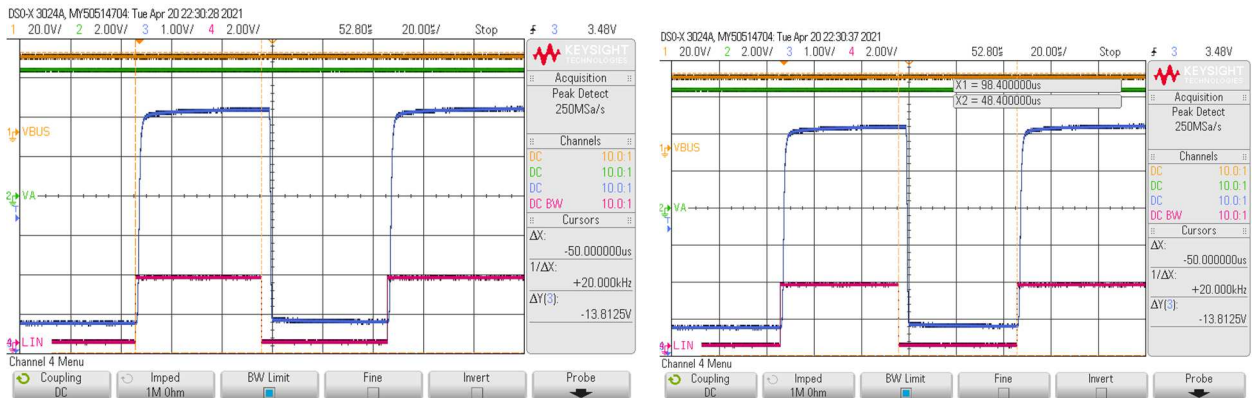
MCU firmware is generating 20000bps very accurately, 50% duty.

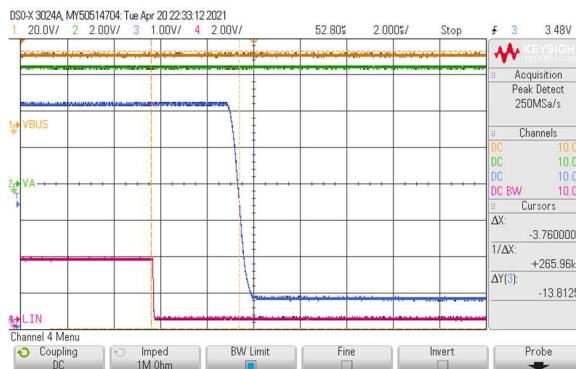
Recessive to Dominant transition has 3.7us delay.

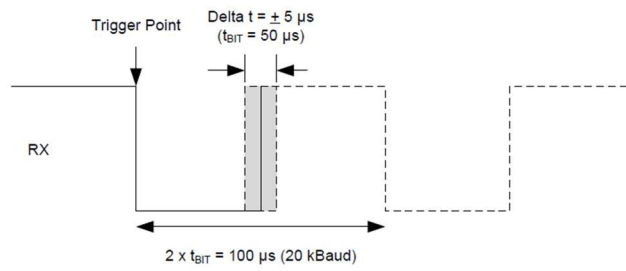
3.7us is within LIN 20kbps specification.

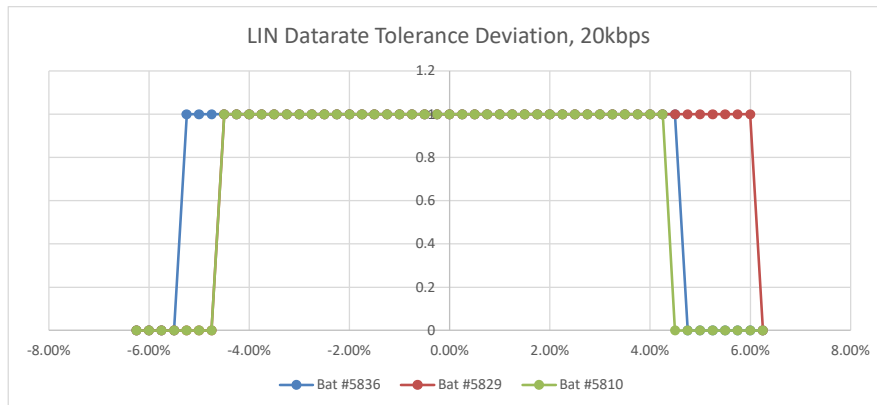
Results show datarate variation tolerance for 3 battery packs within +4.25% to -4.5%. Given small sample size, this is considered a likely ideal 0% bias and a very good result. Good tolerance.

Beyond -5.5% tolerance, battery packs were observed detecting a shorter packet instruction associated with the discovery mechanism. Accumulated bit error was likely within the scope of tolerance. The batteries are cycling responses and not causing a down stream lockout.

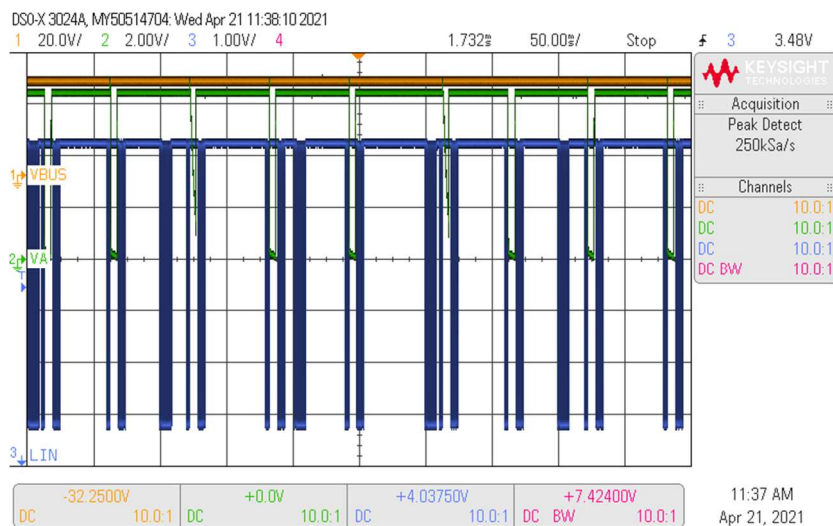
Datarate tolerance and LIN bus within operational requirement. All batteries functioning, unlike initial testing.

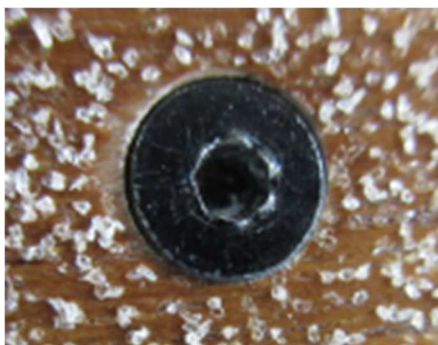
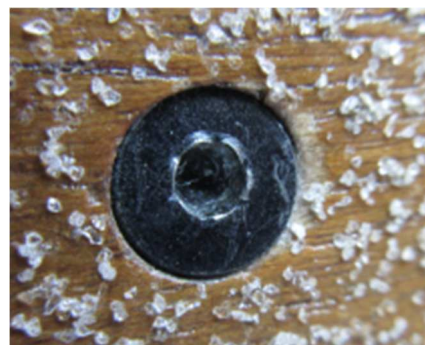
The USB socket is damaged. USB has to be held to one side to establish connection to dot-hub.

Board needs a new charge port cover (tether missing) and two new module bolts (sockets chewed out).

Not my doing!

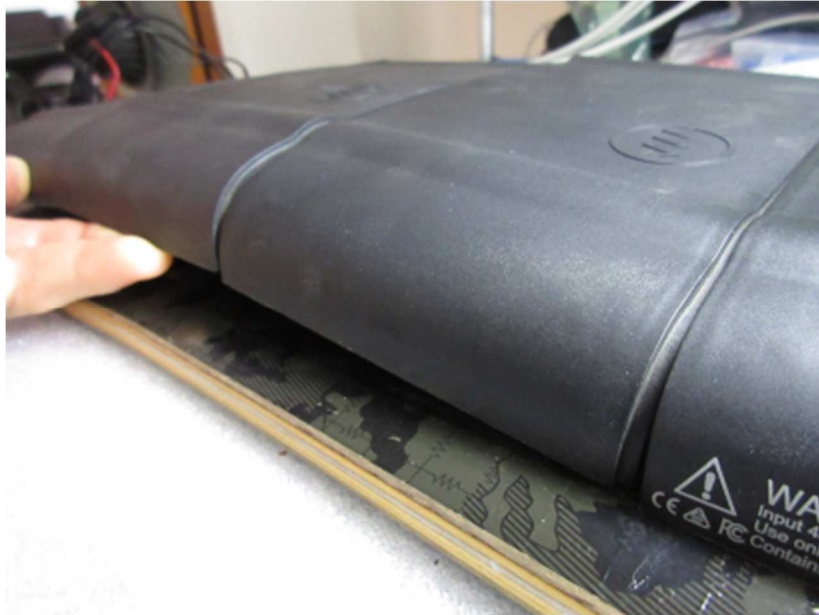
3 batteries fitted.

Turned on and off 30 times. Zero failures to detect all 3 batteries.

Articulating the battery modules to extremes caused no dropouts.

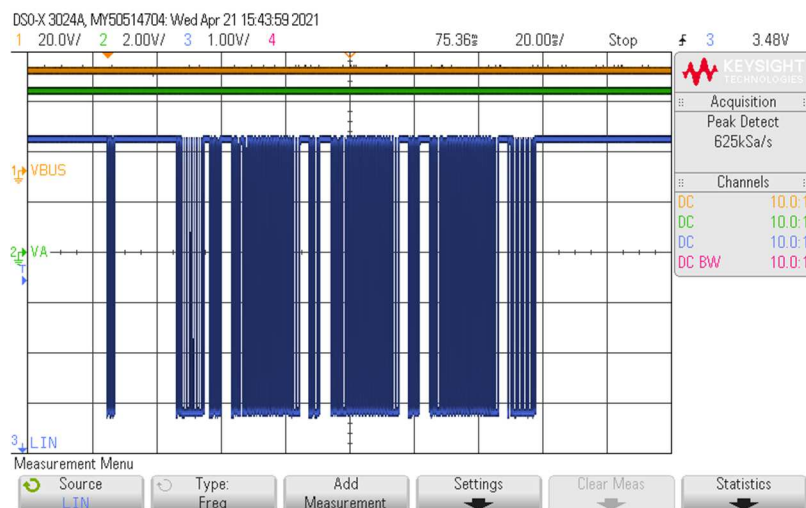
-4.0% BR=1302, 19200bps

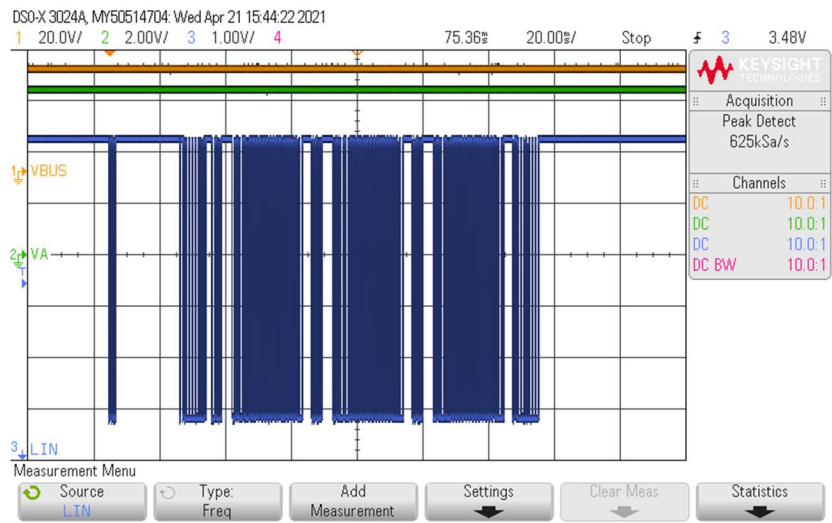
+4.0% BR=1202, 20800bps

Limit was below -5.0% and above +4.25%.

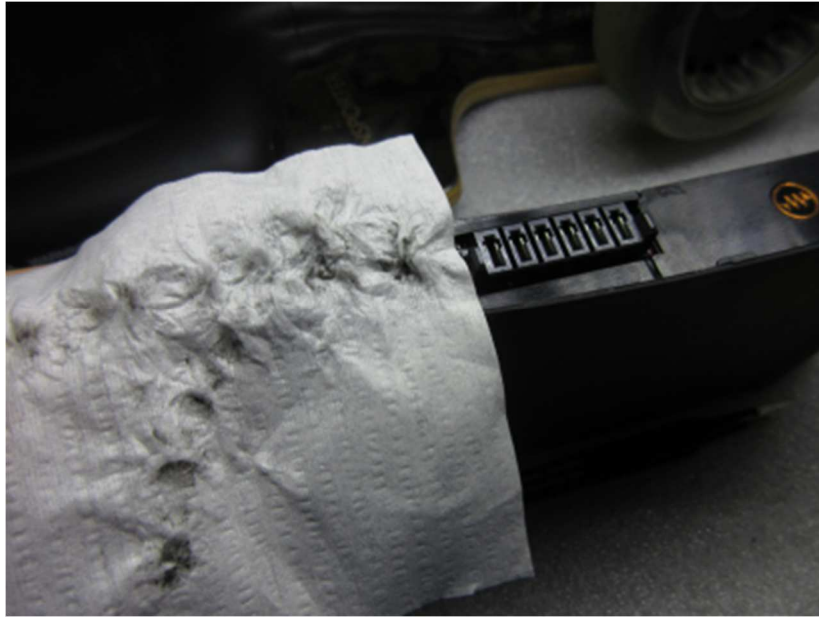
Massive battery flex, twist and gaps... still functioning.

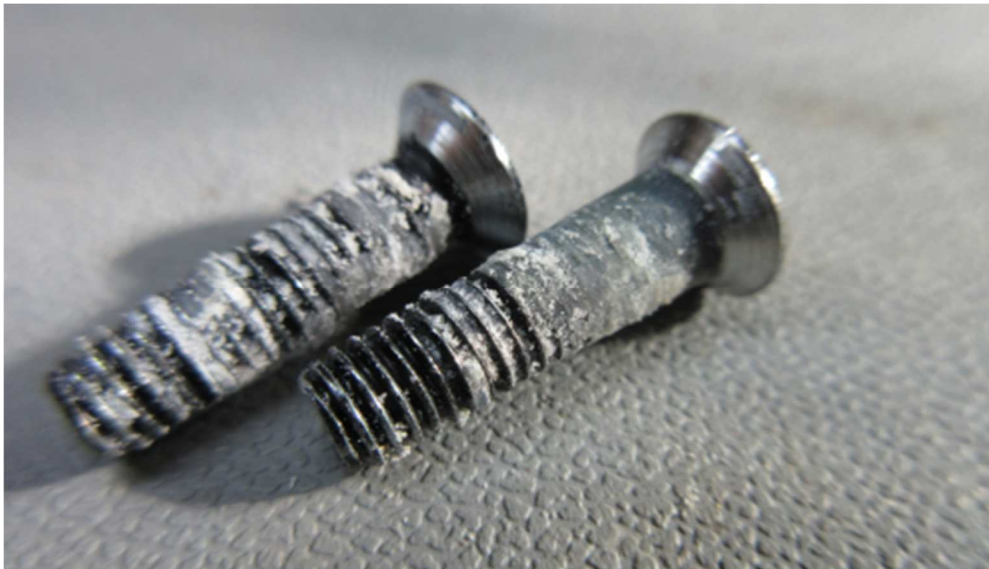
The deck bolts are contaminated with an unexpected hard material (thread lock?). It is not known if this may weaken or damage the Nyloc material. The bulk of the material is on the upper thread and useless for retention. It is recommended to consider whether this practice is acceptable from a service perspective in relation to warranty. Particularly if this is being applied unnecessarily by the dealer.

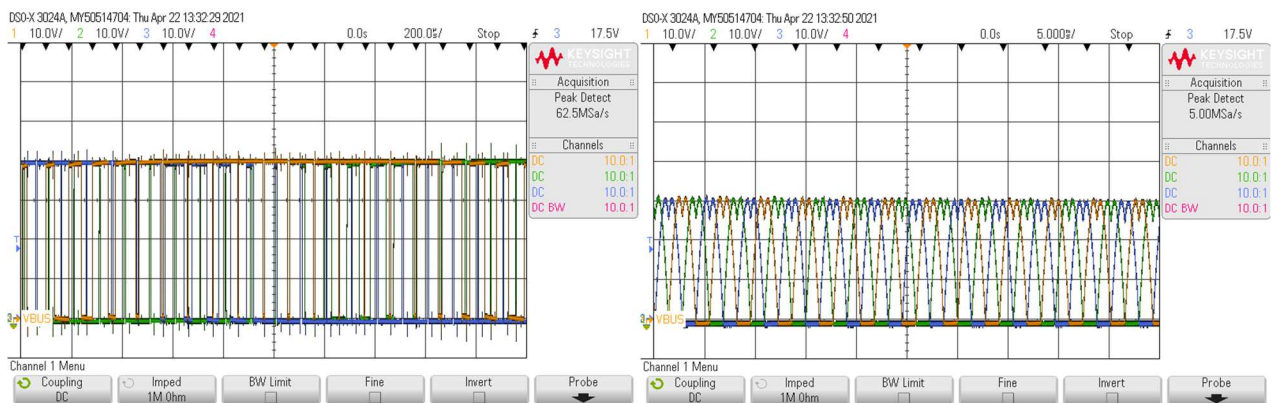
The LHS motor is TERRIBLE. Very noisy. Quite surprised WA sports note only states dropouts, not excessive motor noise. The wheel has wiggle room on the motor. Picture below show the gap pulling to one side.

The motor commutation was electrically checked. The motor is electrically operating as expected and not causing any fault. It is considered a mechanical failure and not considered relevant to this current investigation.

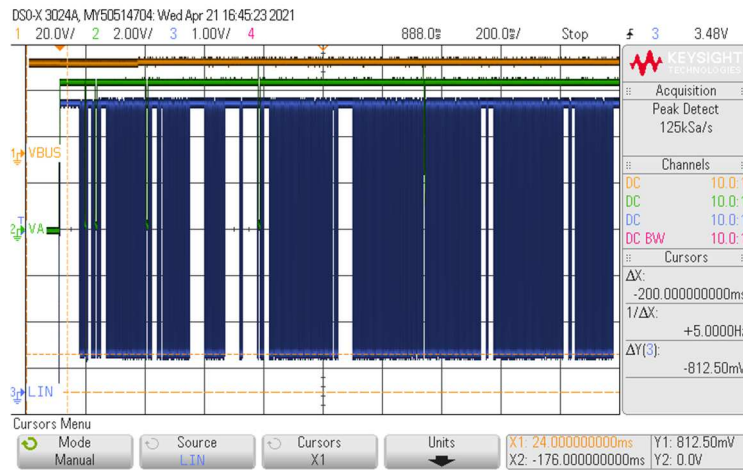
Startup.

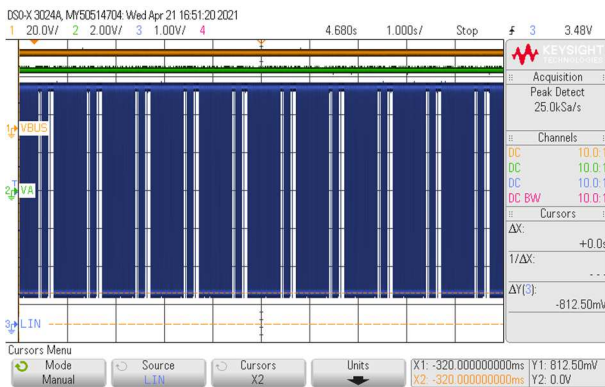
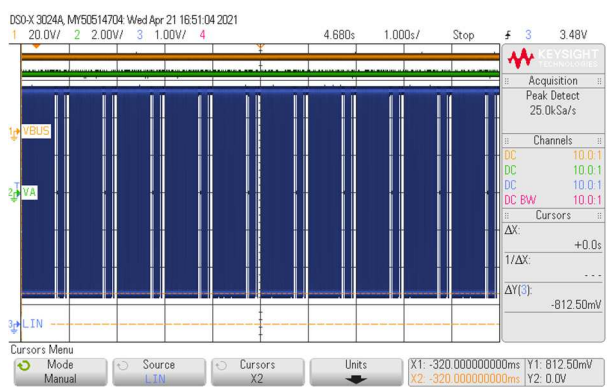
Communications at full load... 1s/div.

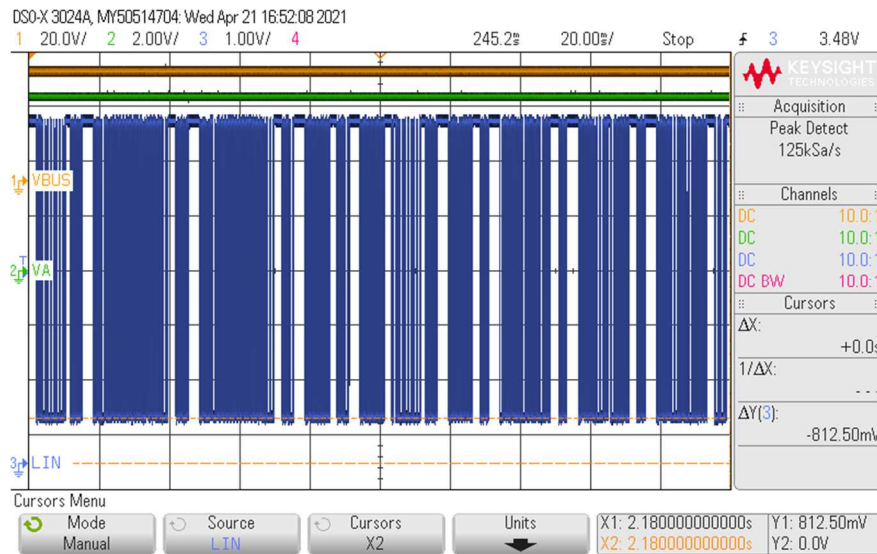
20ms/div

LIN data/communication as expected and operating efficiently. No overload.

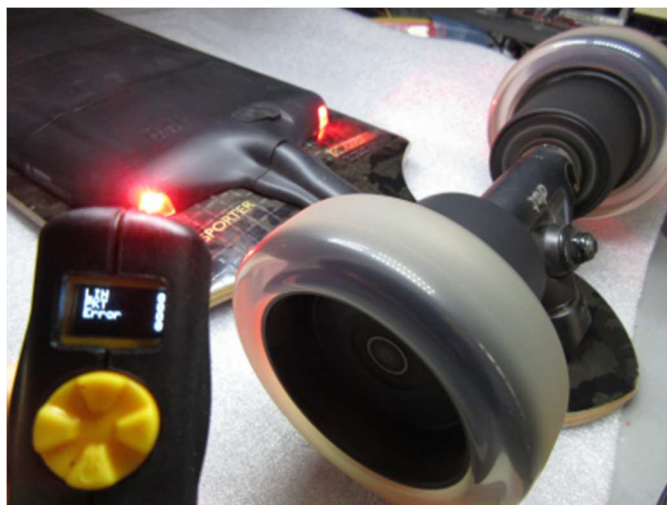
- Zero non-packet responses.
- Zero packet errors
- Zero dropouts

Increased electrical noise evident, but no impact to LIN data stability.

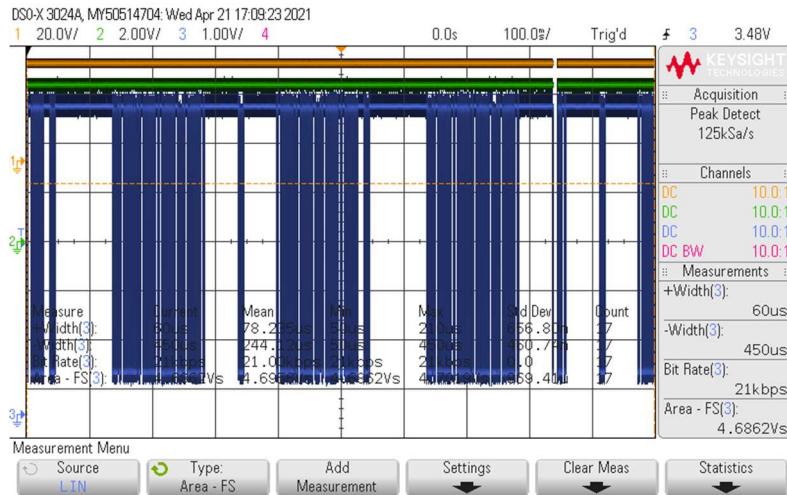
On application of the throttle, there was a noticeable perturbation in voltage levels.

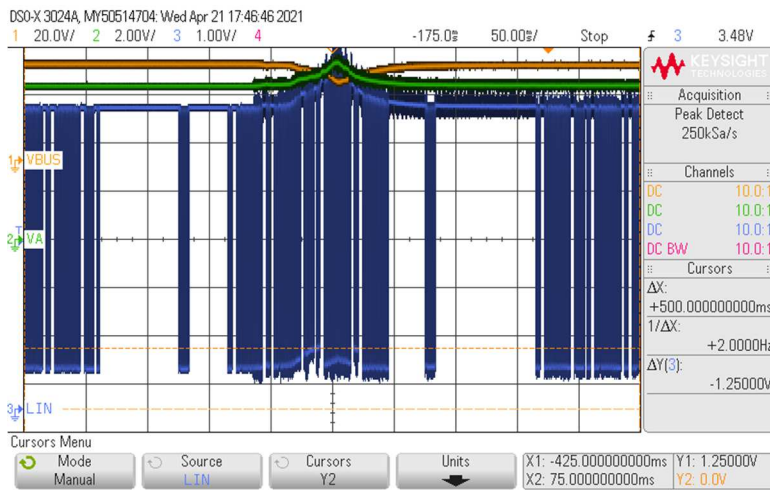
The difference varied on successive tests. The noisy LHS was not significantly different to the RHS.

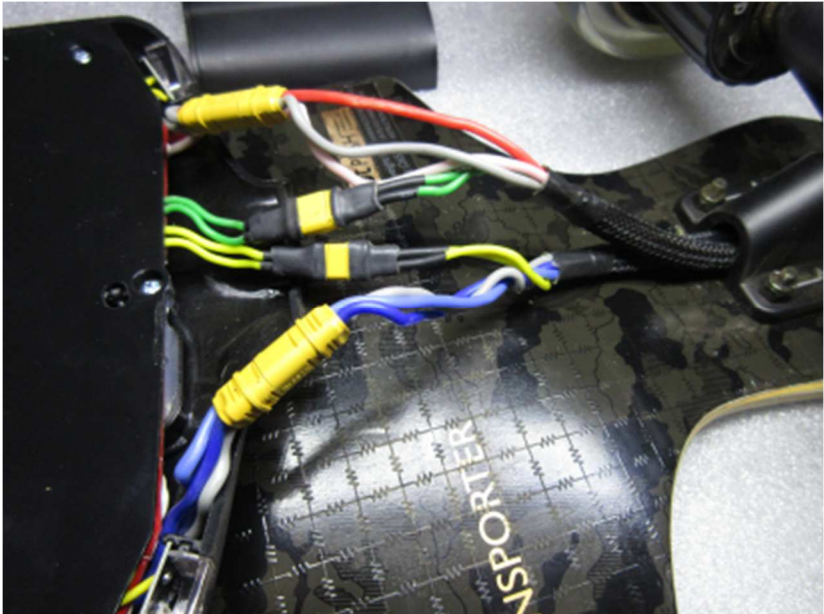
Wiring looks in very good condition.

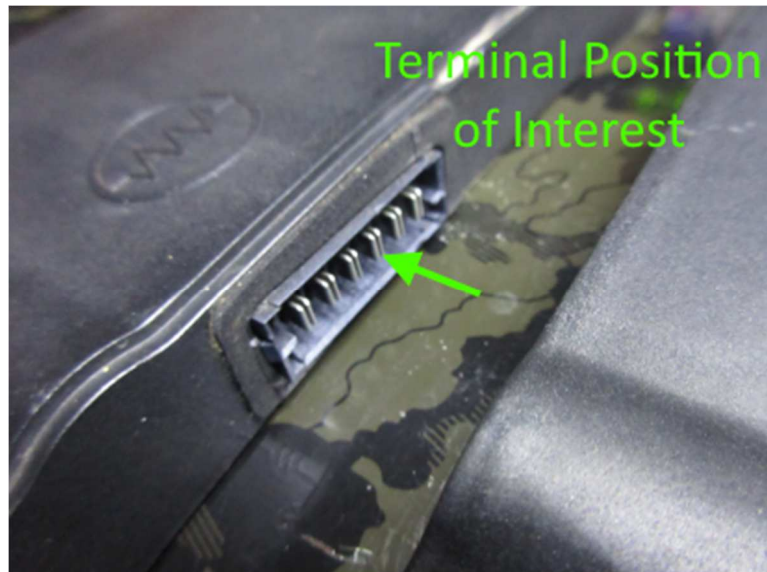
The failure at this location explains why both batteries were logging dropout faults.

The fault only occurred with this battery. Swapping the batteries around did not generate the same fault, indicating the connector on the Main Controller was in better condition.

Quite noticeable terminal oxidization on the battery causing the dropouts.

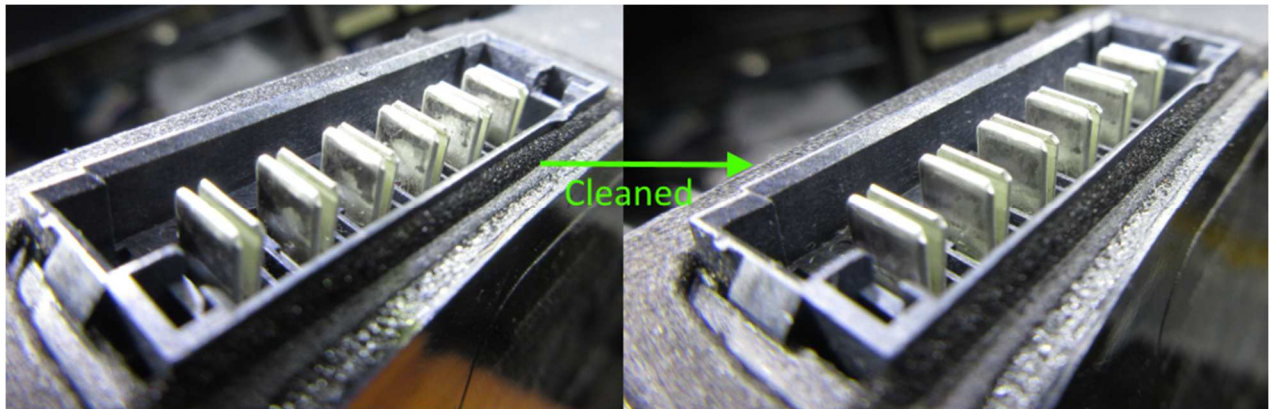
The board exhibited no sensitivity to module movement after connector servicing.

A process for effectively re-conditioning the terminals hasn't been established. The male terminals were sanded with 1200 wet/dry paper. Both male and female were cleaned with contact cleaner. Di-electric grease applied. This connector servicing is not considered full restored. Likely with a better process, the result could be better.
