BATTERY MODULE DROPOUT INVESTIGATION

Date: 23rd April 2021
Revision: 1.0
Author: Tony Little
Product: Electric Skateboard
Company: Globe Brand

5 boards were investigated for power dropout issues. 2 Compact and 3 Transporters.

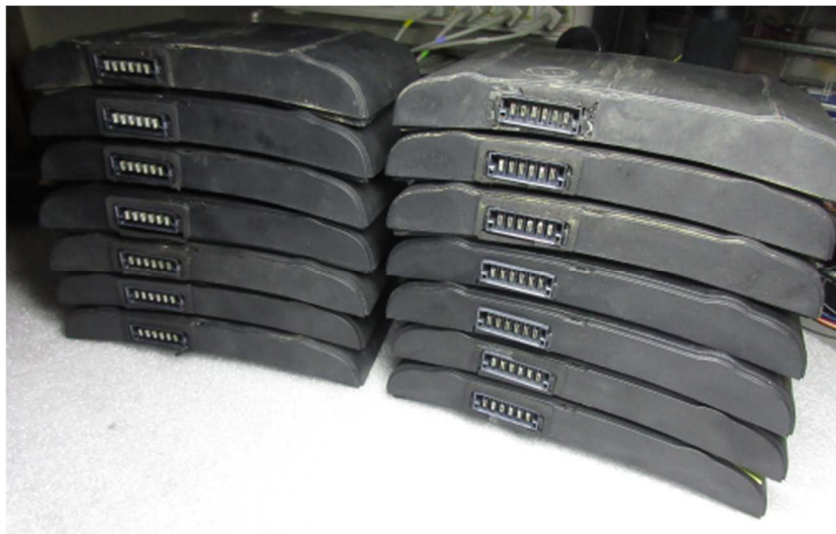
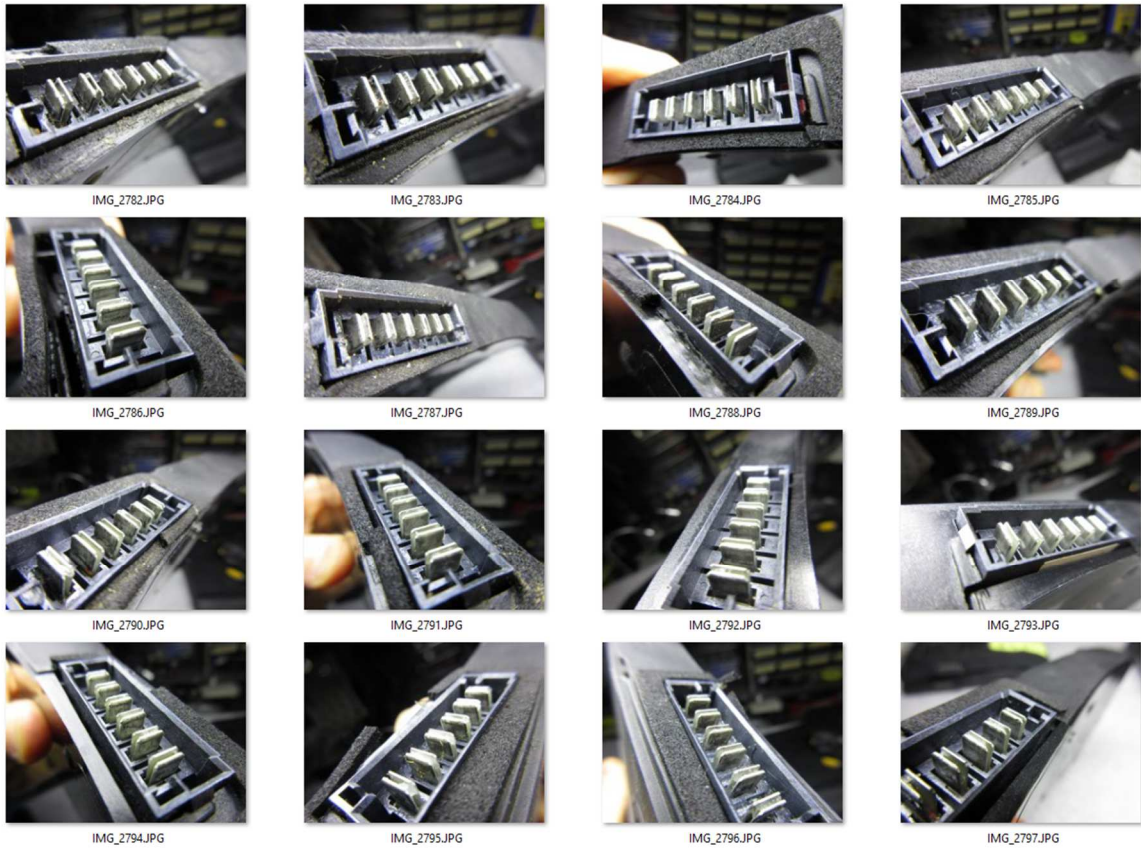
12 used field return battery modules were inspected for connector terminal damage. All had contact grease. It was quite evident that minimum damage to the plating had occurred. The wear marks observed were relatively consistent and evenly distributed. Only the male terminals shown. Females are difficult to photograph to show surface condition.

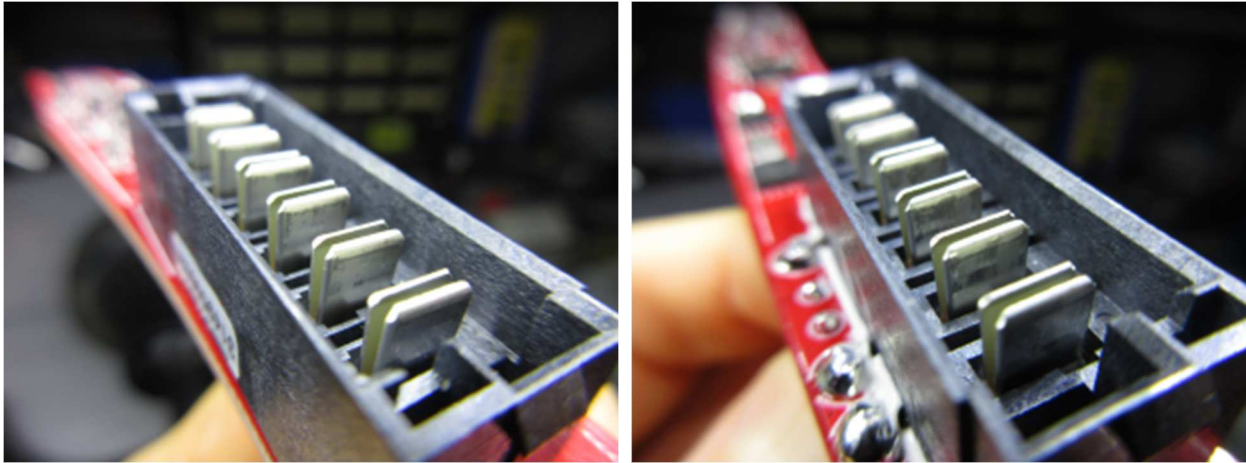
A brand new battery shows markings on the terminals. These will have been plugged/unplugged at least 4 times prior to this picture. Although marked, the plating looks good and there is no black oxidized residue.

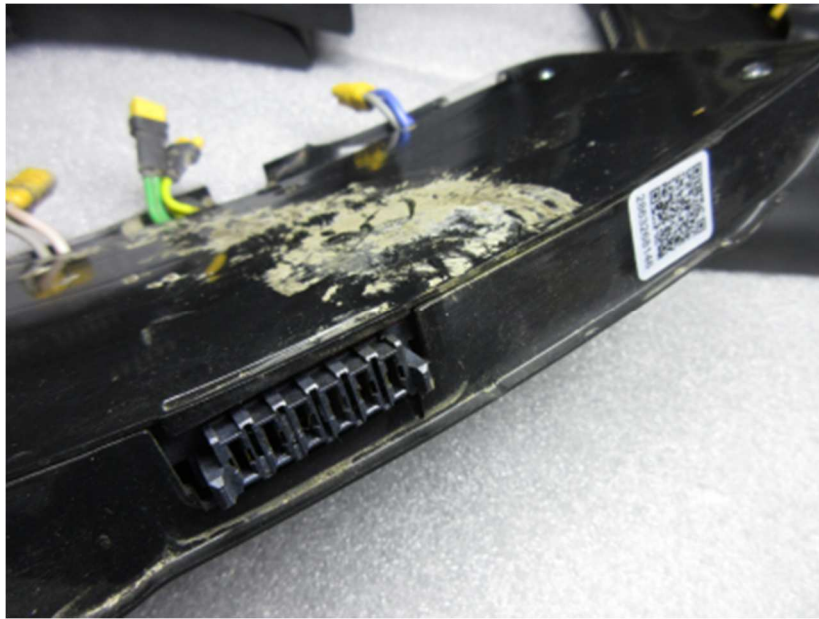
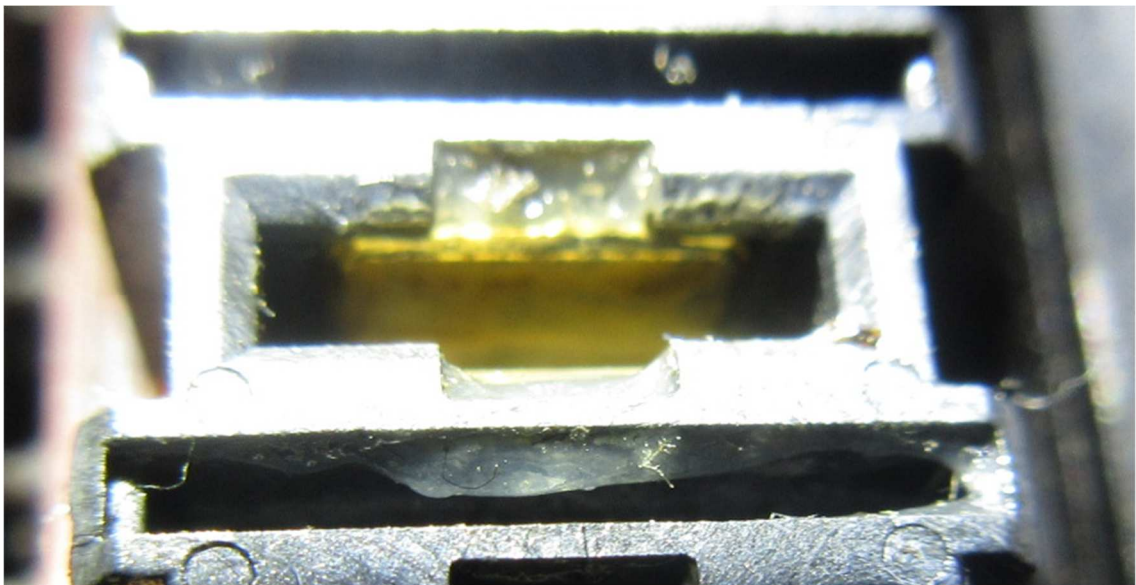
An MC that has gone through some mud was inspected. The connector terminals look in very good shape.

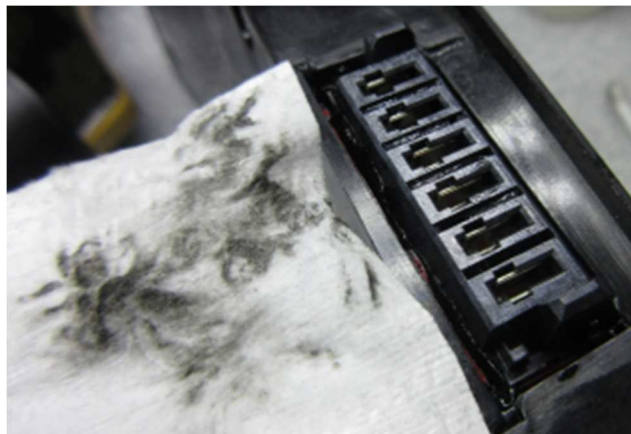
The image below shows the female connector for battery 3149595724. The white cloth shows the oxidized contamination from cleaning this connector. It was a previously a clean cloth.

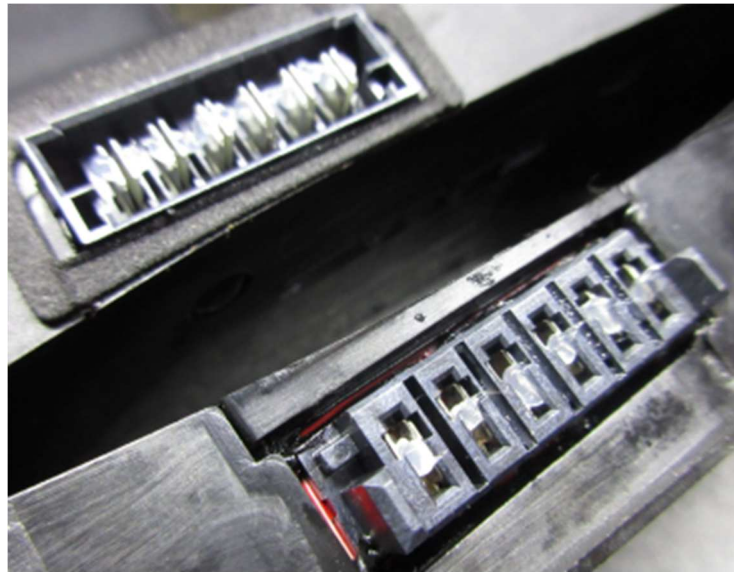
A minimal amount of CRC di-electric grease was added, as shown below. This is the same di-electric grease previously used in production.

The battery modules were re-plugged 10 times prior to measurement to ensure good distribution of the material. The measurement reduced from 26mohm to 23mohm.

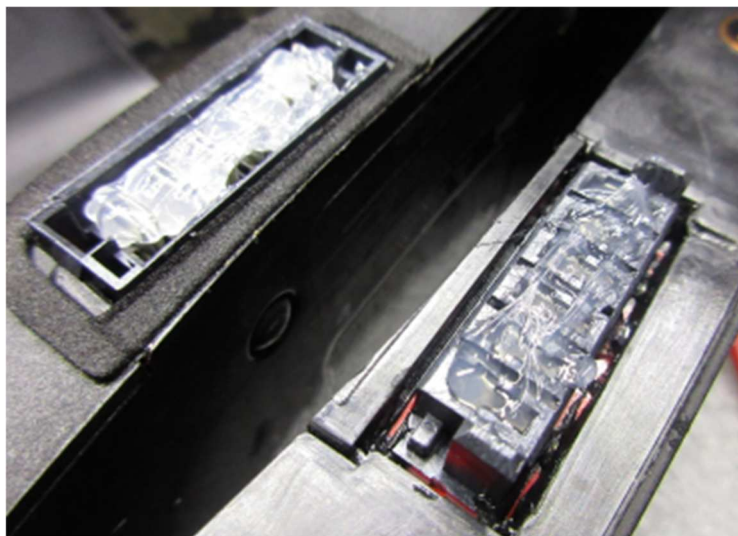
A ridiculous amount of grease was then applied, as shown below.

The measurement further reduced to 21mohm.

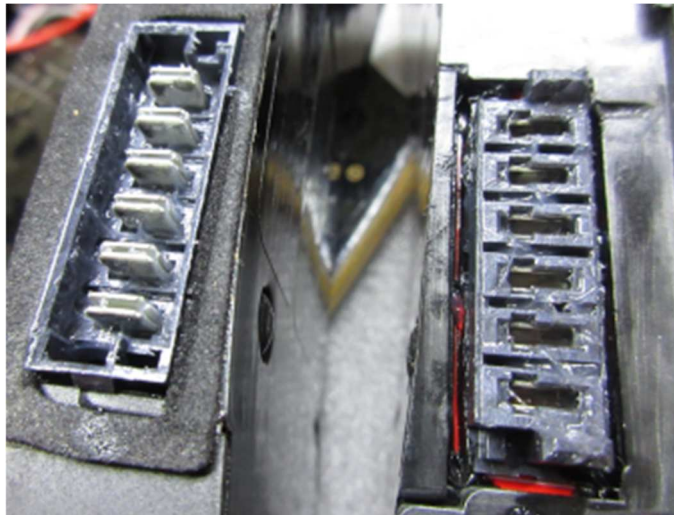
The majority of the grease was pushed to coating the plastic shroud, where it is ineffective/wasteful.

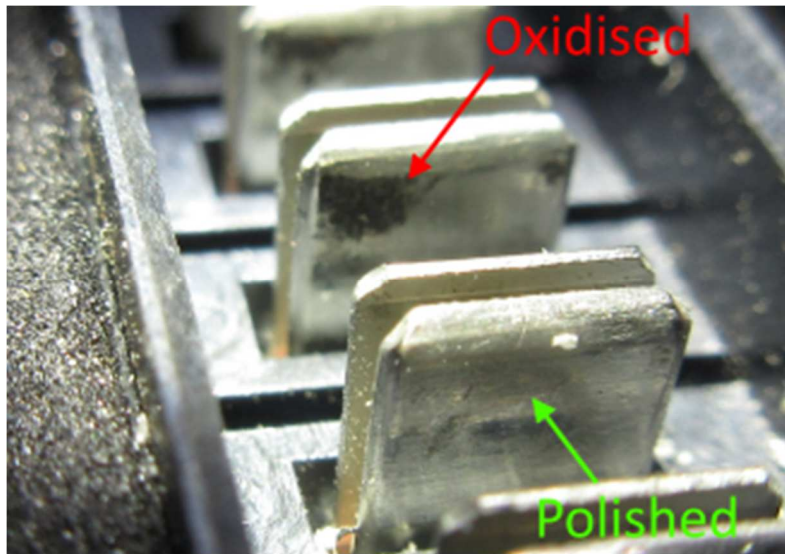
1200 wet/dry paper provided a reasonable approach to removing the oxidized plaque on the male terminals.

All these methods really only helped to address the male terminals. The female connector terminals are considerably more difficult to access.
